Controlling Debris at Pennsylvania Bridges

FINAL REPORT

October 2008

By S. A. Sheeder and P. A. Johnson
The Thomas D. Larson
Pennsylvania Transportation Institute

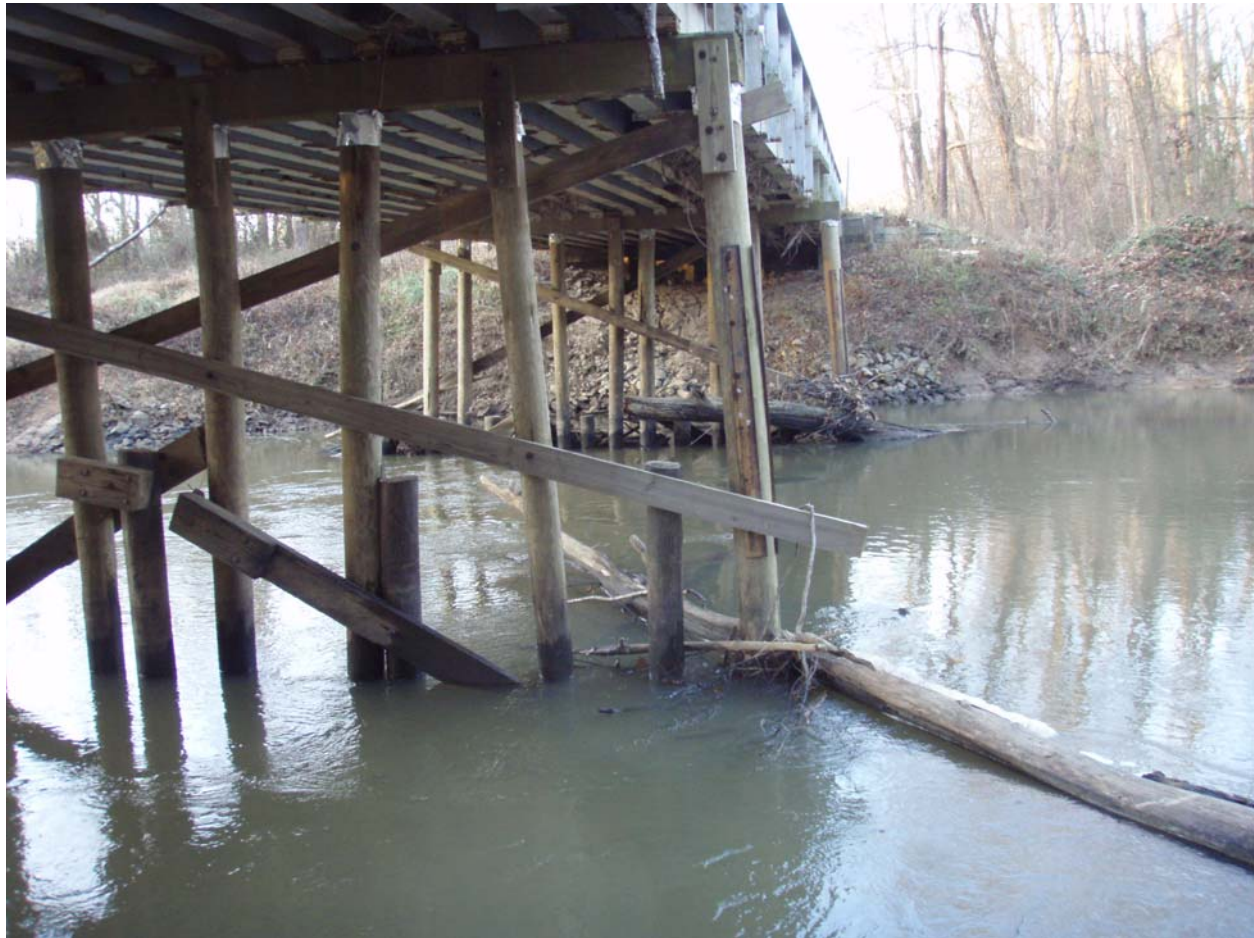
Figure 4. Crib structures could be installed on the exposed multiple piles supporting this bridge to prevent debris from becoming trapped between the piles.

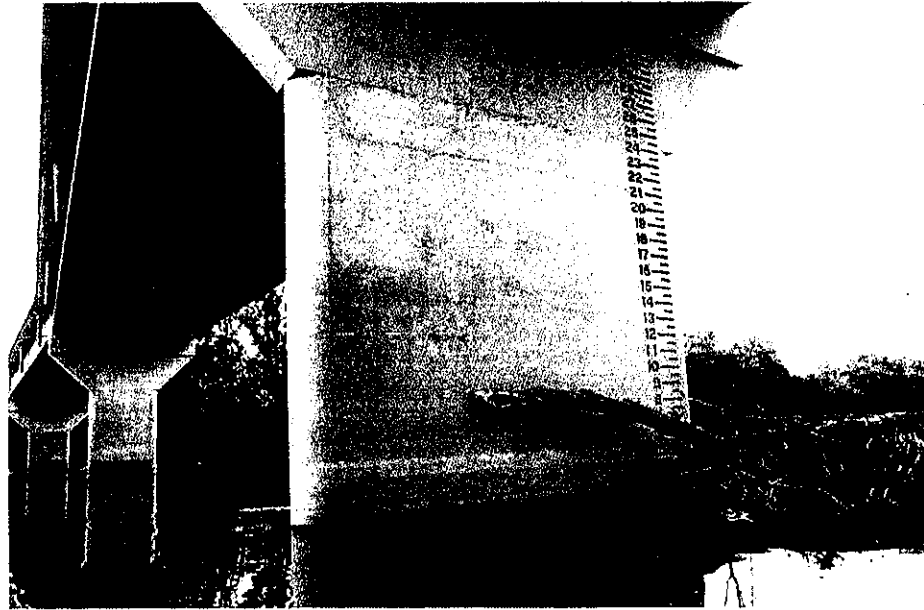
5. Pier 3, far face. Note the water gauge.

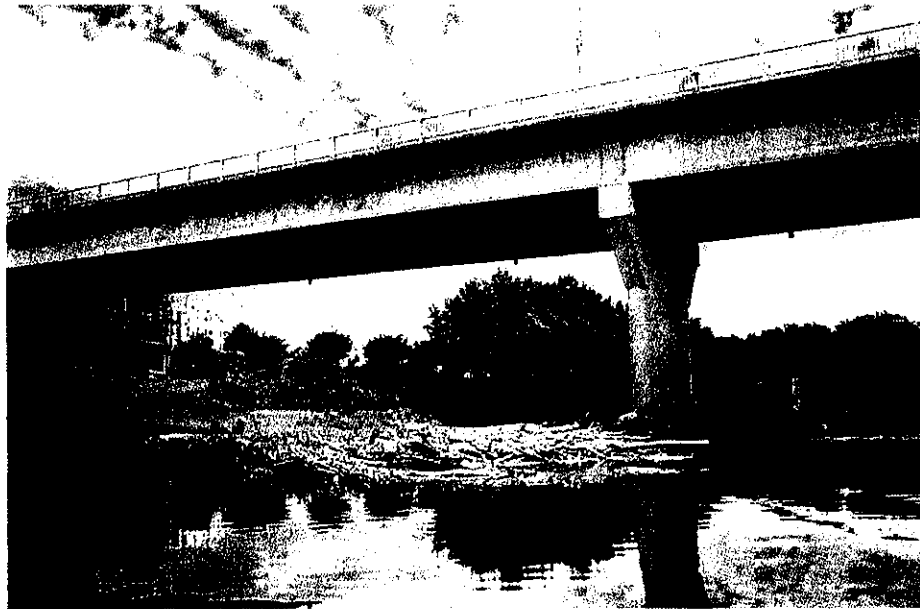
6. Pier 3, upstream nose. Note the large build-up of timber debris.

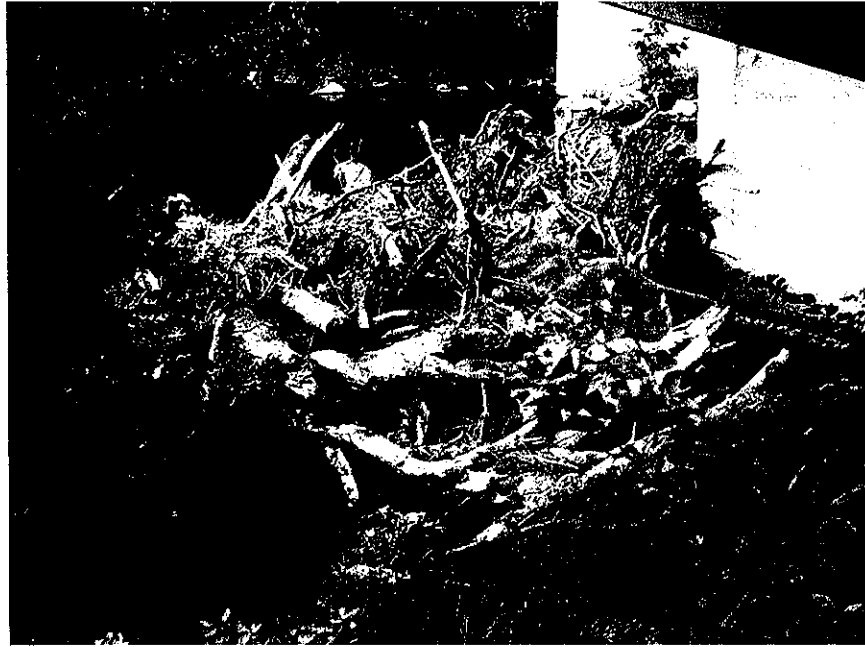
HEAVY DRIFT AT PIER #3

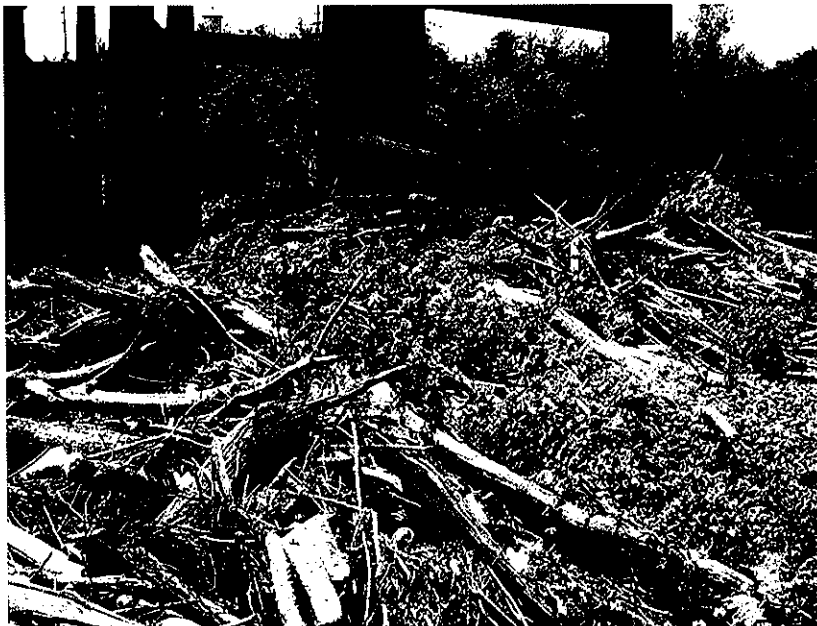
DRIFT AT BENT #8, RIGHT SIDE
