**ADDENDUM NO. 7**

**PROJECT NO. DGS C-0251-0108 PHASE 001**

**PROJECT TITLE - PennDOT District 5 Engineering & Maintenance Campus - Decommissioning  
PROFESSIONAL:**

**Ref: Limited Asbestos-Containing Materials Survey**  
Hamburg State Center  
3560 Old Route 22  
Hamburg, PA 19526  
Job No. 00031345\_003

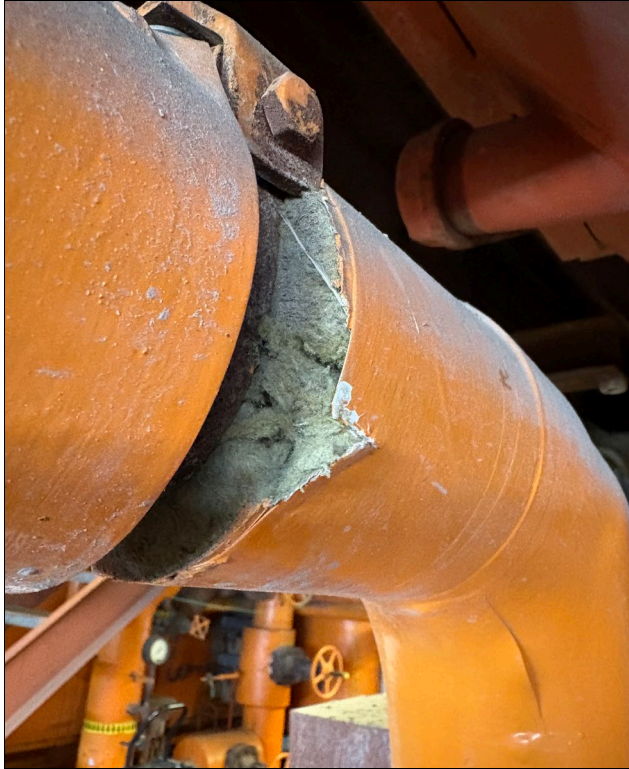
| Table 2.3.1: ACM Sampling Results Summary | | | | |
|---|---|---|---|---|
| HC-01A | White Paper Pipe Wrap | Main Boiler Building – High Pressure Steam Line | NAD | Good |
| HC-01B | Brown Insulation | | NAD | Good |

Photo 1 - HC-01A and HC-01B: White Paper Pipe Wrap and Brown Insulation

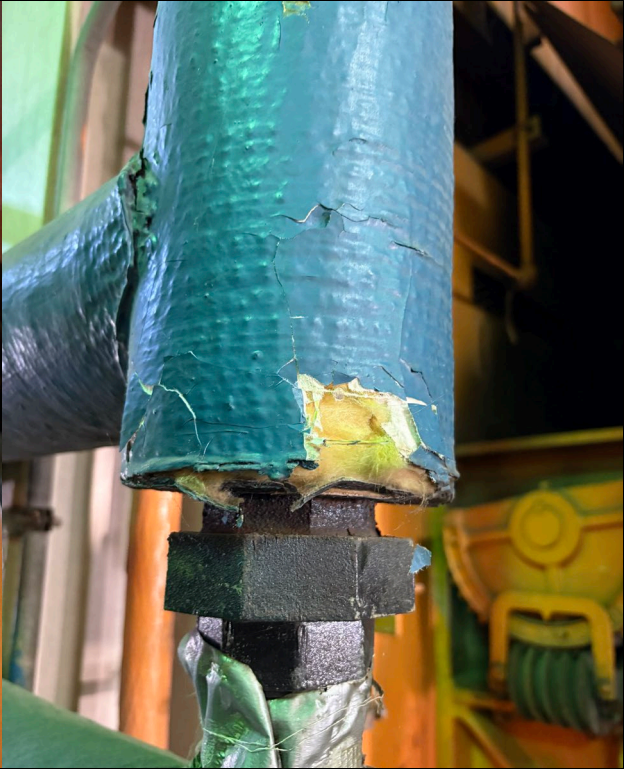
| Table 2.3.1: ACM Sampling Results Summary | | | | |
|---|---|---|---|---|
| HC-02A | White Paper Pipe Wrap | Main Boiler Building – Boiler Feed Water Line | NAD | Good |
| HC-02B | Yellow Insulation | | NAD | Good |

Photo 2 - HC-02A and HC-02B: White Paper Pipe Wrap and Yellow Insulation

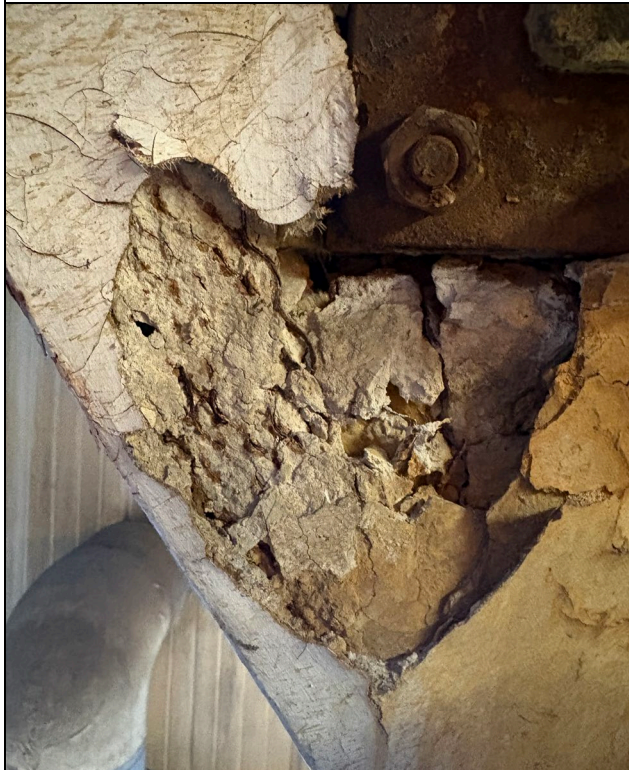
| Table 2.3.1: ACM Sampling Results Summary | | | | |
|---|---|---|---|---|
| HC-03 | Mudded Wrap | Main Boiler Plant | NAD | Good |

Photo 3 - HC-03: Mudded Wrap

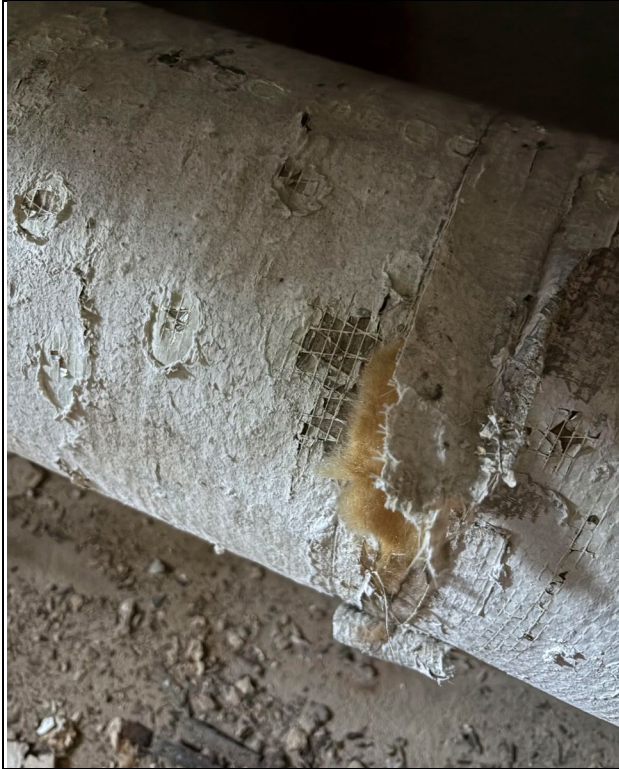
| Table 2.3.1: ACM Sampling Results Summary | | | | |
|---|---|---|---|---|
| HC-05A | White Paper Pipe Wrap | Low Pressure Steam Line Entering Building 15 | NAD | Good |
| HC-05B | Yellow Insulation | | NAD | Good |

**Photo 5 - HC-05A and HC-05B: White Paper Pipe Wrap and Yellow Insulation**

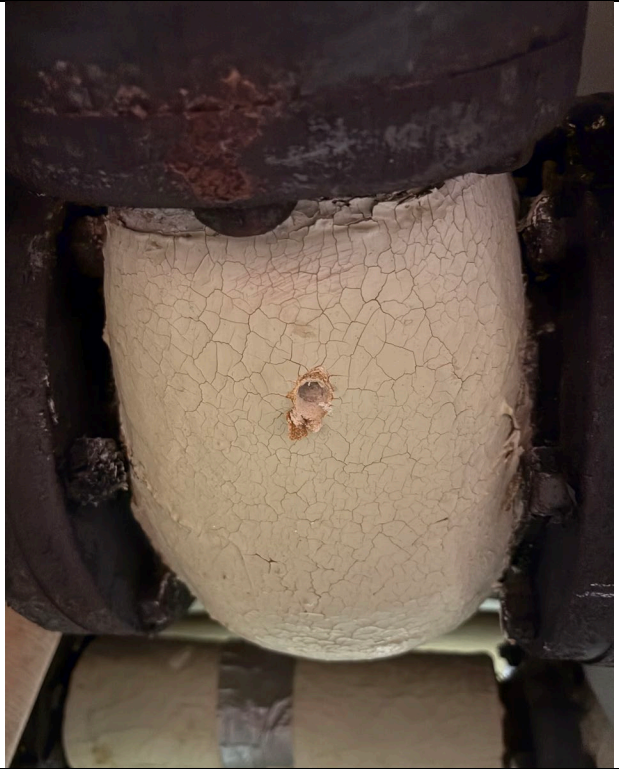
| Table 2.3.1: ACM Sampling Results Summary | | | | |
|---|---|---|---|---|
| HC-06 | Cream Wrap | Admin/Building 15 - High Pressure Steam Line | NAD | Good |
| | White Mudded Fitting | | 65% Chry | Good |

**Photo 6 - HC-06: White Mudded Fitting (ACM)**

Based on the findings of the limited ACM Survey, all suspect pipe insulation should be assumed to be asbestos-containing unless future sampling determines otherwise. KCI understands that decommissioning work may include cutting small sections of pipe to allow for draining of the systems. Prior to any decommissioning work that may impact known or suspected asbestos-containing materials, KCI recommends a licensed and experienced asbestos abatement contractor remove all ACM required to safely perform decommissioning activities. The amount of removal will be dependent upon the condition and friability of the material as well as the amount of space needed for decommissioning work. KCI anticipates that any required abatement work will be performed via glovebag or mini-containment procedures.

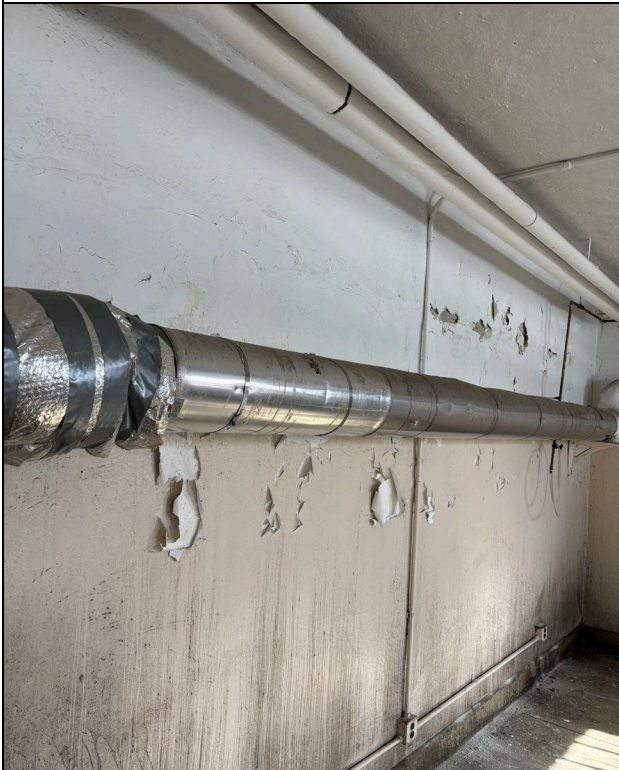
| Table 2.3.1: ACM Sampling Results Summary | | | | |
|---|---|---|---|---|
| HC-07 | Cream Wrap | Corridor Between Admin Building and West Wing | NAD | Good |
| | White Pipe Insulation – TSI | | 65% Chry | Good |

**Photo 7 - HC-07: White Pipe Insulation – TSI (ACM)**

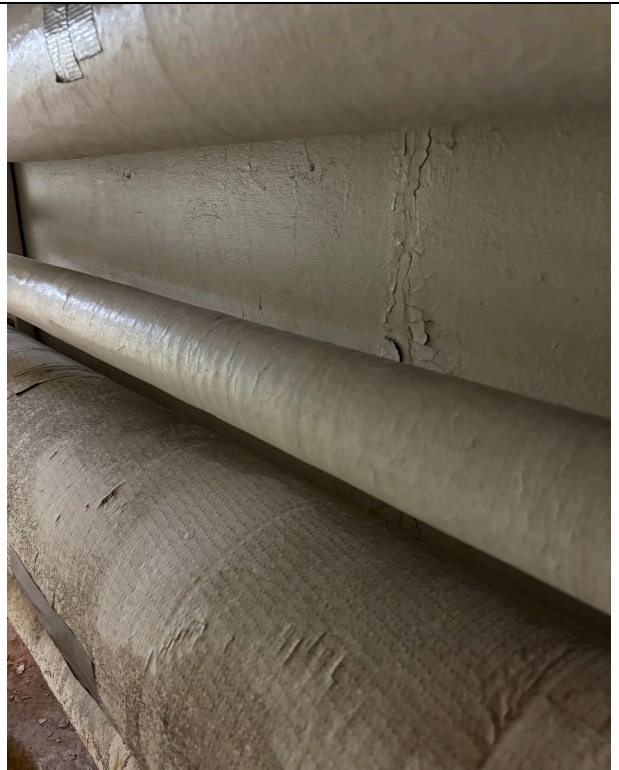
| Table 2.3.1: ACM Sampling Results Summary | | | | |
|---|---|---|---|---|
| HC-08 | Cream Wrap | Small Pipe in Corridor Between West Wing and Buildings 1, 2, 3, and 9 | NAD | Good |
| | White Pipe Insulation – TSI | | 90% Chry | Good |

**Photo 8 - HC-08: White Pipe Insulation – TSI (ACM)**

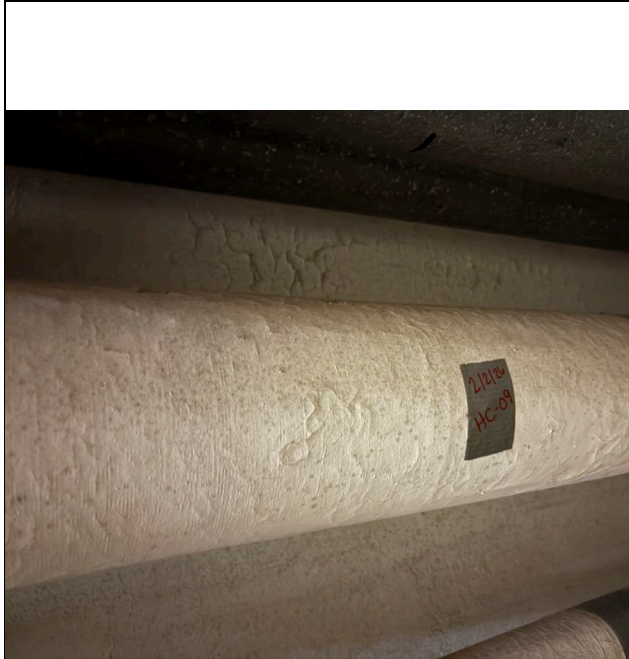
| Table 2.3.1: ACM Sampling Results Summary | | | | |
|---|---|---|---|---|
| HC-09 | Cream Wrap | Large Pipe in Corridor Between West Wing and Buildings 1, 2, 3, and 9 | NAD | Good |
| | White Pipe Insulation – TSI | | 90% Chry | Good |

**Photo 9 - HC-09: White Pipe Insulation – TSI (ACM)**

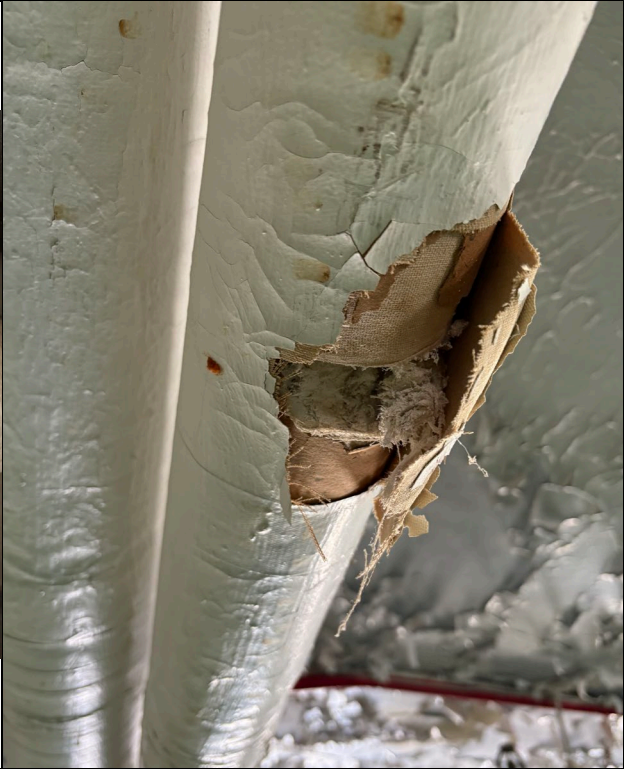
| Table 2.3.1: ACM Sampling Results Summary | | | | |
|---|---|---|---|---|
| HC-10 | White Pipe Insulation – TSI | West Wing - Maple Hall | 65% Chry | Good |

**Photo 10 - HC-10: White Pipe Insulation – TSI (ASM)**

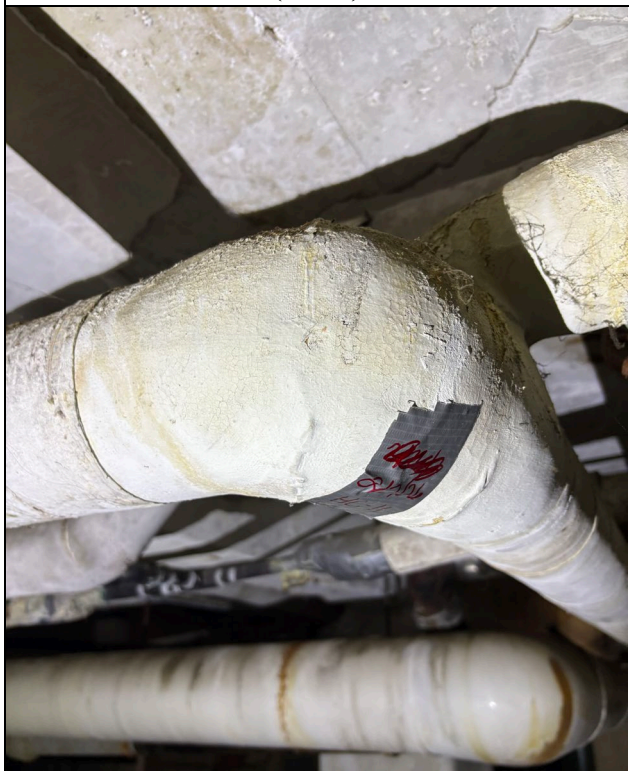
| Table 2.3.1: ACM Sampling Results Summary | | | | |
|---|---|---|---|---|
| HC-11 | Cream Wrap | West Wing – Maple Hall - Mechanical Room | NAD | Good |
| | White Mudded Fitting | | 65% Chry | Good |

**Photo 11 - HC-11: White Mudded Fitting (ACM)**

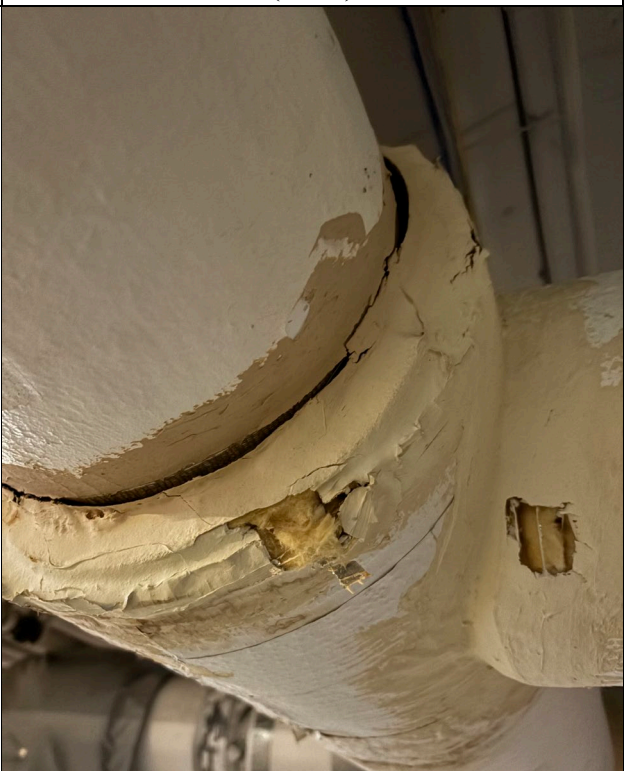
| Table 2.3.1: ACM Sampling Results Summary | | | | |
|---|---|---|---|---|
| HC-12 | Tan Pipe Seam Sealant | West Wing – Maple Hall - Mechanical Room | NAD | Good |

**Photo 12 - HC-12 and HC-13: Tan Pipe Seam Sealant**

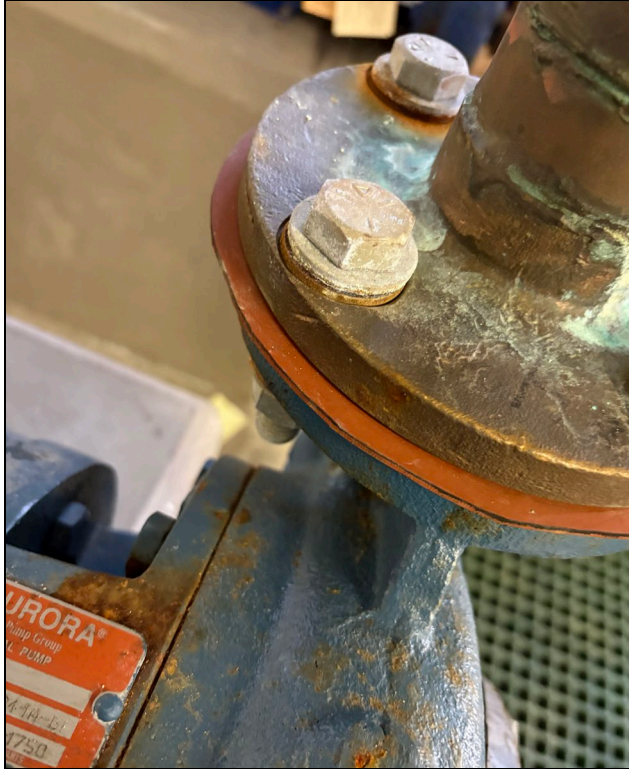
| Table 2.3.1: ACM Sampling Results Summary | | | | |
|---|---|---|---|---|
| HC-14 | Red Pipe Gasket | East Wing – Building 12 | NAD | Good |

Photo 13 - HC-14 and HC-15: Red Pipe Gasket

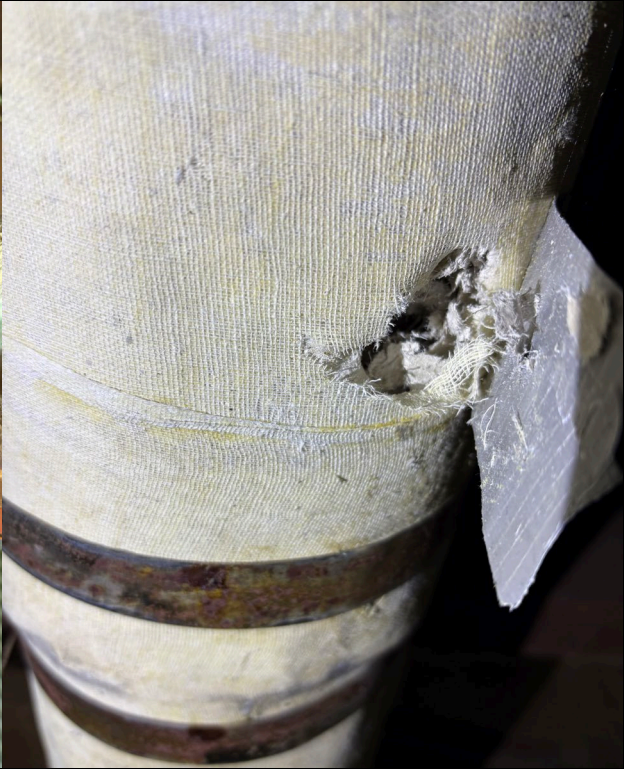
| Table 2.3.1: ACM Sampling Results Summary | | | | |
|---|---|---|---|---|
| HC-16 | White Pipe Wrap – TSI | Auditorium/Building 20 Basement | 55% Chry | Good |

Photo 14 - HC-16: White Pipe Wrap – TSI (ACM)

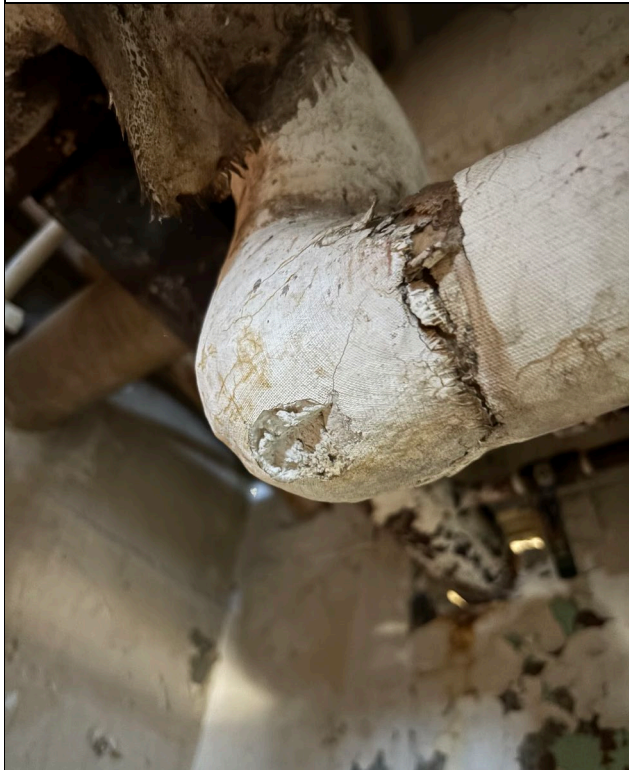
| Table 2.3.1: ACM Sampling Results Summary | | | | |
|---|---|---|---|---|
| HC-17 | Grey Mudded Fitting | Under Building 6 – Domestic Hot Water Line | NAD | Good |

Photo 15 - HC-17: Gray Mudded Fitting

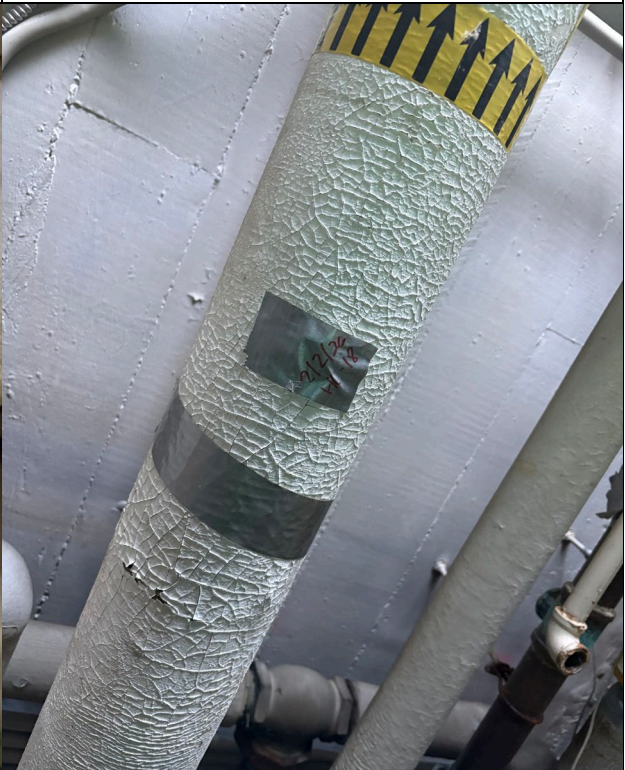
| Table 2.3.1: ACM Sampling Results Summary | | | | |
|---|---|---|---|---|
| HC-18 | Cream Wrap | Under Building 6 – Low Pressure Steam Line | NAD | Good |
| | White Pipe Insulation – TSI | | 20% Chry<br>6% Croc | Good |

Photo 16 - HC-18: White Pipe Wrap – TSI (ACM)

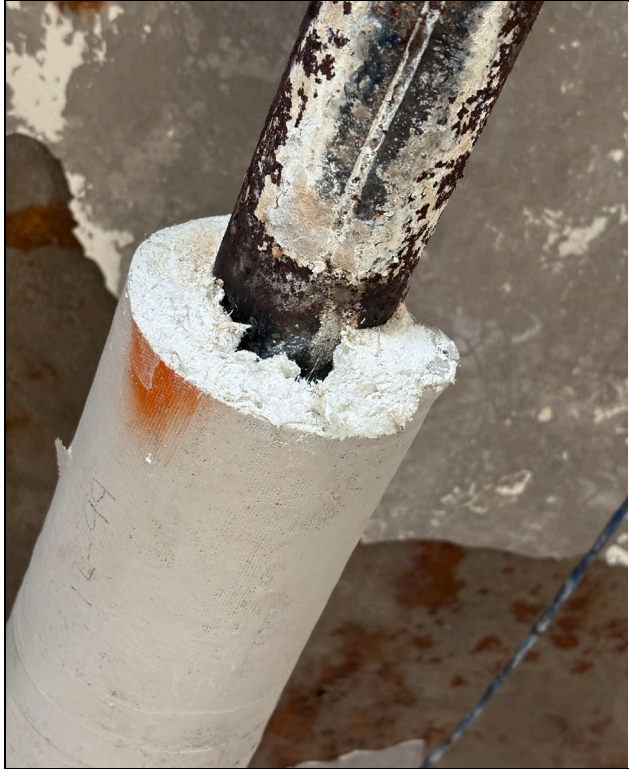
| Table 2.3.1: ACM Sampling Results Summary | | | | |
|---|---|---|---|---|
| HC-19 | White Pipe Insulation – TSI | Building 8 – Connection Room | 20% Chry<br>4% Am | Good |

**Photo 17 - HC-19: White Pipe Wrap – TSI (ACM)**

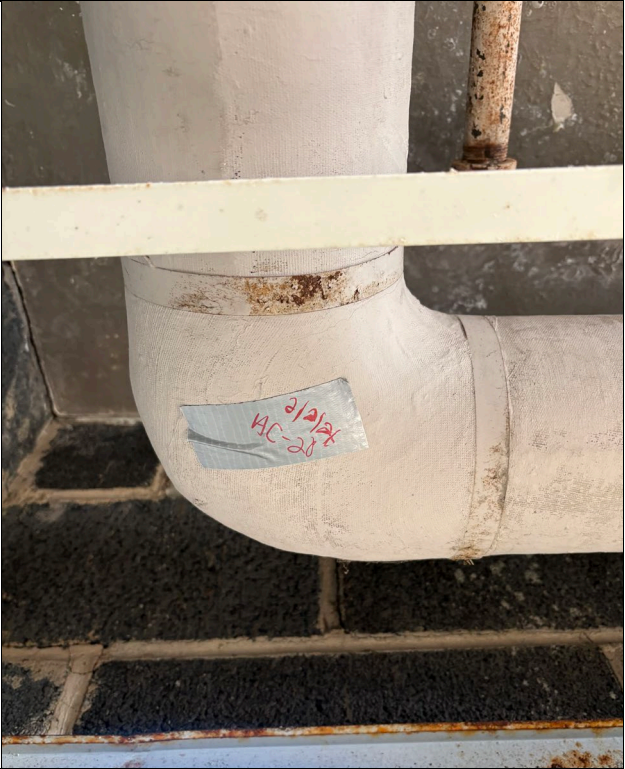
| Table 2.3.1: ACM Sampling Results Summary | | | | |
|---|---|---|---|---|
| HC-20 | Cream Wrap | | NAD | Good |
| | Gray Mudded Fitting | | 55% Chry | Good |

**Photo 18 - HC-20: Gray Muddied Fitting (ACM)**
