**ADDENDUM NO. 1**

**PROJECT NO. DGS C-0404-0034 PHASE 001**

**PROJECT TITLE - McKeever Environmental Center Demolition Project**

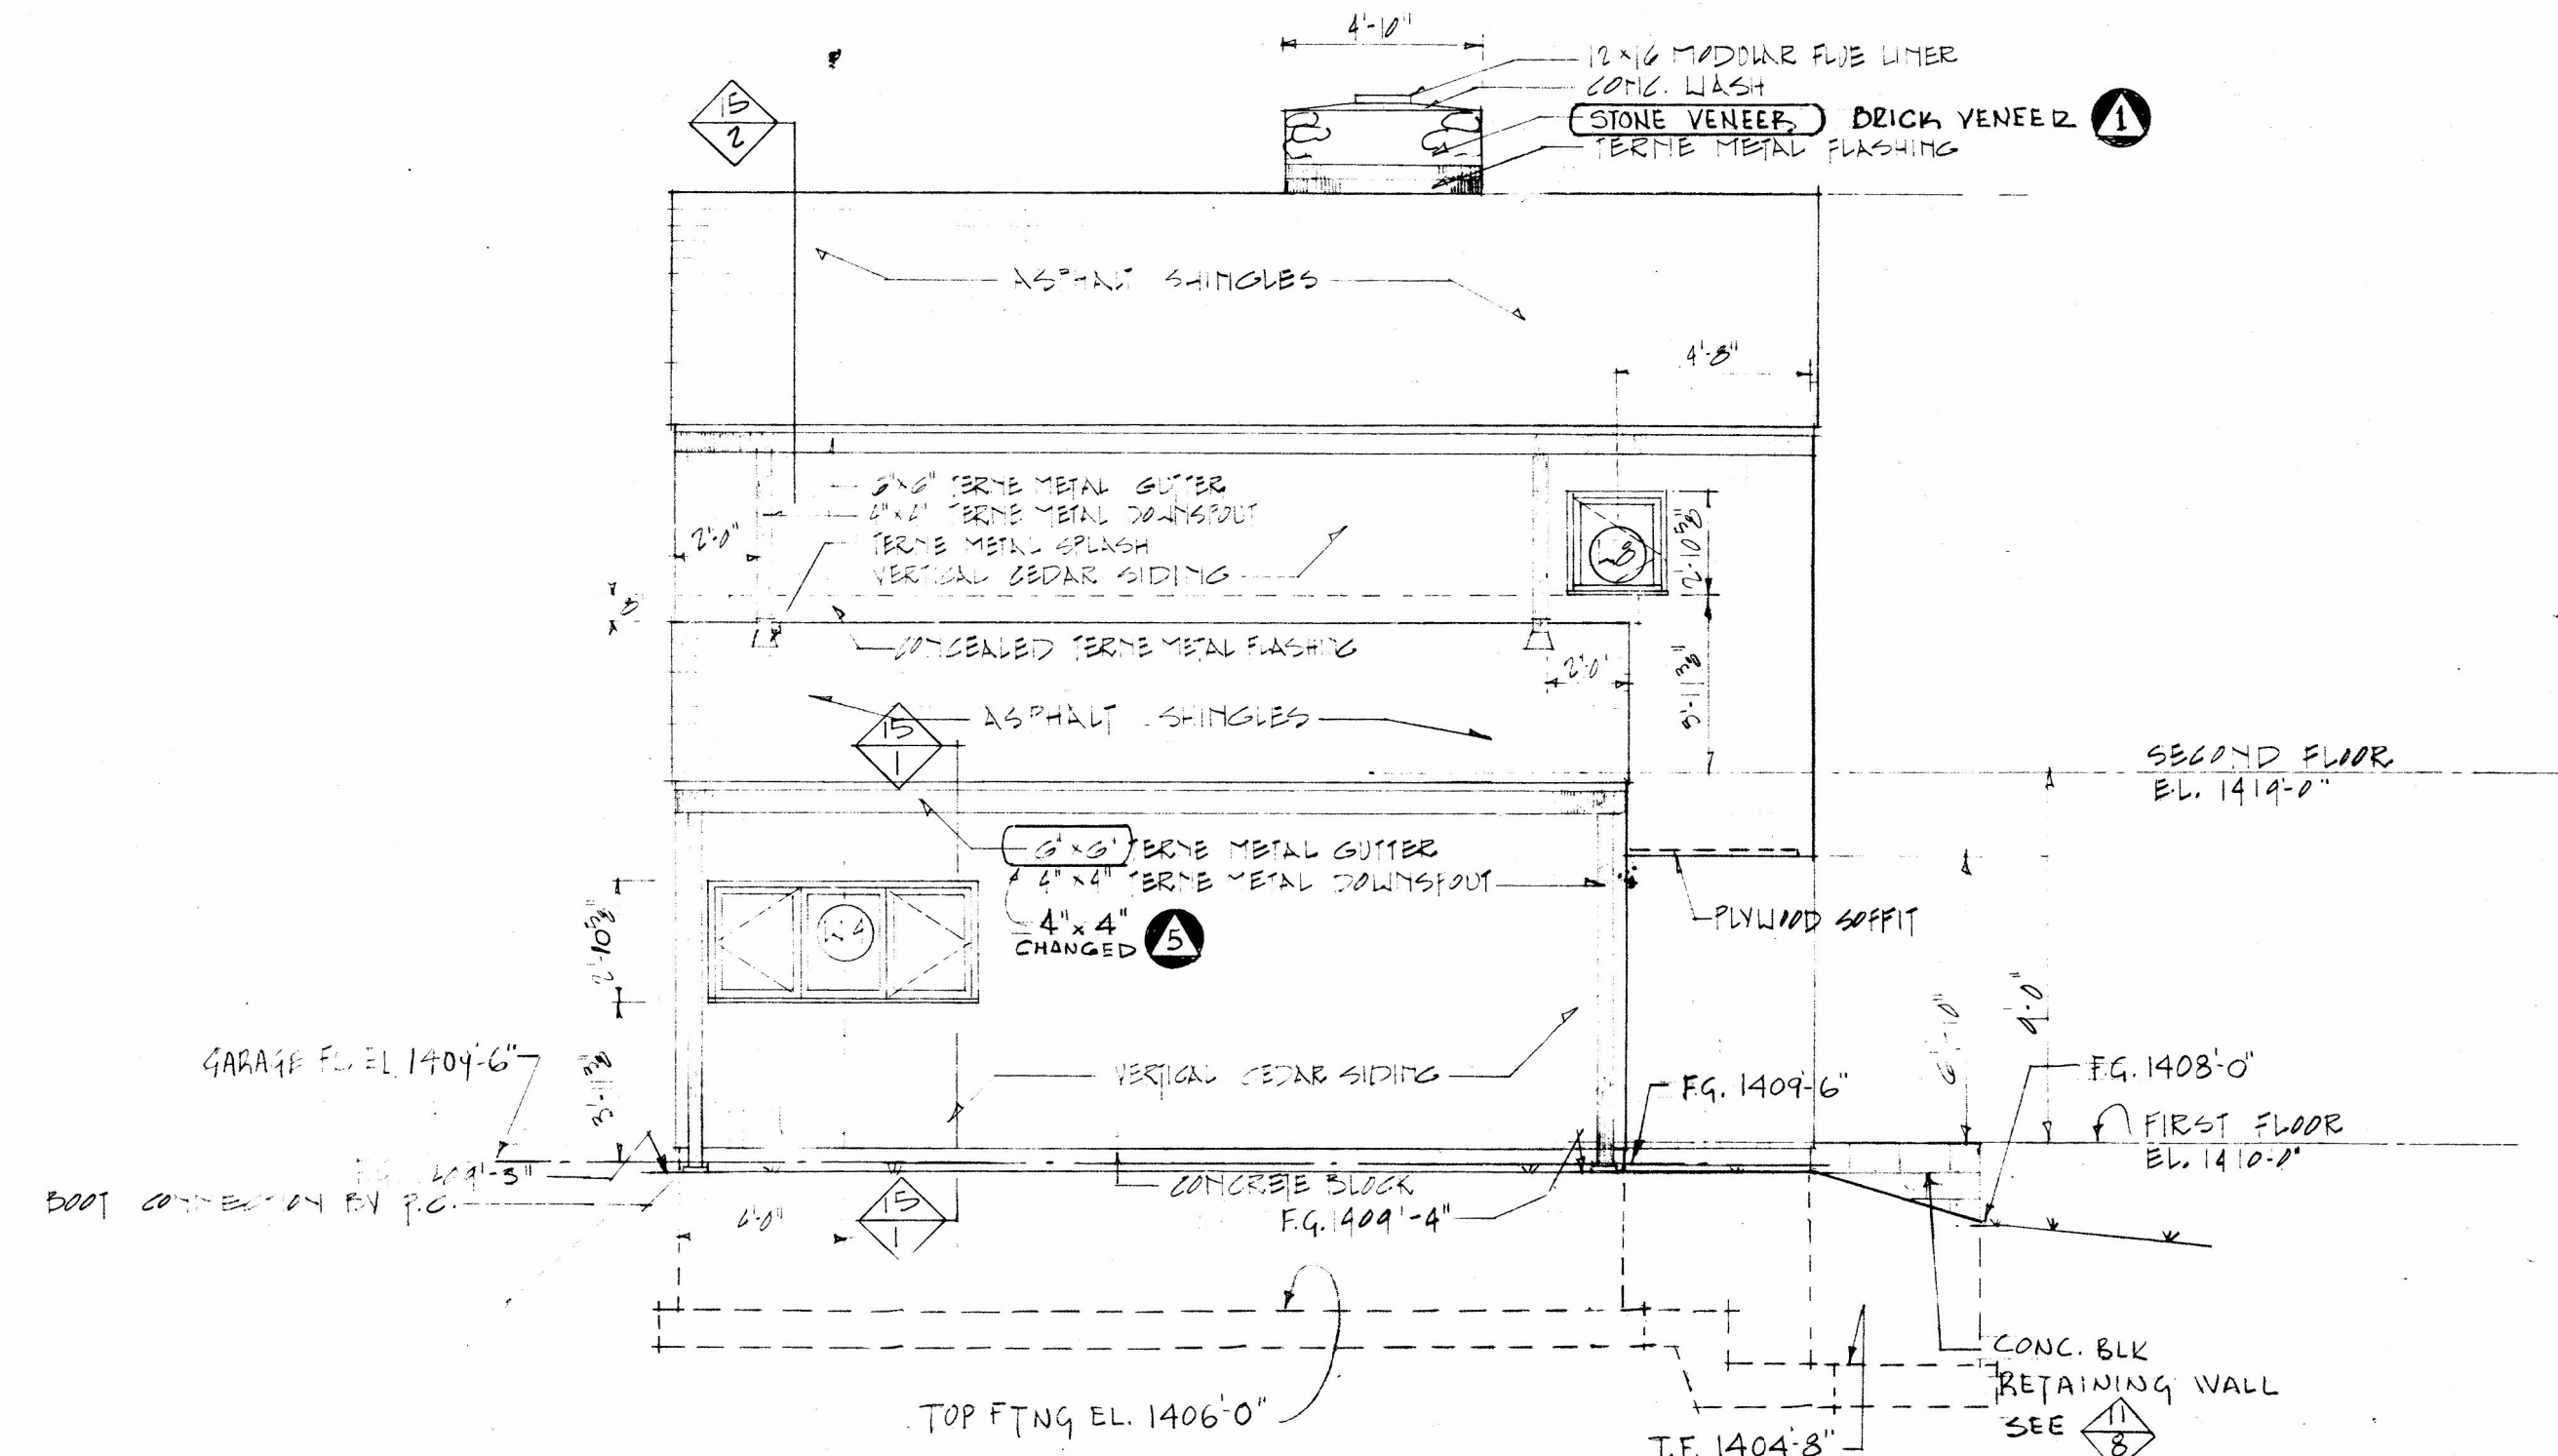
12 EAST ELEVATION. RESIDENCE. SCALE. 1" = 1'-0"

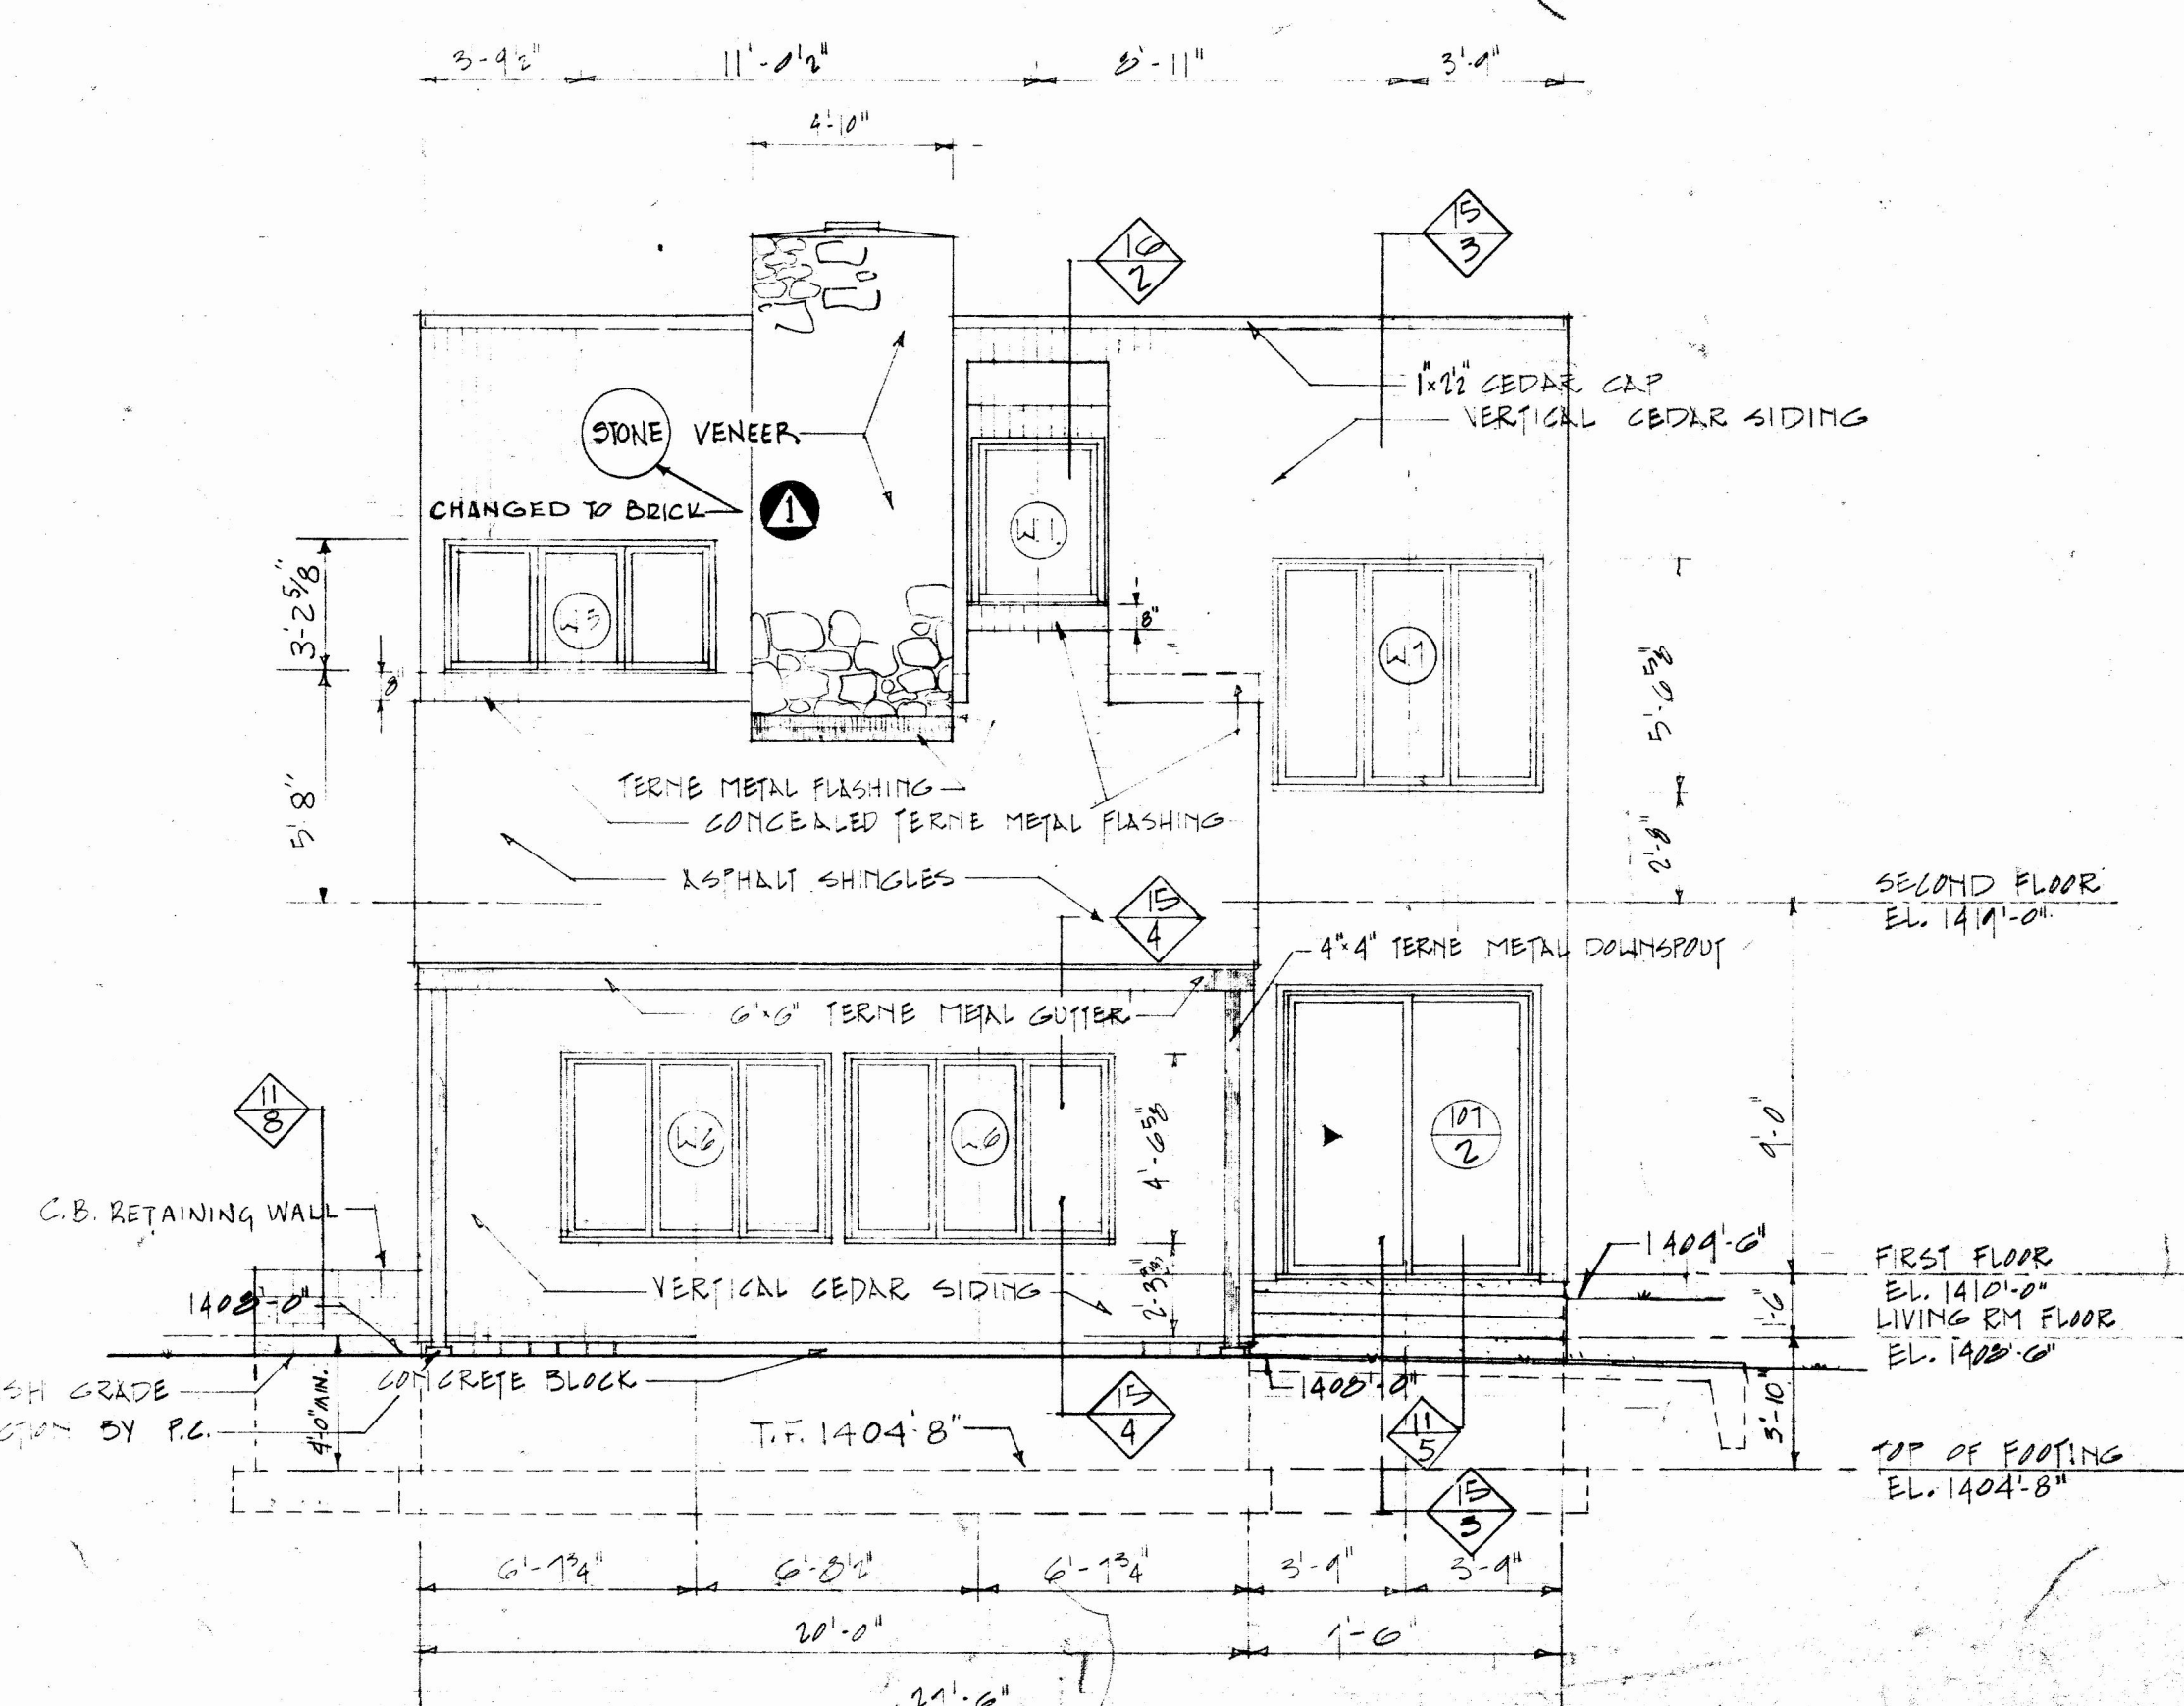
12 • WEST ELEVATION • RESIDENCE •

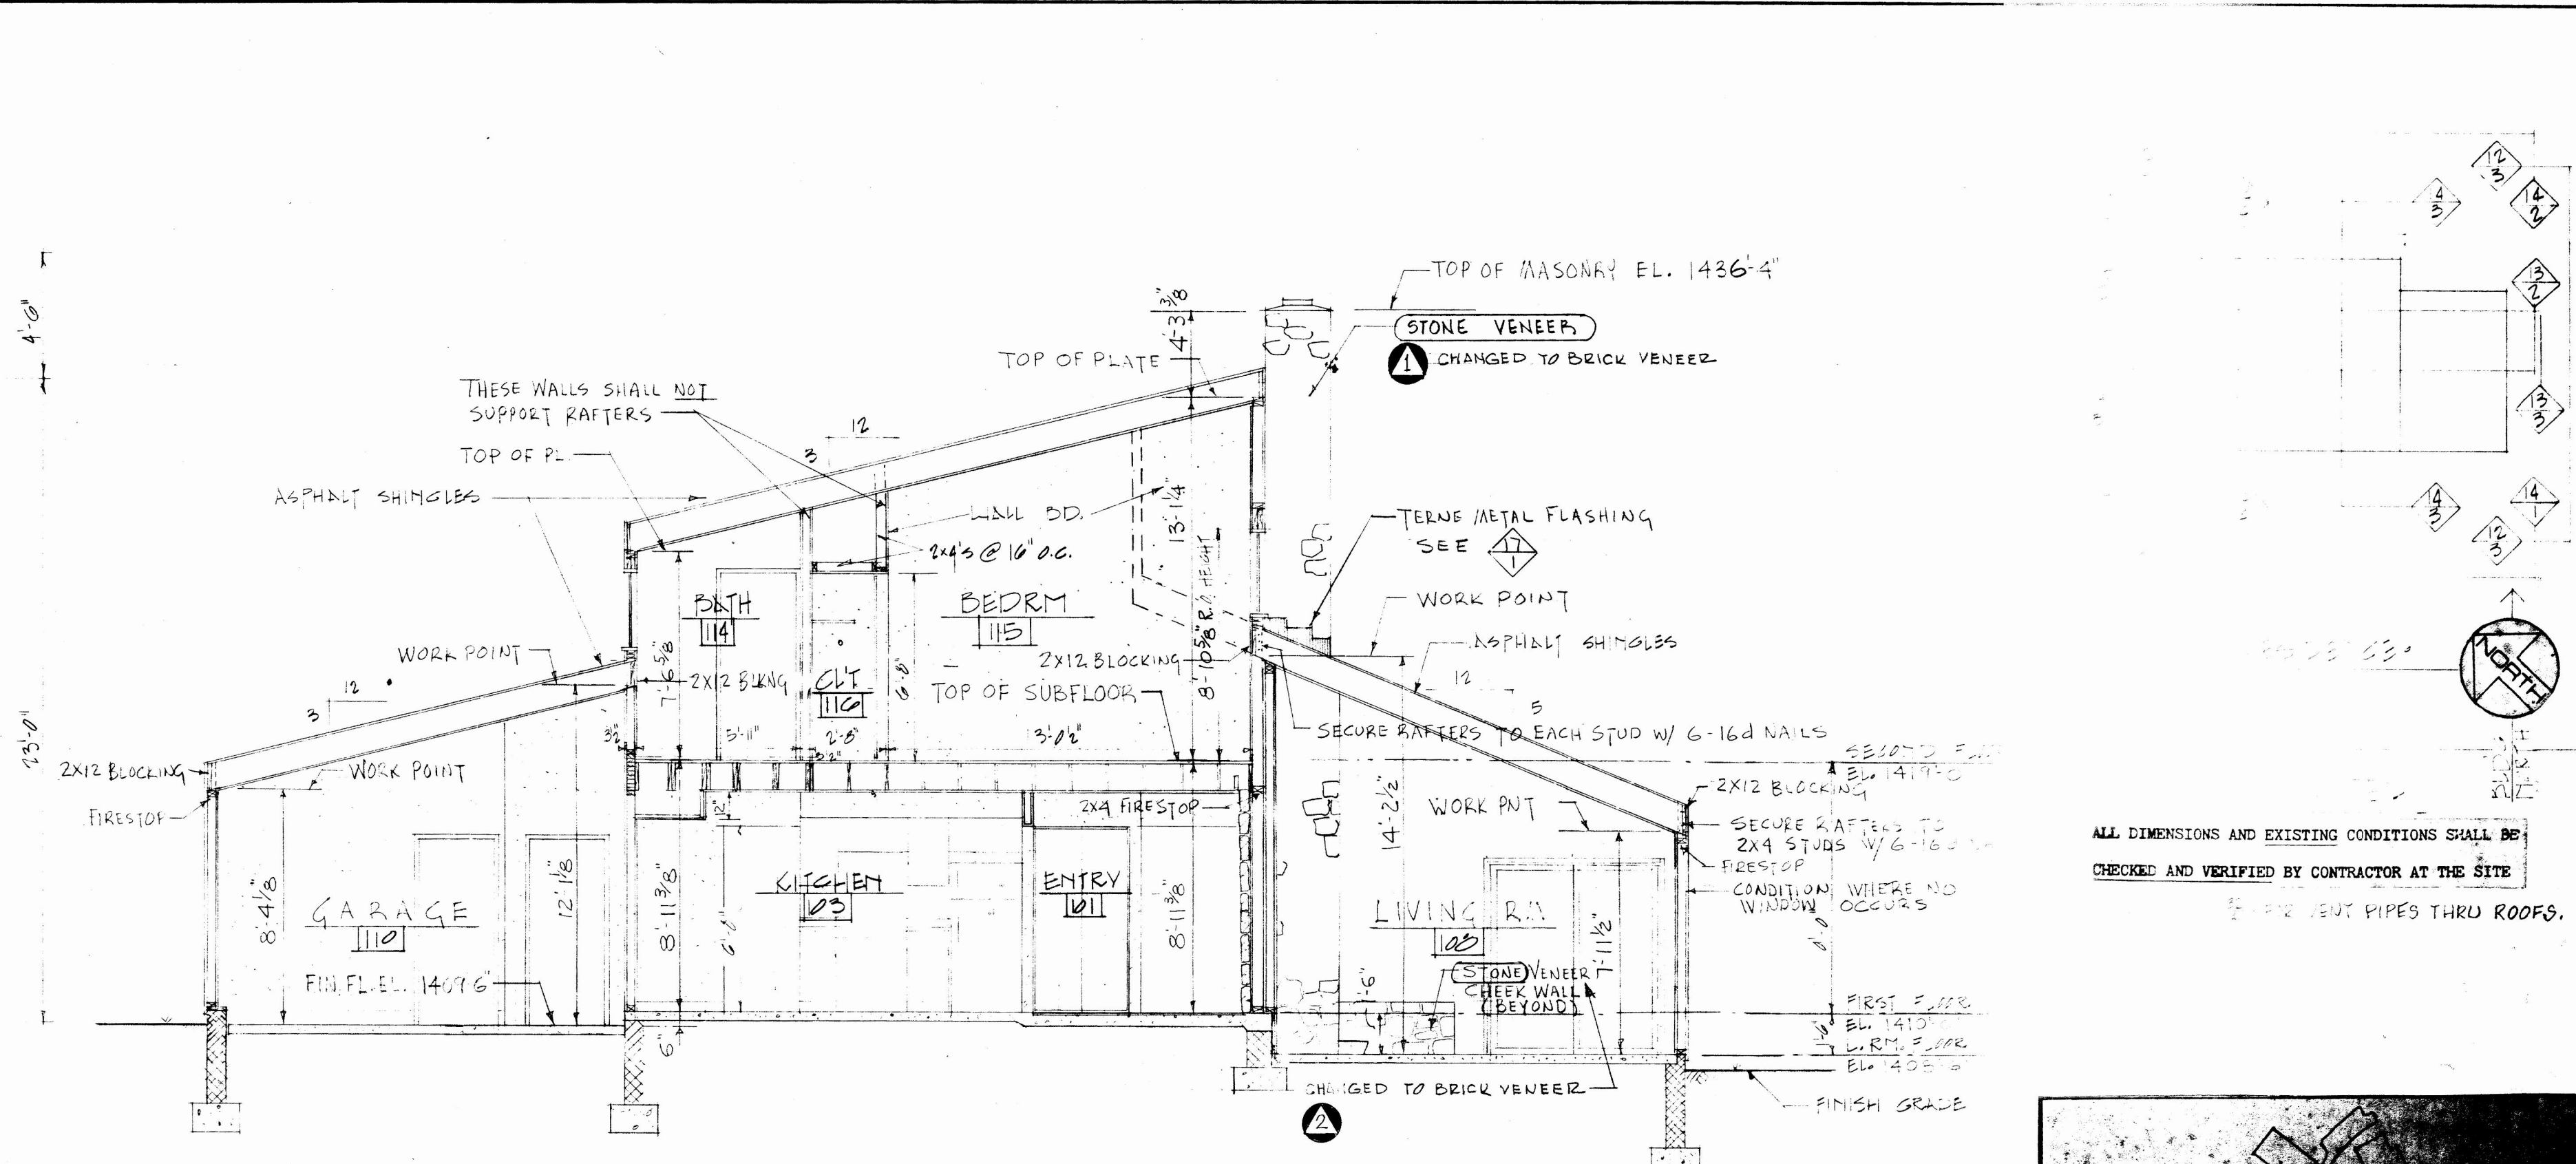
LONGITUDINAL SECTION. RESIDENCE.

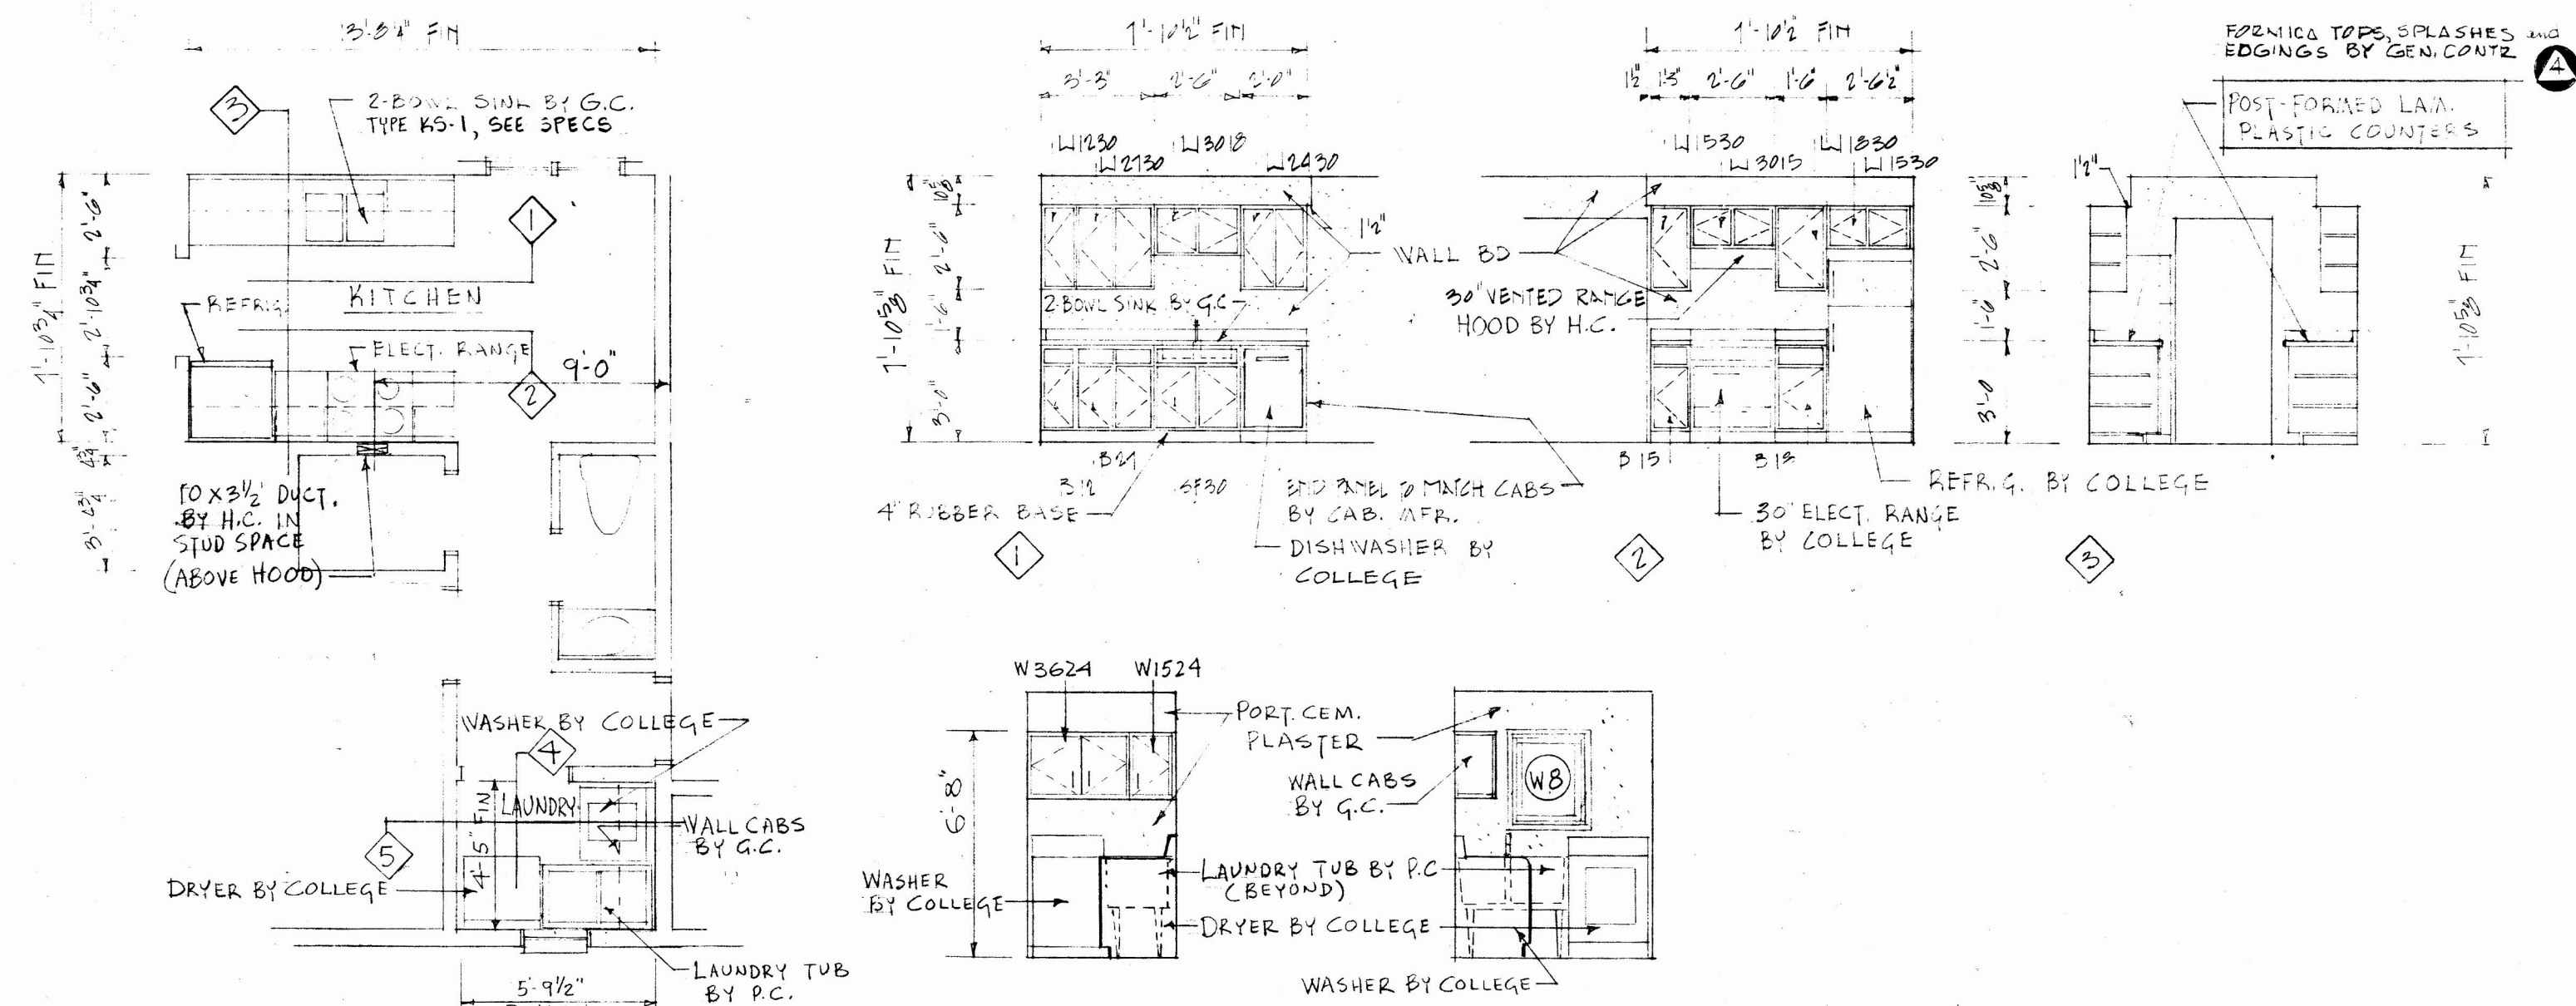
3 • KITCHEN & LAUNDRY • PLAN & ELEVATIONS • RESIDENCE • 0 5' 10'

4 ALL DIMENSIONS ARE FINISHED DIMENSIONS • SCALE: 1/4" = 1'-0"

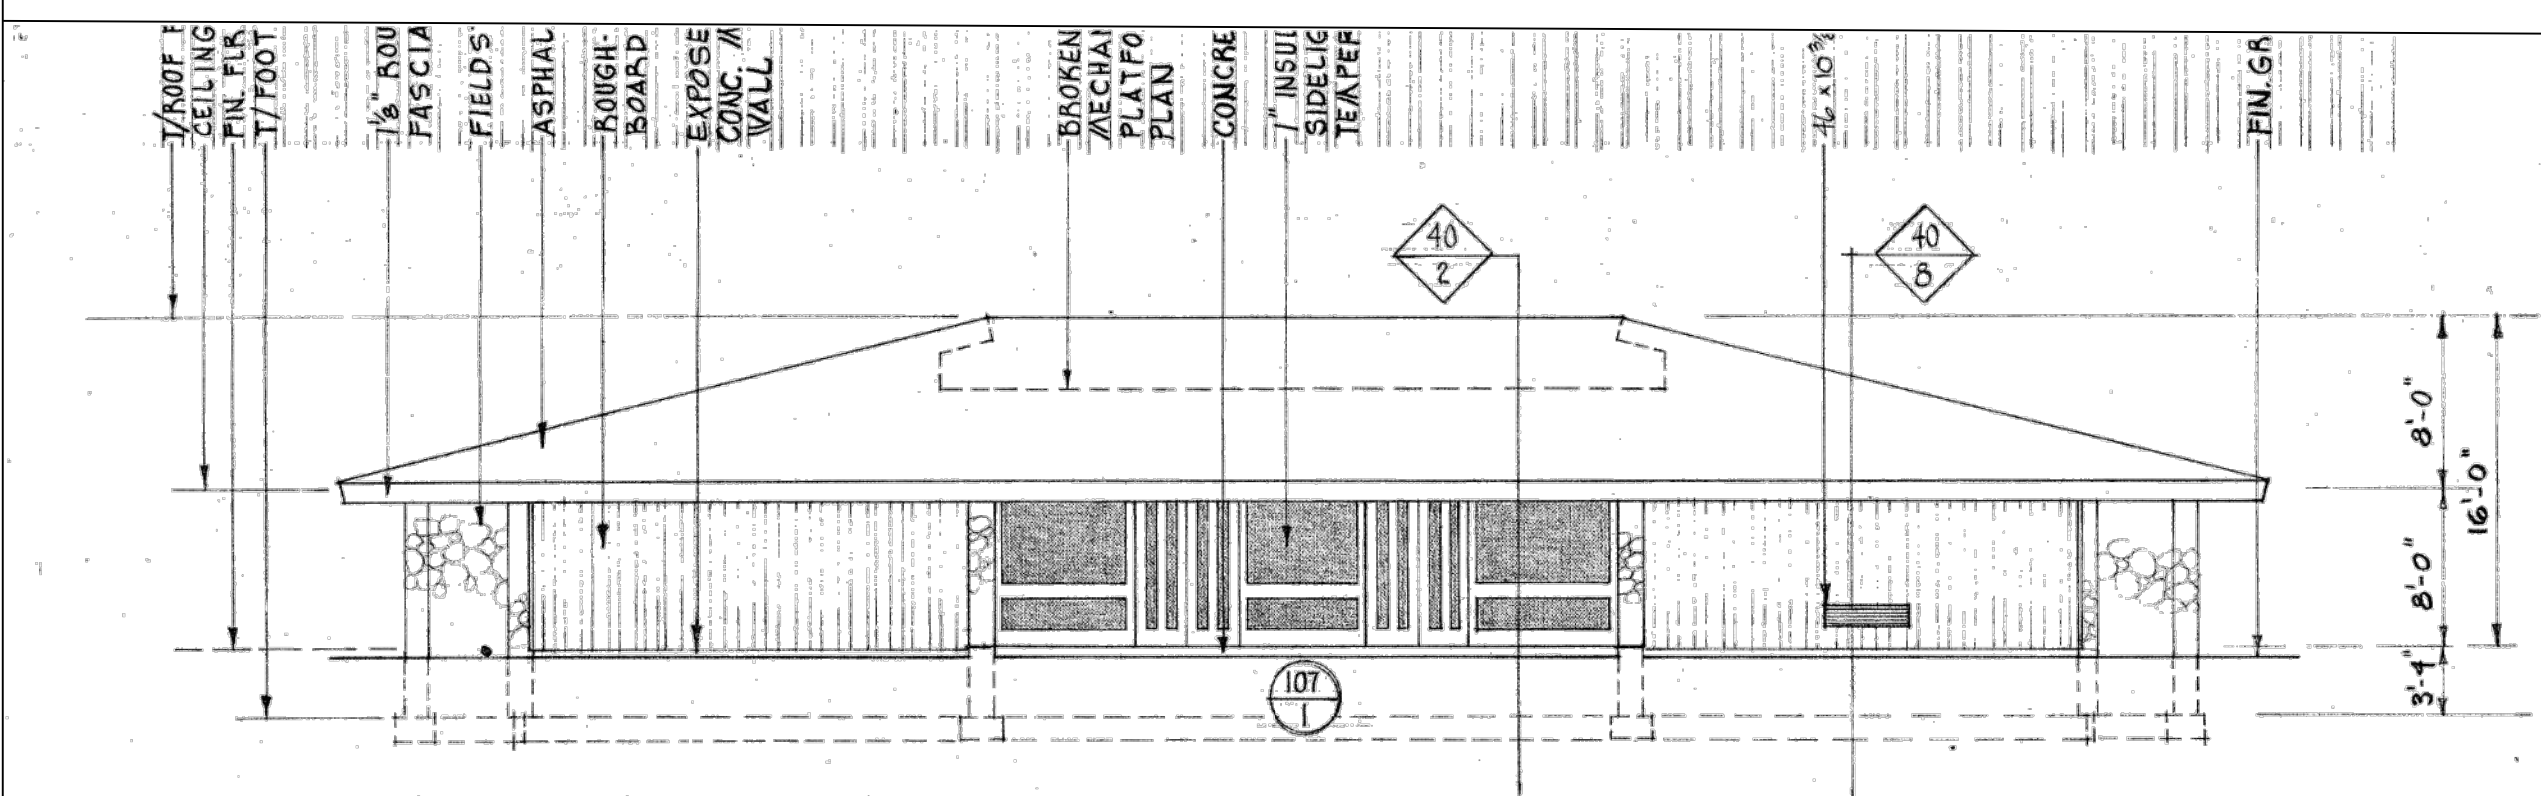
30 3 INTERPRETIVE EDUCATION WEST ELEVATION  
(SHOWING MAIN ENTRANCE DOORS)

SCALE: 1/8" = 1'-0"

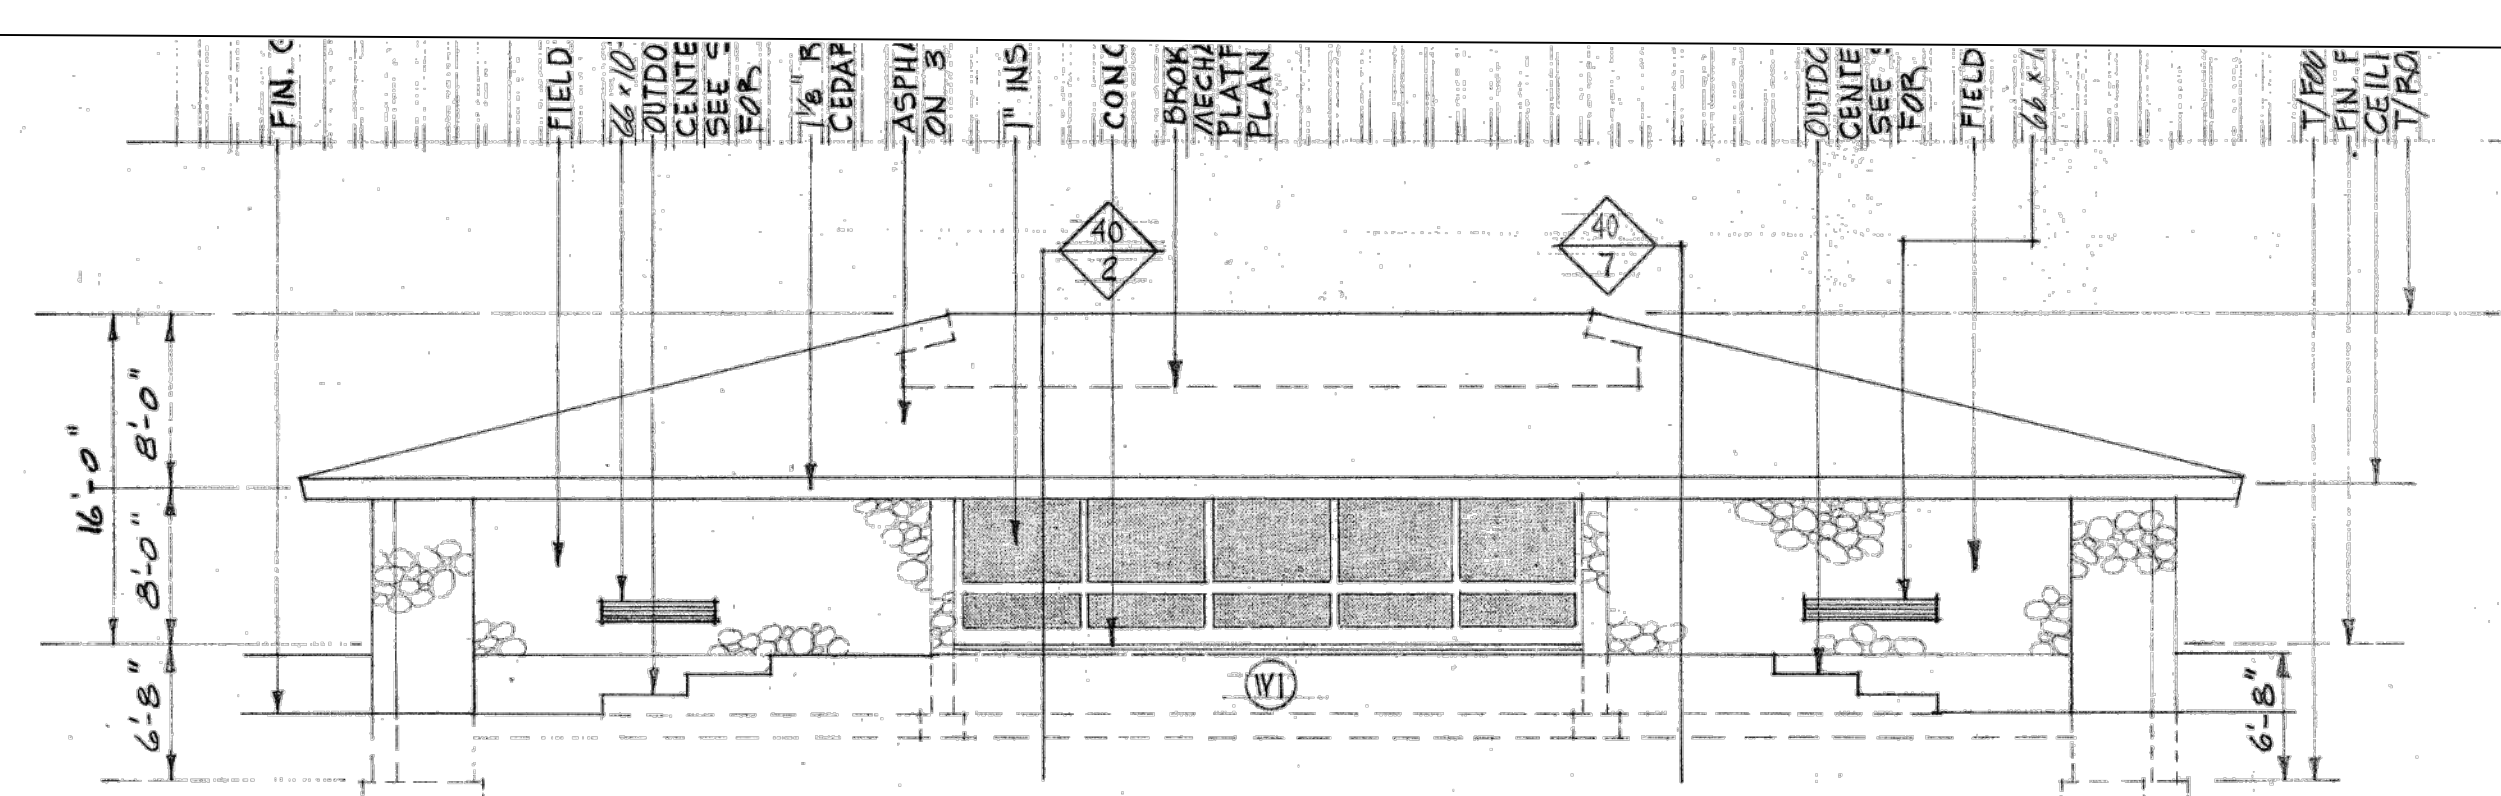
30 4 INTERPRETIVE EDUCATION EAST ELEVATION

SCALE: 1/8" = 1'-0"

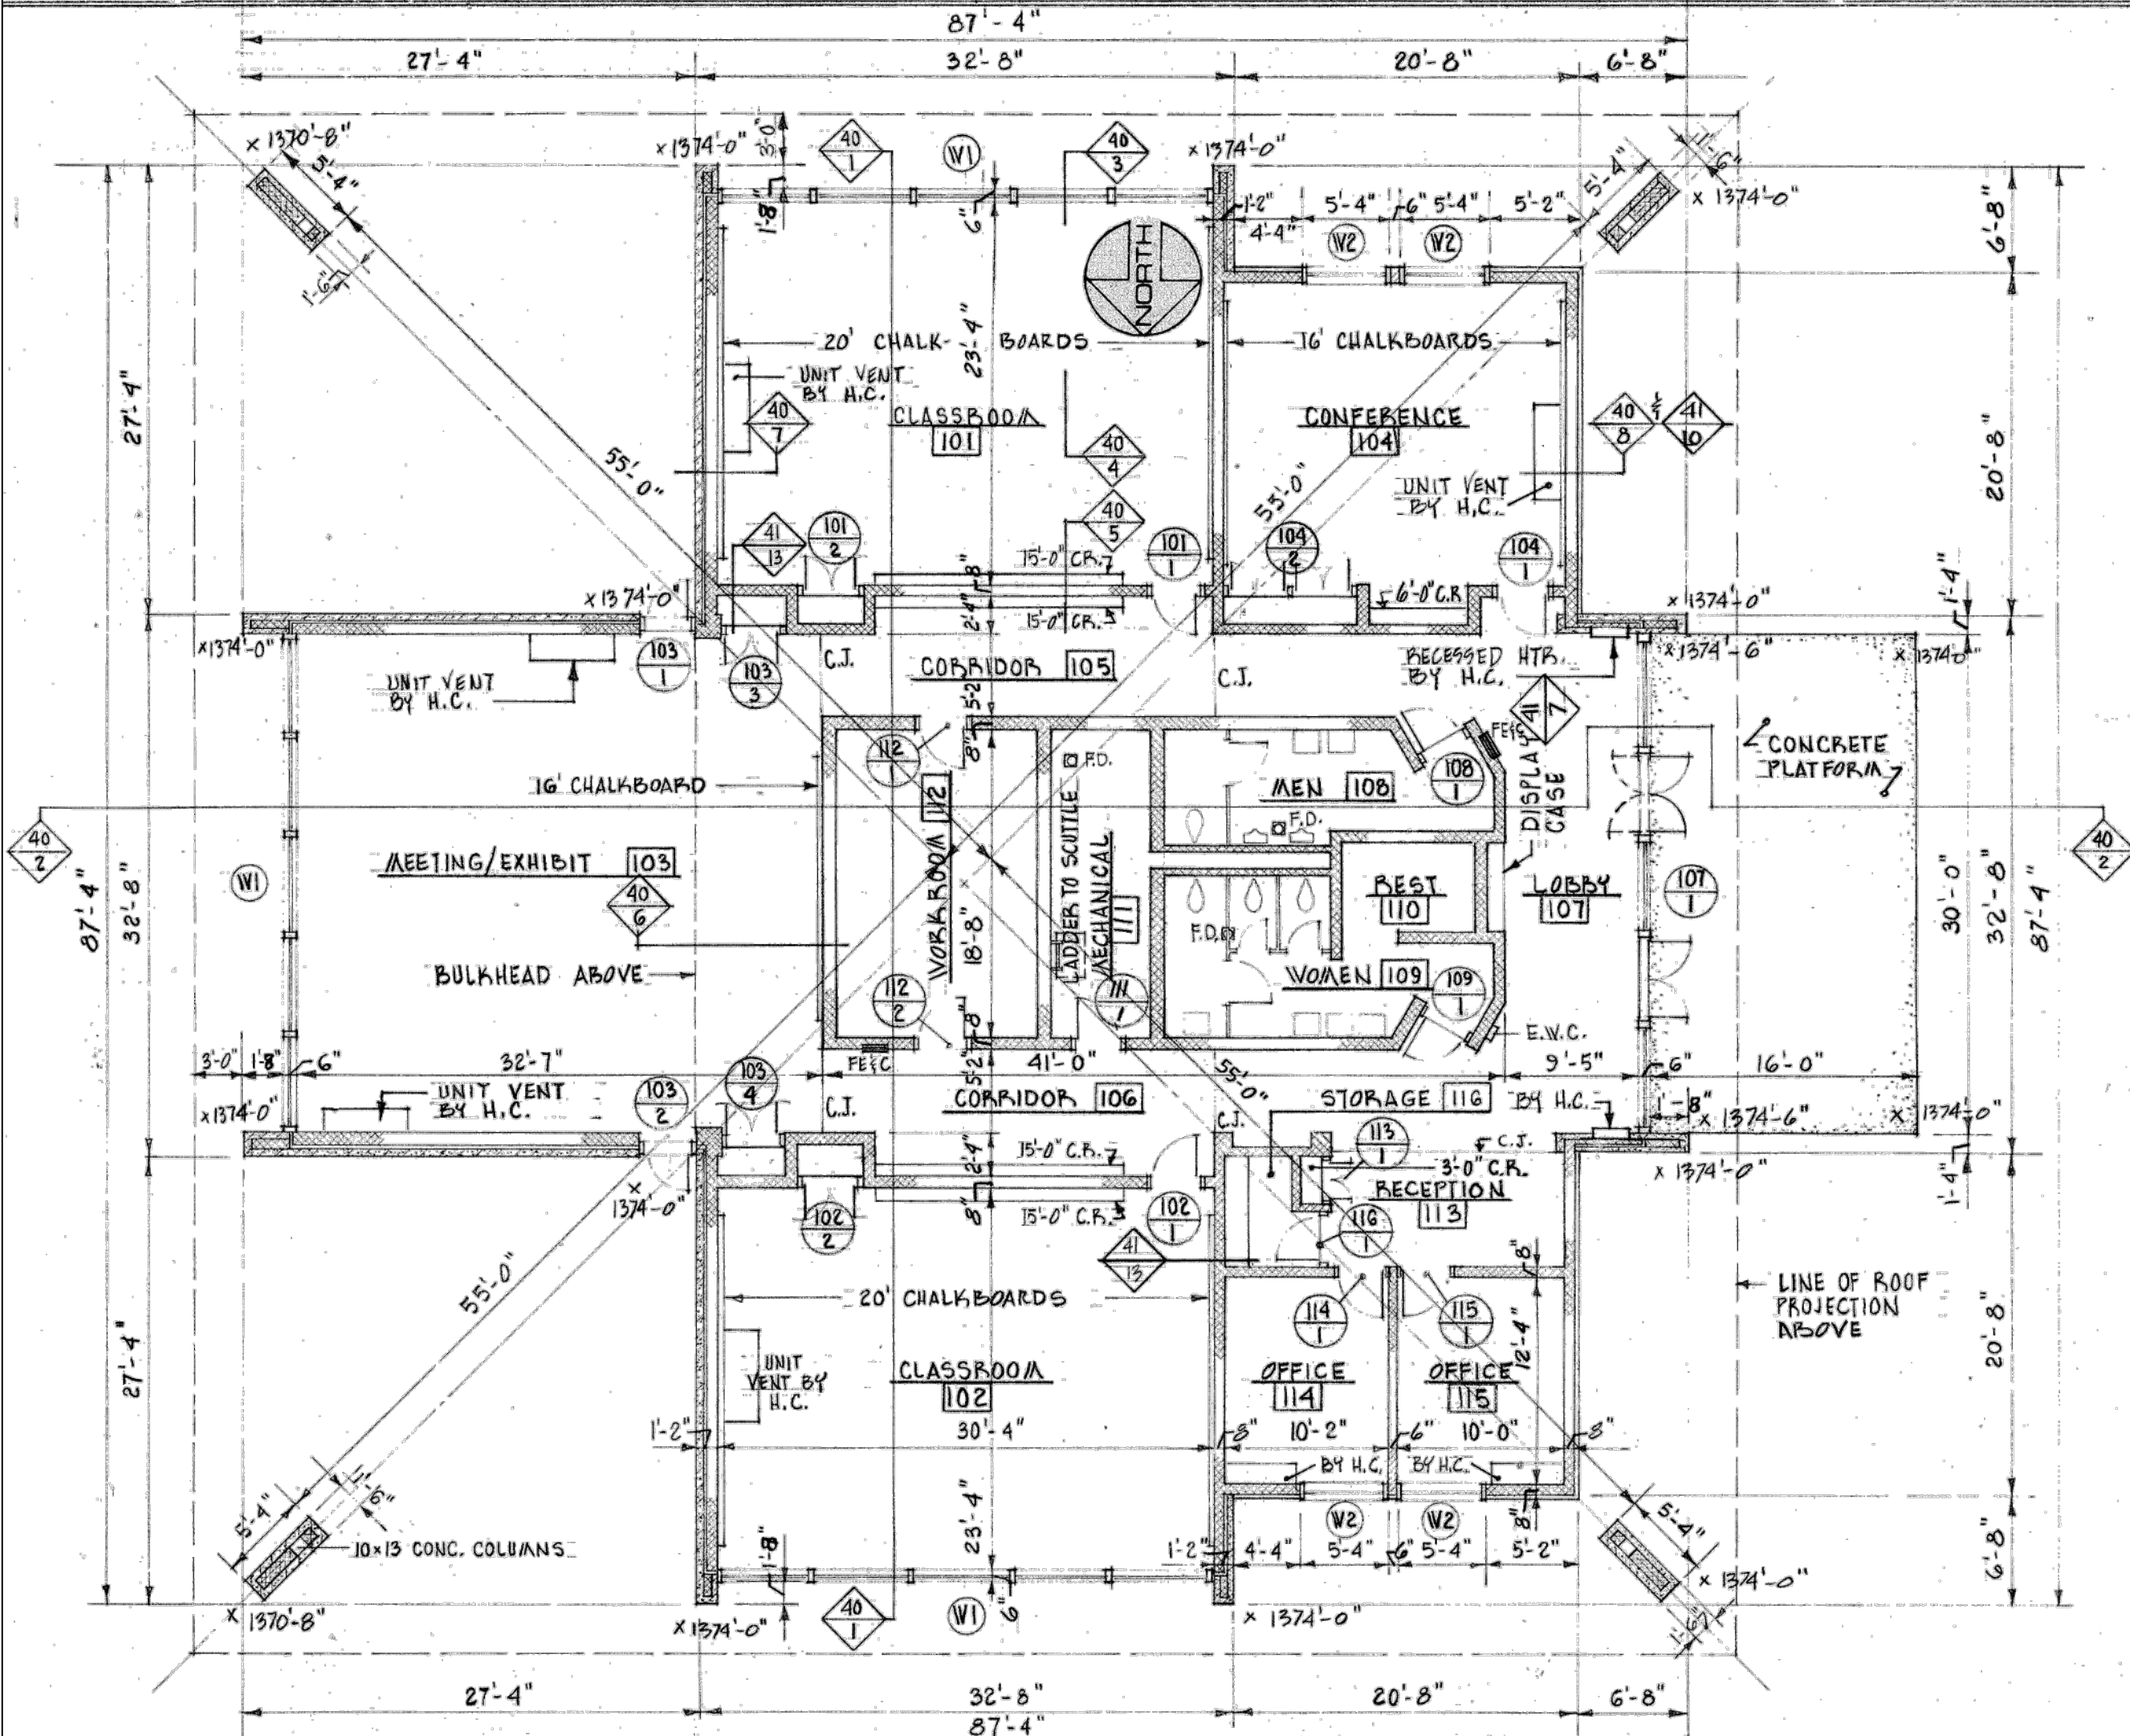
30 1 INTERPRETIVE EDUCATION PLAN

(SEE 1/4" SCALE PLAN 4 FOR EQUIPMENT & DIMENSIONS IN ROOMS 108, 109, 110, 111 & 112)

SCALE: 1/8" = 1'-0"

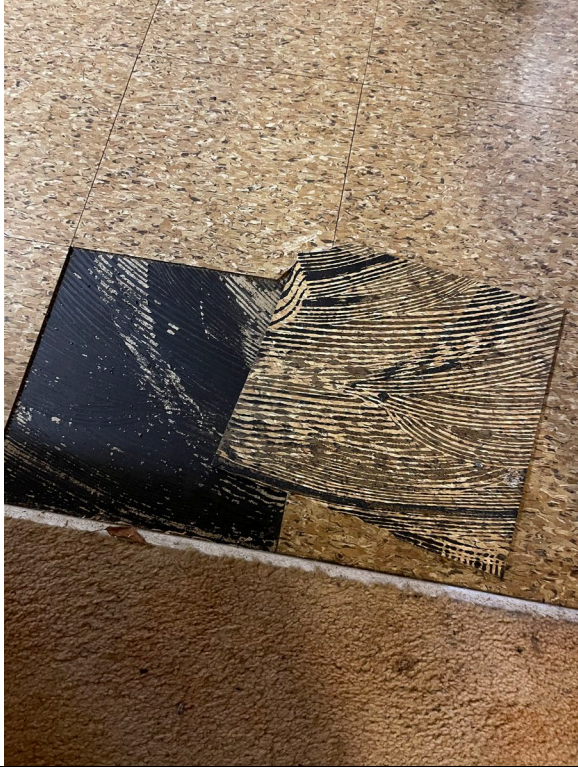
12" Floor Tile – Beige/Tan Flecked

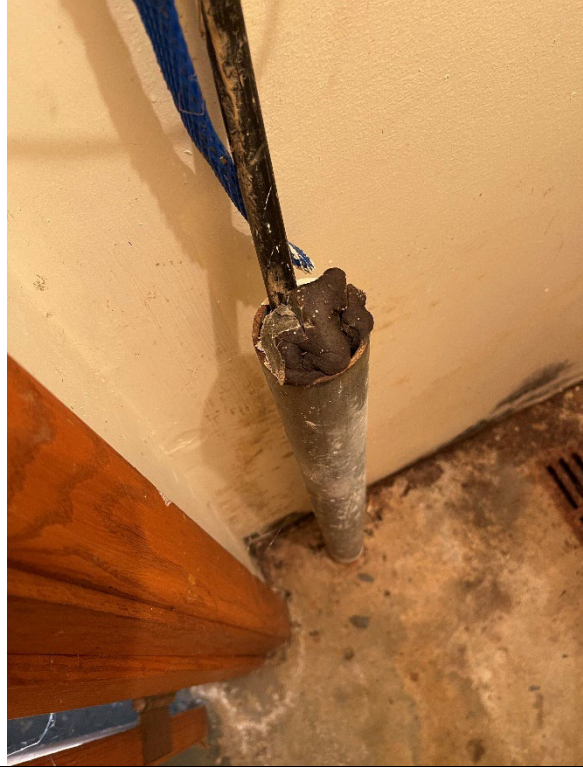
Fire Stop - Black

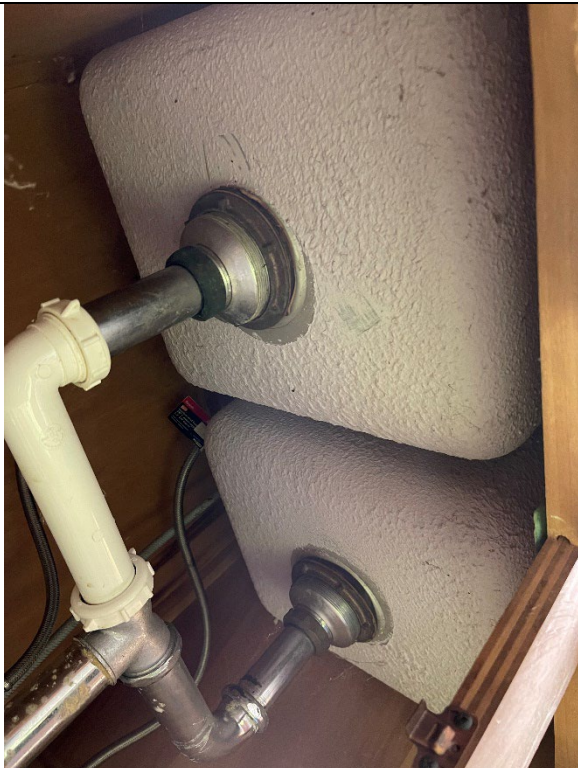
Under Sink Coating - Purple
