# Phase I Environmental Site Assessment

Somerset County
Fairgrounds

January 17, 2024

US 6219, Section 050
Transportation Improvement Project
Meyersdale, PA to Old Salisbury Road, MD

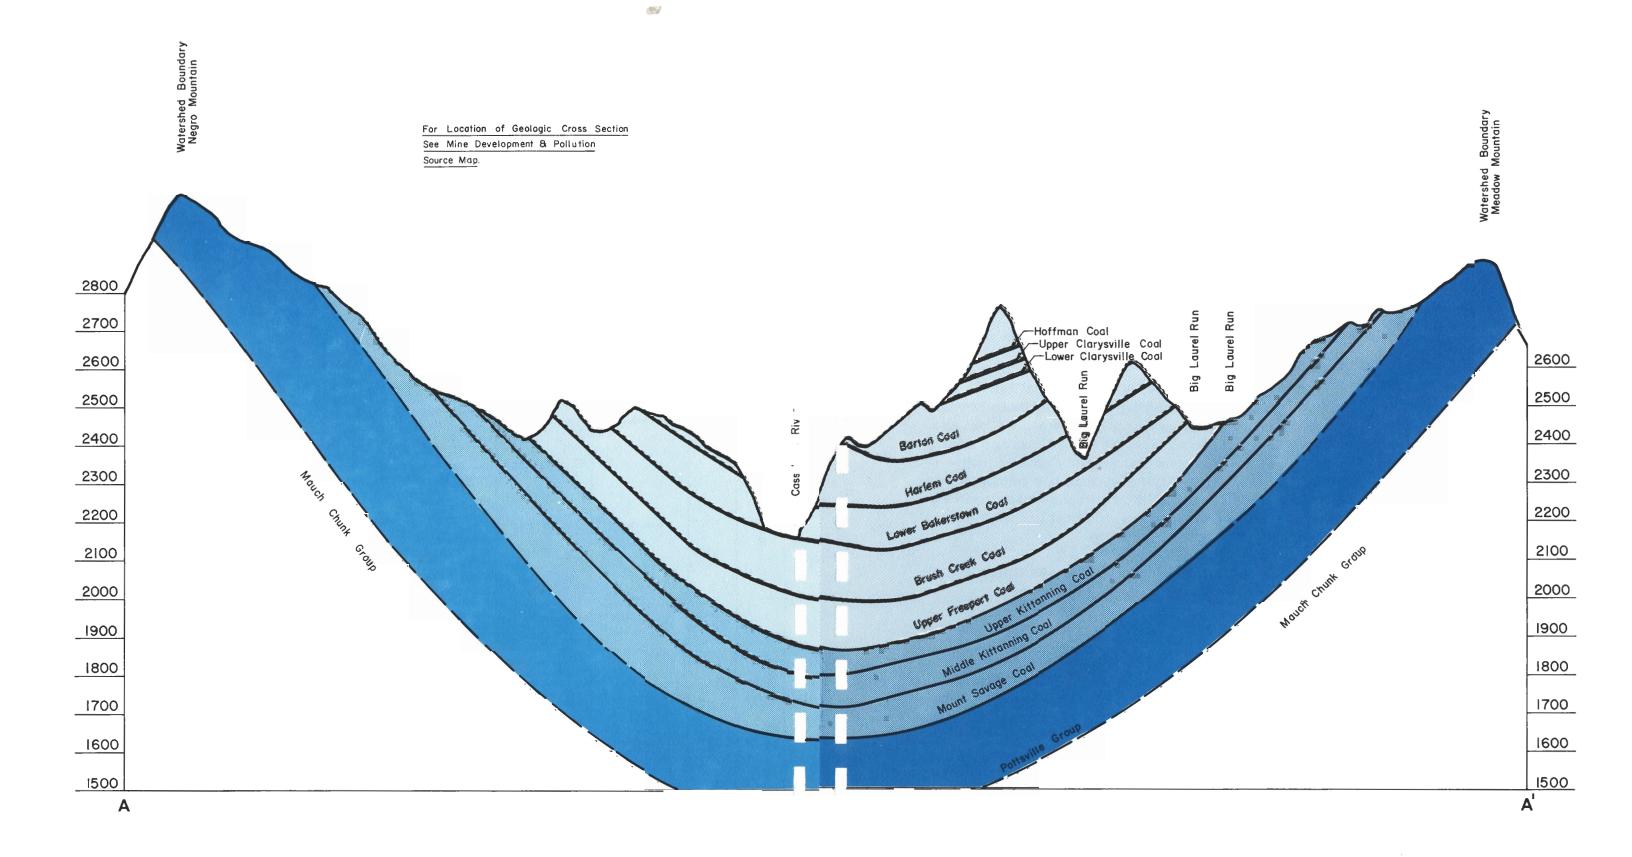
# GEOLOGIC CROSS SECTION CASSELMAN BASIN

The older, resistant, Allegheny Group rocks outcrop along the flanks of the mountains where erosion has eliminated the overlying rocks. The younger, less resistant, Conemaugh Group rocks occur in the topographic low in the center of the syncline where erosion rates are slower than on the surrounding topographic highs.
