Controlling Debris at Pennsylvania Bridges

FINAL REPORT

October 2008

By S. A. Sheeder and P. A. Johnson
The Thomas D. Larson
Pennsylvania Transportation Institute

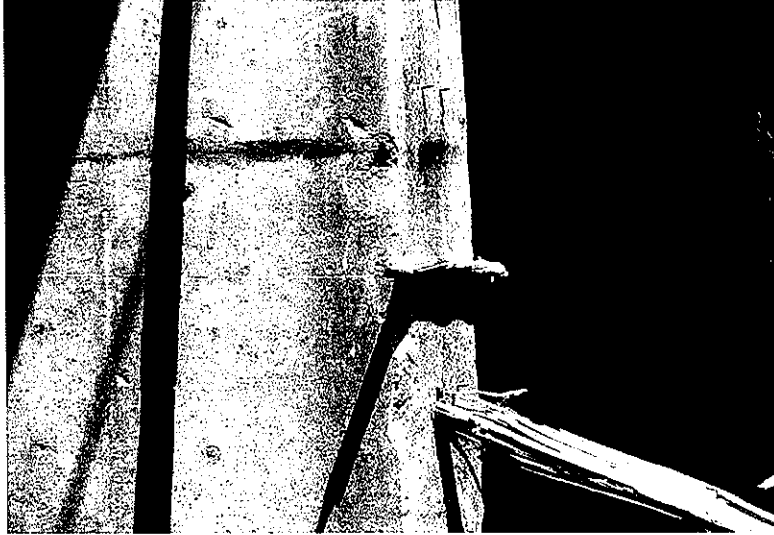
PIC8

CHIPS AT PIER NO. 1

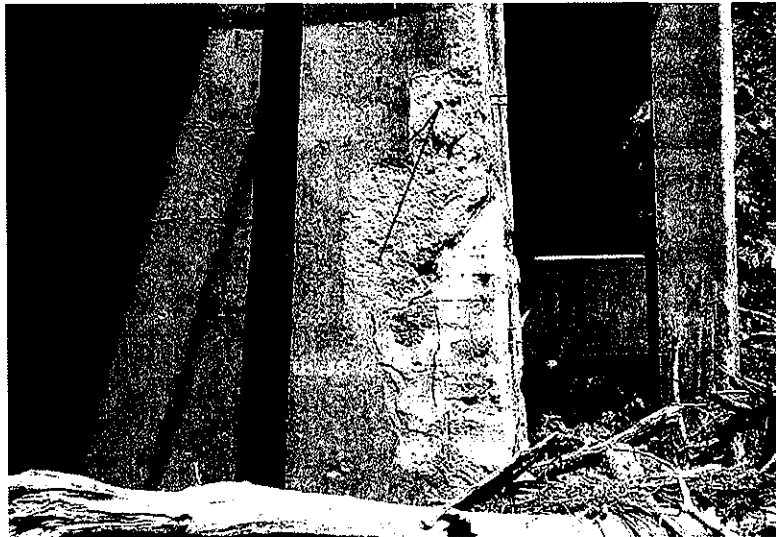
PIC9

CHIPS AT PIER NO. 2

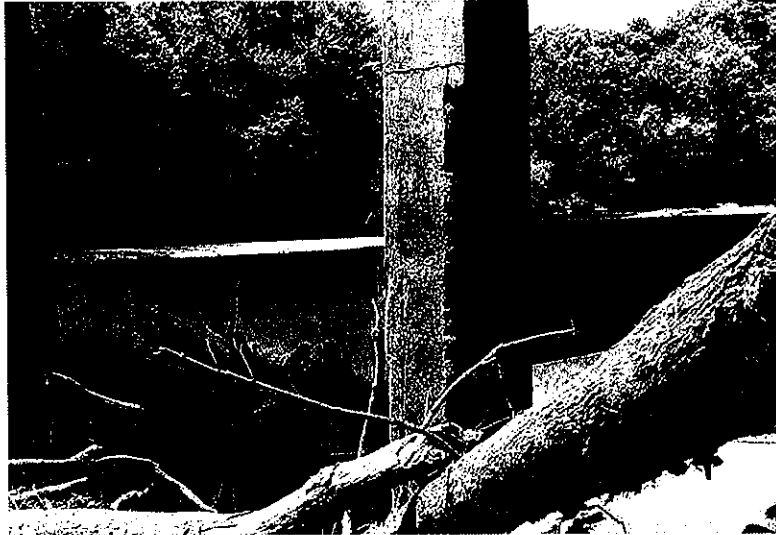
PIC10

CHIPS AT RIGHT END OF BENT NO. 12.

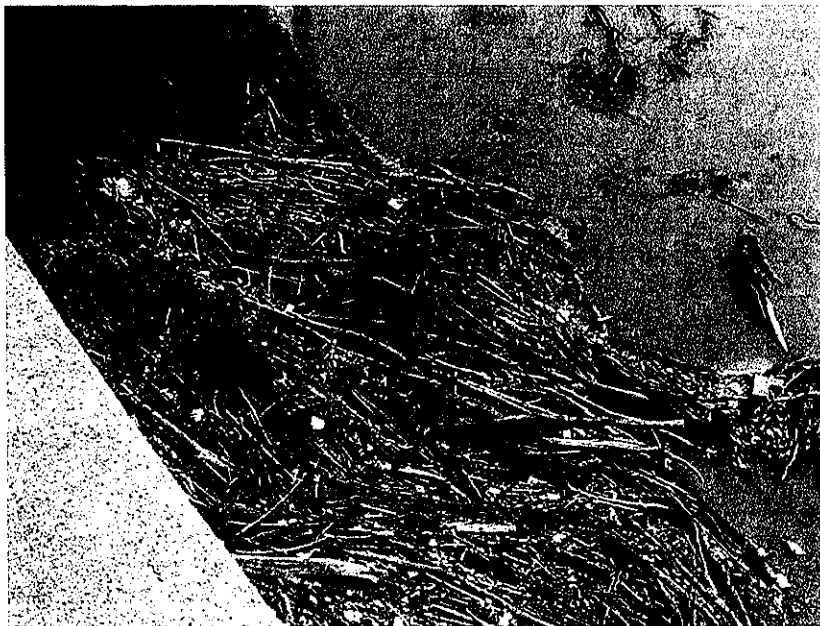
VIEW OF CHANNEL LOOKING RIGHT AT DRIFT

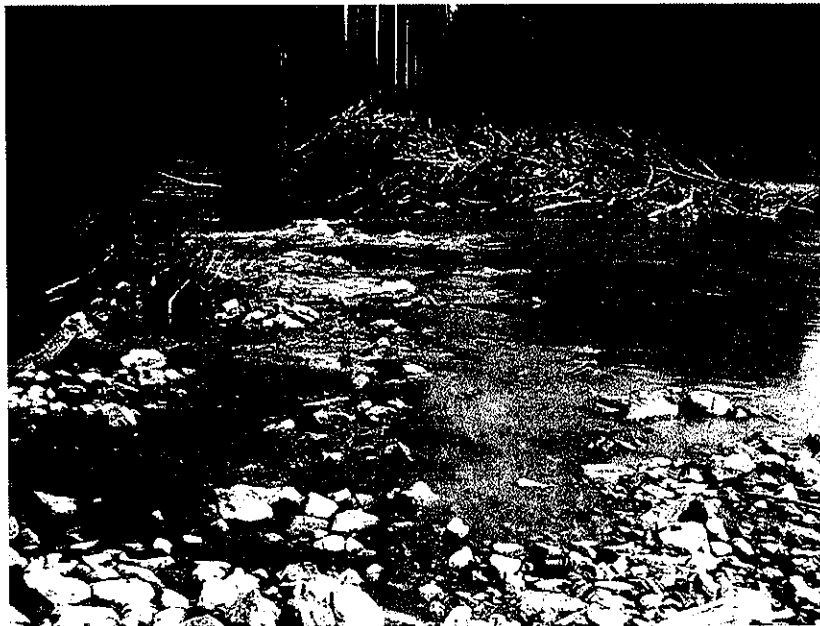
DRIFT AT RIGHT SIDE AT BENTS #6 & #8
