# Traffic Report for Project Needs

**PA 41 INTERSECTIONS STUDY  
Londonderry and London Grove Townships,  
Chester County**

Prepared for:  
**Pennsylvania Department of Transportation  
Engineering District 6-0  
7000 Geerdes Blvd  
King of Prussia, PA 19406**

**July 2014**

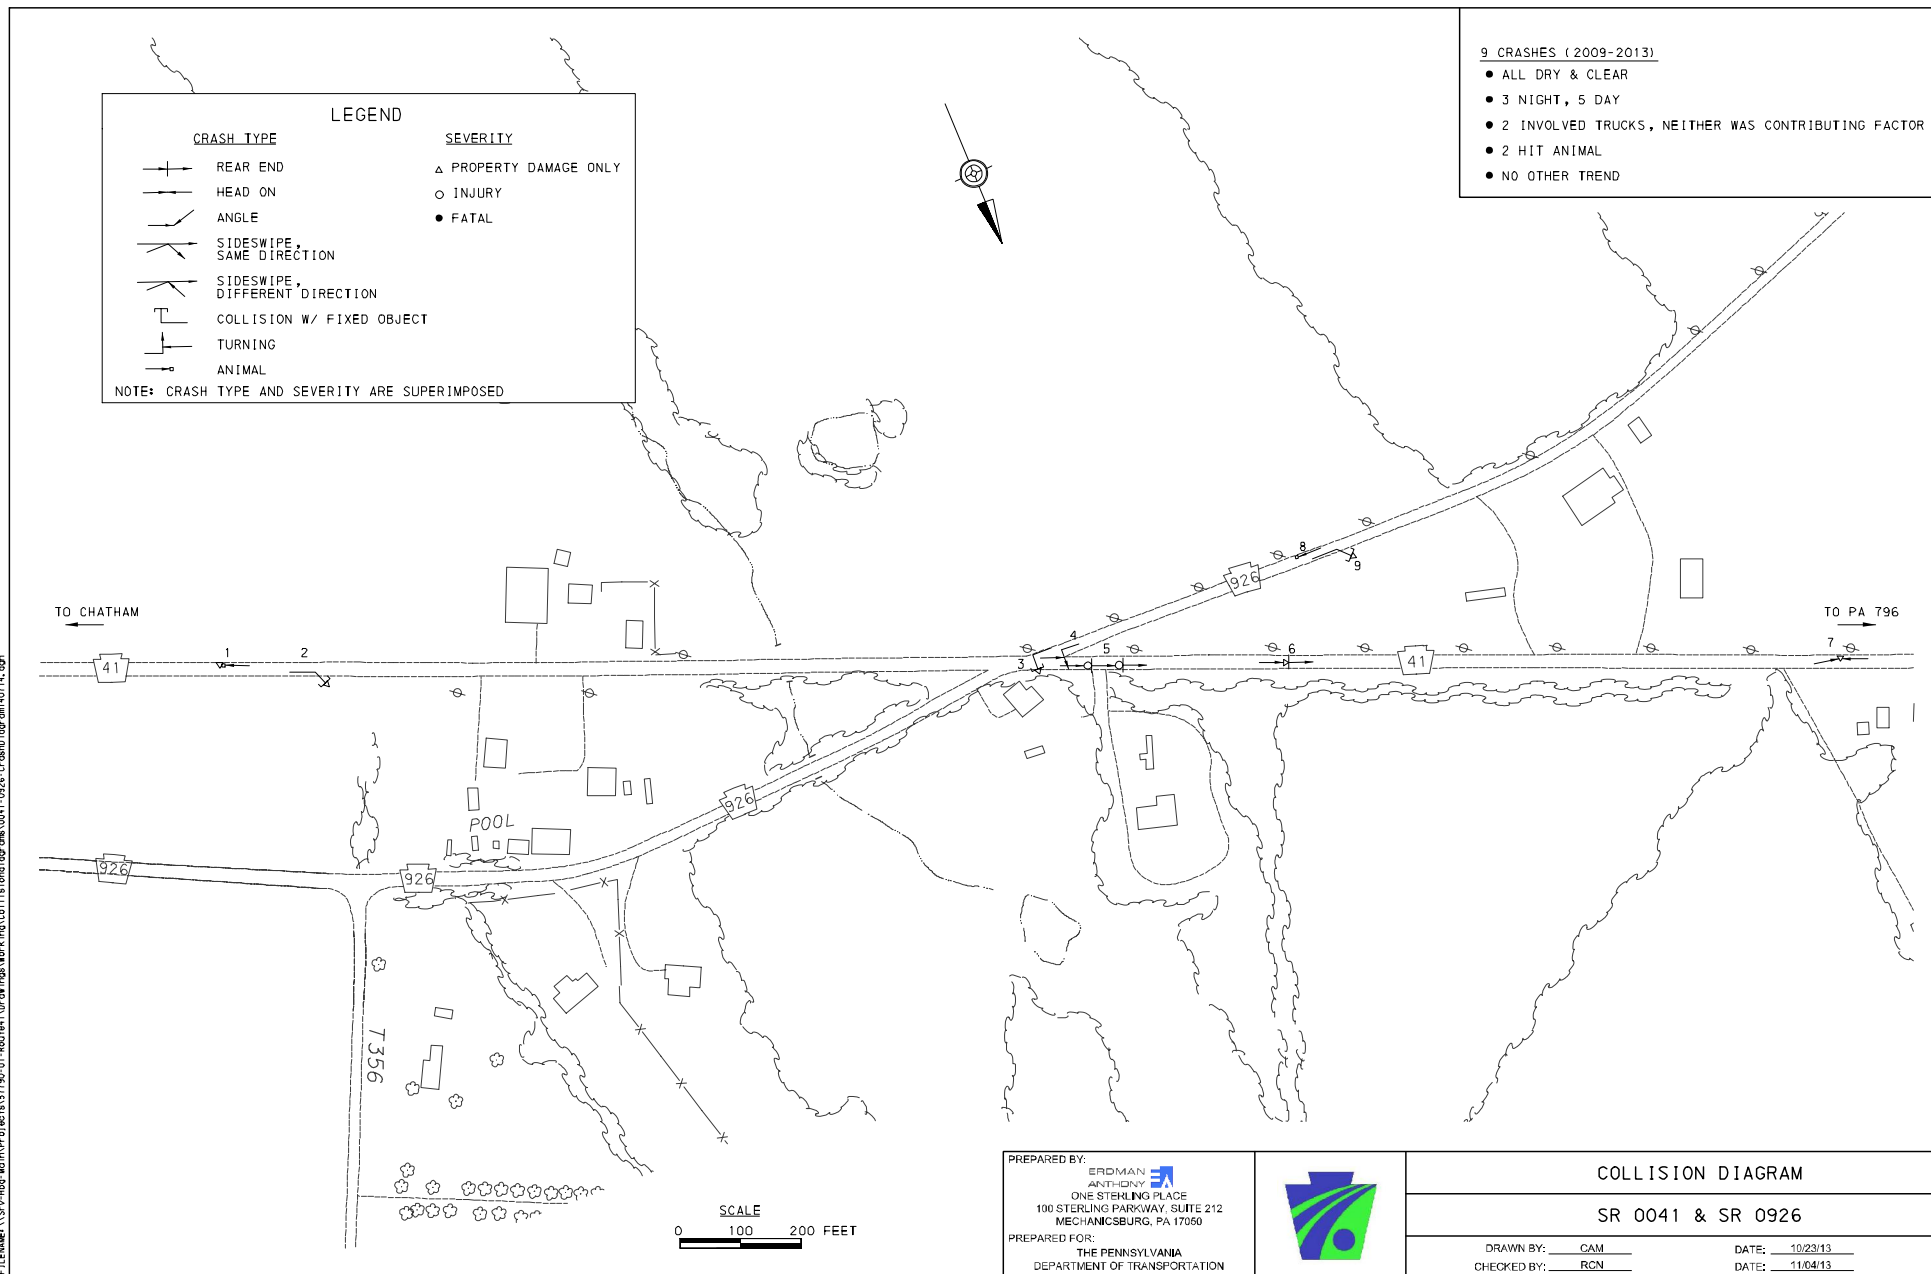
7/24/2014 1:46:04 PM  
FILENAME: \\SR-\\lib-\\data\\proj\\01-Rep\\041\\0926\\figs\\figs\\001-0926-CrashDiagram.dgn  
C:\Users\jag\Documents\001-0926-CrashDiagram.dgn

Collision diagrams can be found in Appendix B of this memorandum. As shown in the collision diagram, seven of the crashes involve angle collisions, which most likely can be attributed to speeds, lack of adequate gaps, and/or lack of adequate sight distance. Two of the crashes involves a rear end collision, which most likely can be related to speeding and/or lack of adequate sight distance. Three head-on crashes also occurred and one of those resulted in a fatality.

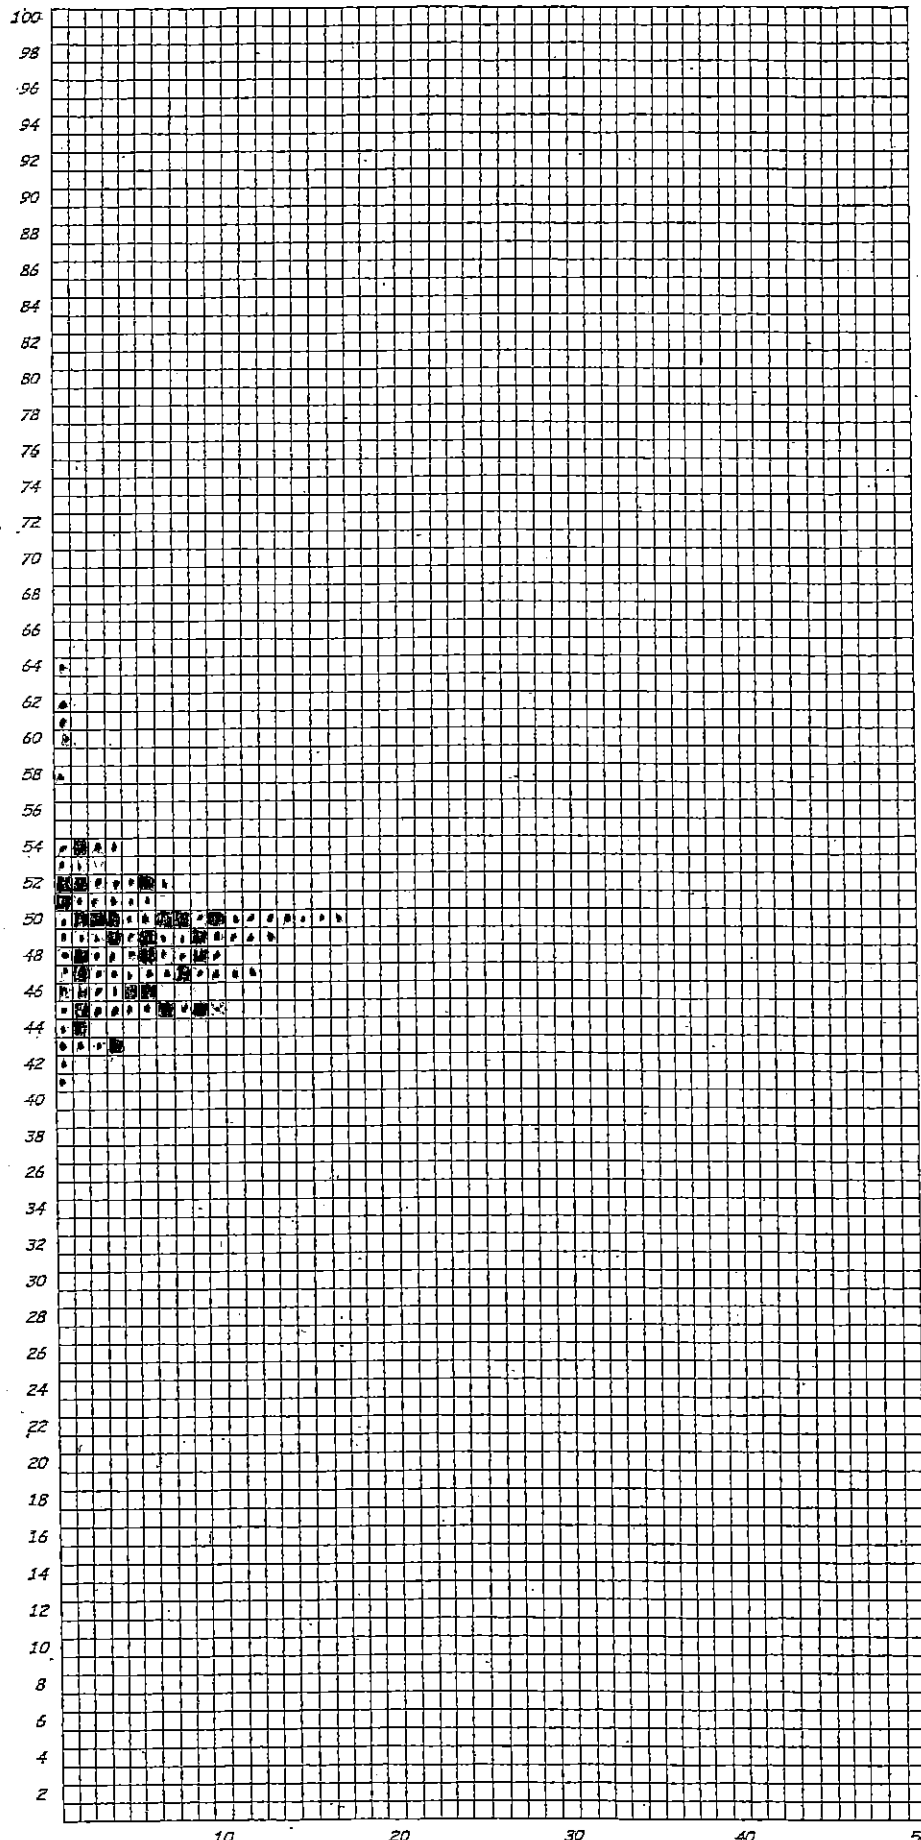
Date 03/21/14  
County CHESTER  
Municipality LOWDOWDER  
Street Name GAP NEWPORT  
State Route 0041  
Segment / Offset      /       
Radar Location       
Speed Limit 45  
Pavement Type MACADAM  
Number of Lanes 1  
Travel Direction (N) S E W  
Time Started 11:15 AM : PM  
Time Finished 11:50 AM : PM  
Weather GOOD  
Road Conditions GOOD  
Number of Vehicles 100  
Pace      MPH to      MPH

TRUCKS - 27%

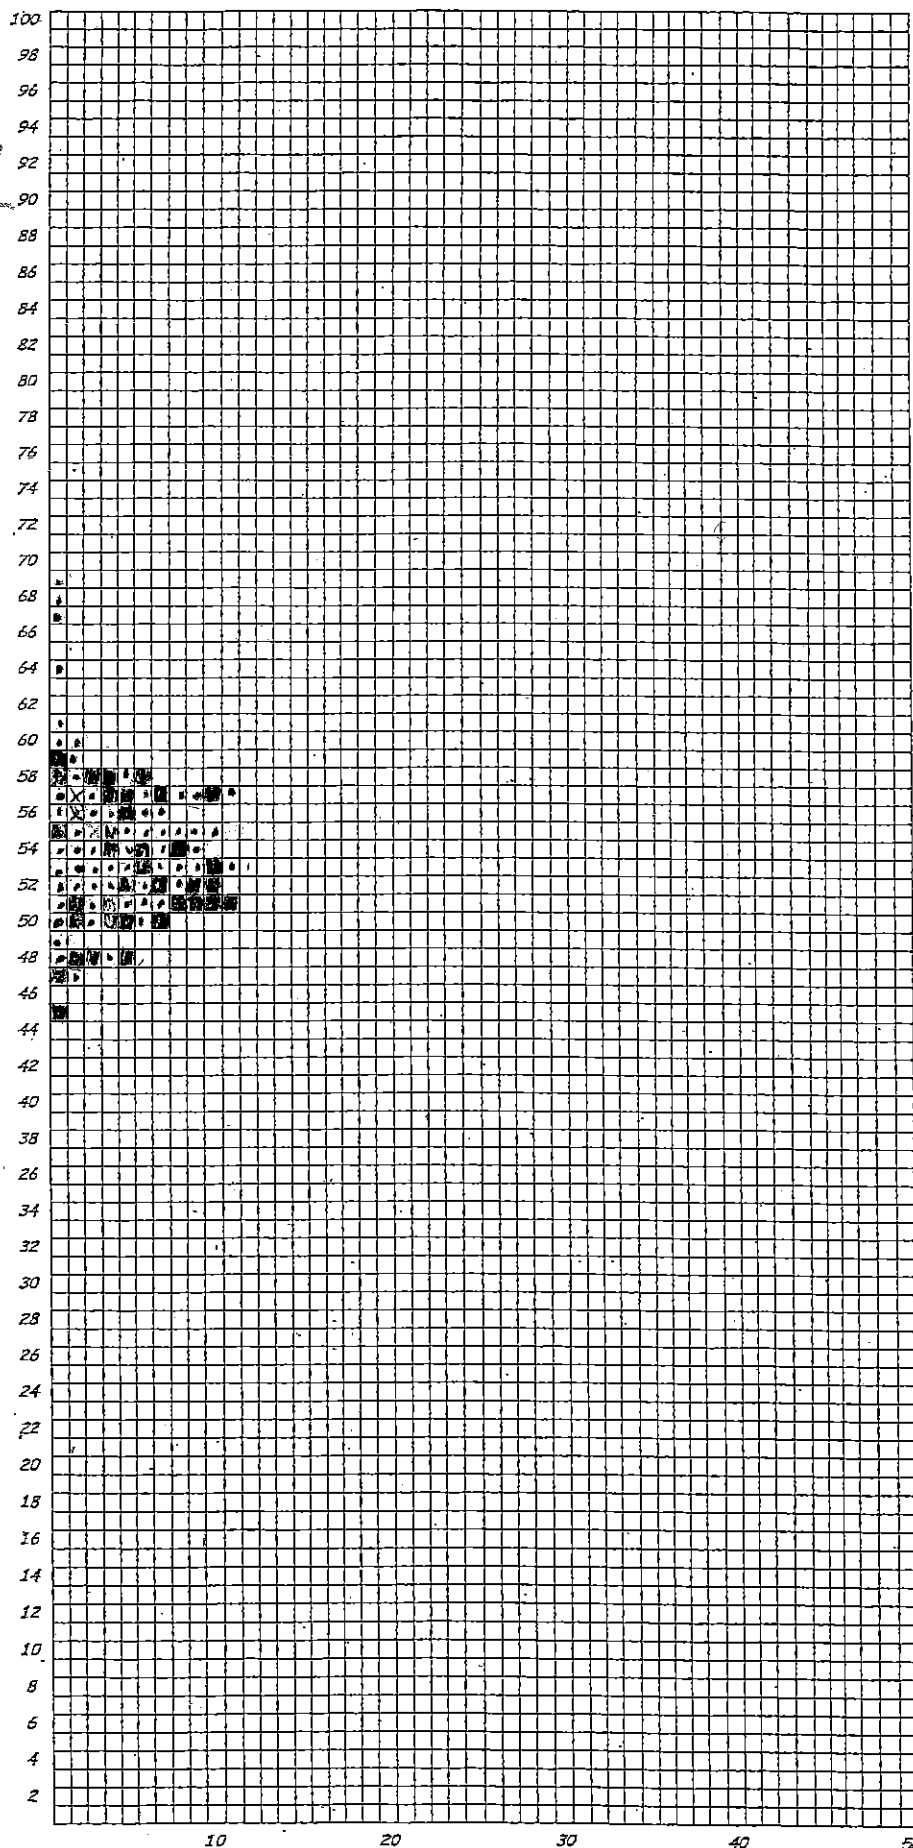
# SPEED DISTRIBUTION SURVEY (Radar Survey)

Date 03/21/14  
 County CHESTER  
 Municipality LONDONDERBY  
 Street Name GAP NEWPORT  
 State Route 0041  
 Segment / Offset      /       
 Radar Location       
 Intersection at 926  
 Speed Limit 45  
 Pavement Type MACADAM  
 Number of Lanes 1  
 Travel Direction N S E W  
 Time Started 10:15 AM : PM  
 Time Finished 11:05 AM : PM  
 Weather GOOD  
 Road Conditions GOOD  
 Number of Vehicles 100  
 Pace      MPH to      MPH

TRUCKS - 38%

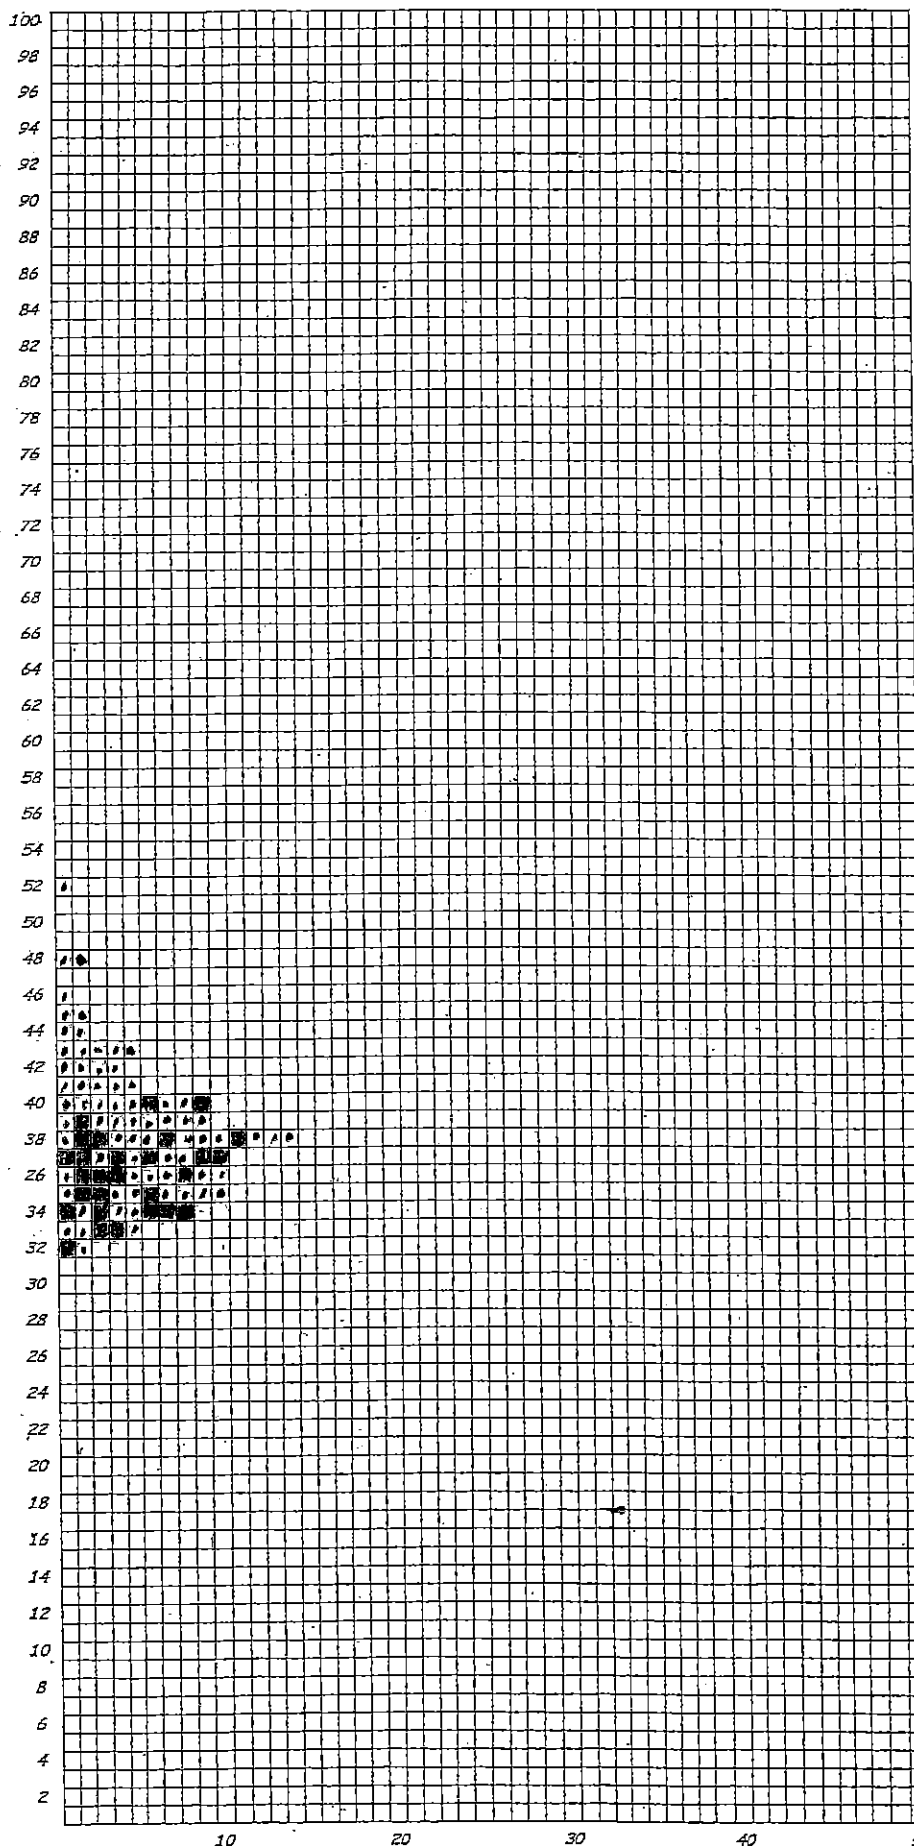
Date 03/21/14  
 County CHESTER  
 Municipality LONDON GENE  
 Street Name GAP NEWPORT  
 State Route 0041  
 Segment / Offset      /       
 Radar Location       
 Speed Limit 45  
 Pavement Type MACADAM  
 Number of Lanes 1  
 Travel Direction (N) S E W  
 Time Started      :      AM :      PM  
 Time Finished      :      AM : 1:05 PM  
 Weather GOOD  
 Road Conditions GOOD  
 Number of Vehicles       
 Pace      MPH to      MPH

TRUCKS 28%

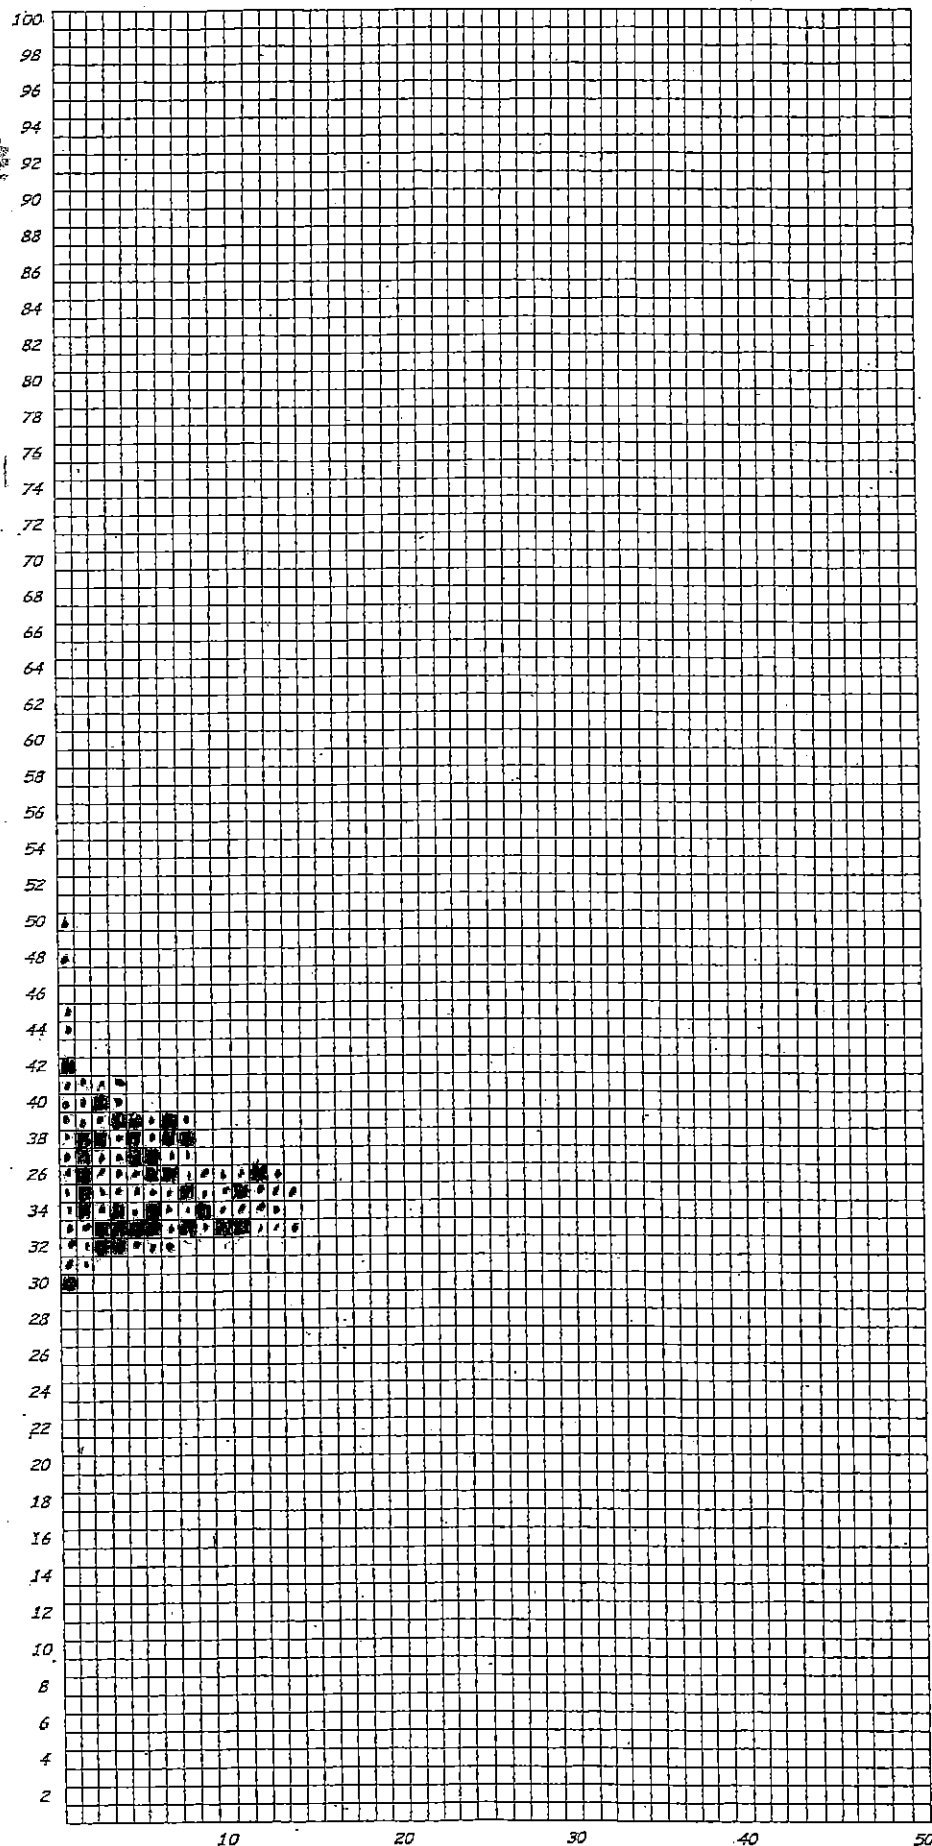
# SPEED DISTRIBUTION SURVEY (Radar Survey)

Date 03/21/14  
 County CHESTER  
 Municipality LONDON GROVE  
 Street Name GAP NEWPORT  
 State Route 0041  
 Segment / Offset      /       
 Radar Location Intersection at SR 804  
 Speed Limit 35  
 Pavement Type MACADAM  
 Number of Lanes 1  
 Travel Direction N (S) E W  
 Time Started      : AM 12:05 PM  
 Time Finished      : AM 12:50 PM  
 Weather Good  
 Road Conditions Good  
 Number of Vehicles 100  
 Pace      MPH to      MPH

39 MPH

TRUCKS - 34%
