Fact Sheet:  
Military Munitions Response Program  
Remedial Investigation/Feasibility Study  
For Mount Gretna Range Munitions Response Site  
Mount Gretna, Pennsylvania

## Mount Gretna Range Munitions Response Site Background

## Highlights of the Remedial Investigation Step-Out Sampling

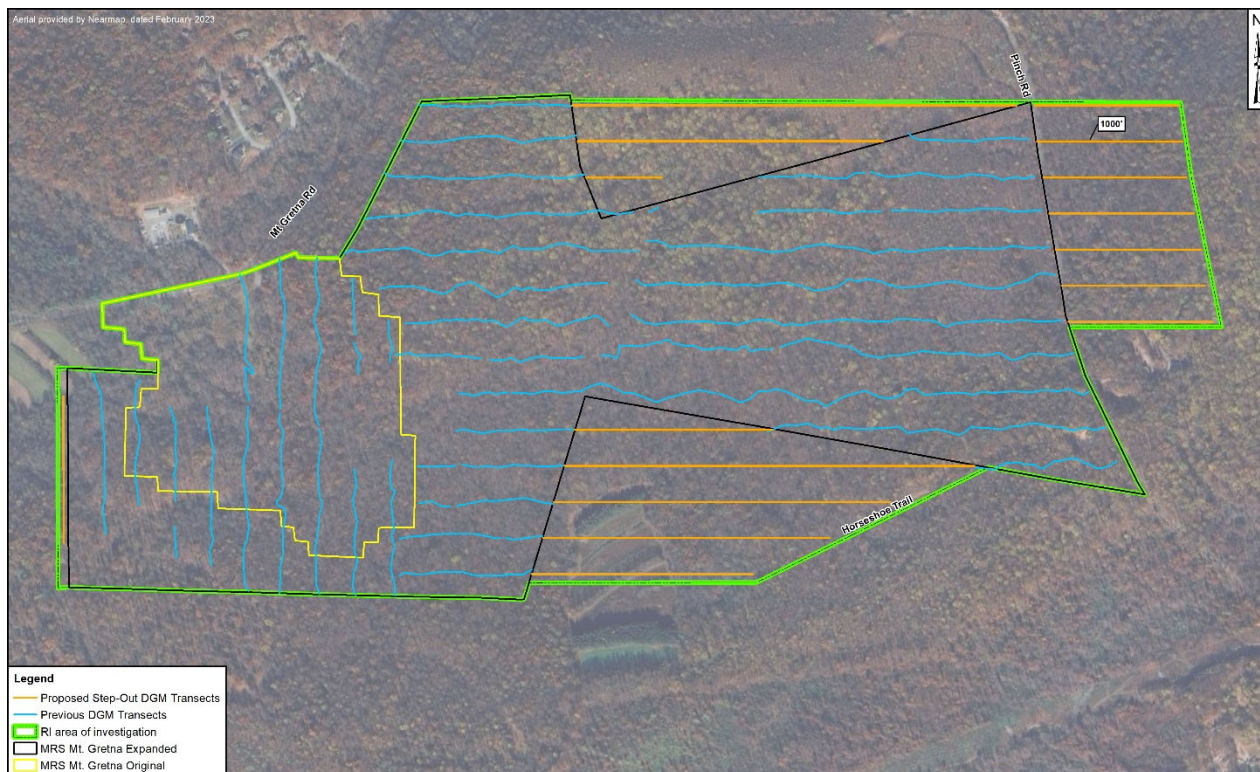
The figure provided in this fact sheet shows the existing MRS boundary with the expanded step-out sampling that started in June 2025. This includes land associated with State Game Land 145, as well as property that is part of the Clarence Schock Memorial Park.

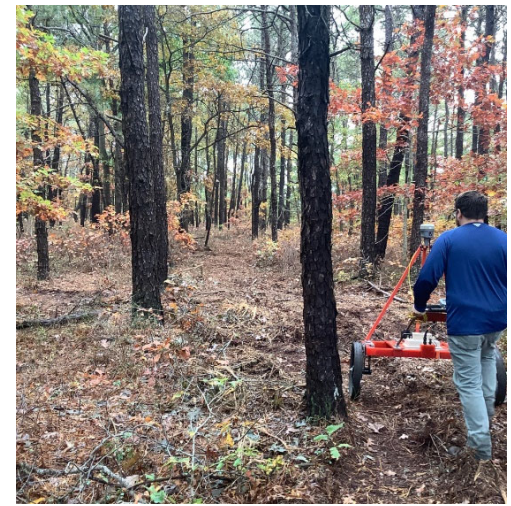
Geophysical data collection with EM61

- **Phase 1** – Transects placed approximately 250 feet apart thought all areas included in the step out sampling will be walked with geophysical equipment to map any areas of metallic response. To facilitate the passage of the equipment and operators, vegetation reduction will be conducted along the transects, leaving any trees greater than 3 inches in diameter and not cutting any vegetation lower than 6 inches above the ground surface. This work begins June 2025 and will be completed in approximately 4 weeks. After demobilization from the site to process date, the field team will come back to the MRS to complete phase 2 activities.
