# Environmental and Cost Effectiveness of Partially Grouted Riprap for Scour Countermeasure

FINAL REPORT

By (PI): Bechara Abboud, Ph.D., P.E., and  
(CO-PI) Joseph Coe, Ph.D.  
Temple University

COMMONWEALTH OF PENNSYLVANIA  
DEPARTMENT OF TRANSPORTATION

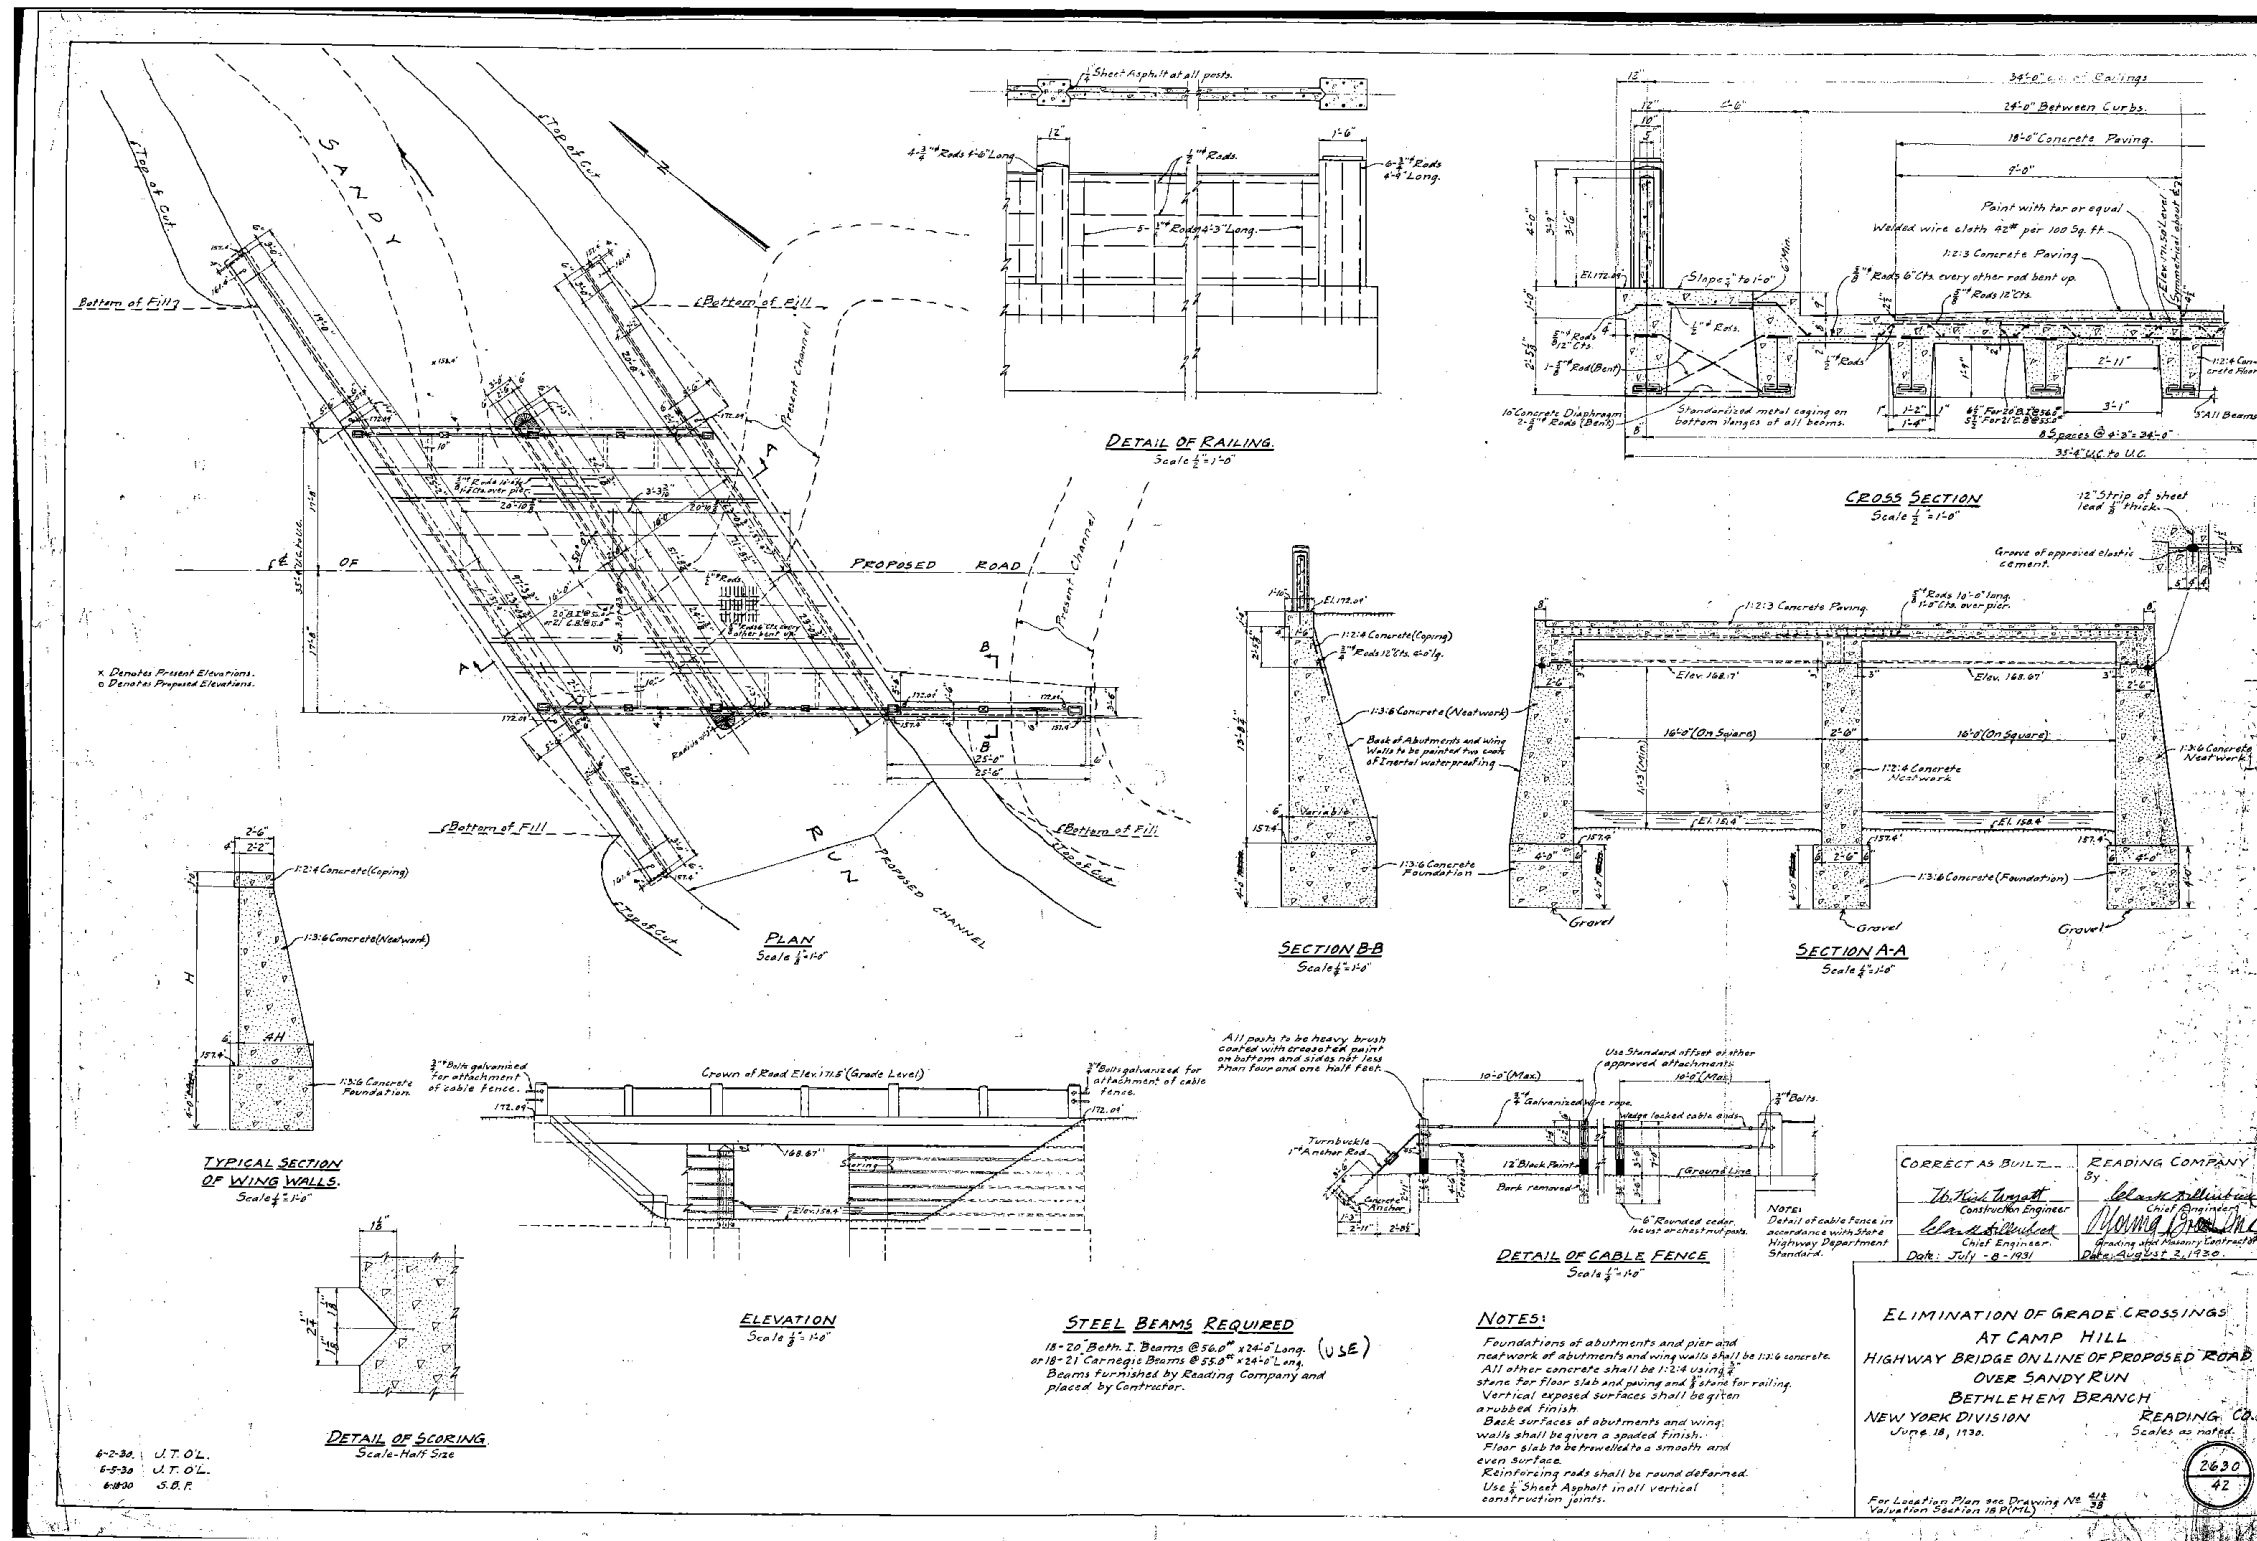
Figure 4 Bridge carrying State Route (SR) 2028 (Camp Hill Road) over Sandy Run

The existing structure shown in Figure 4 was originally constructed in 1931. The bridge is a two-span concrete encased rolled steel I-beam bridge, with a total length of approximately 46-feet and a width of 36-feet. The bridge features one 3-foot wide, reinforced concrete pier that runs parallel to Sandy Run, as well as two reinforced concrete abutments that taper in width from 4'-6" at the bottom to 2'-6" at the top. The structure is surrounded by hills and valleys with steep side slopes in convex linear shapes. Due to degradative scour action, the structural longevity of the bridge has come into question. The existing flow conditions have caused an accumulation of sediment and debris, as well as deep scour holes throughout the project area. The streambed elevation under Span 2 (right span looking downstream), between the abutment and the pier, has steadily increased in height due to particle migration as shown in Photo 1. Additionally, a large scour hole has formed below Span 1 (left span looking downstream), between the abutment and the pier as shown in Photo 2.

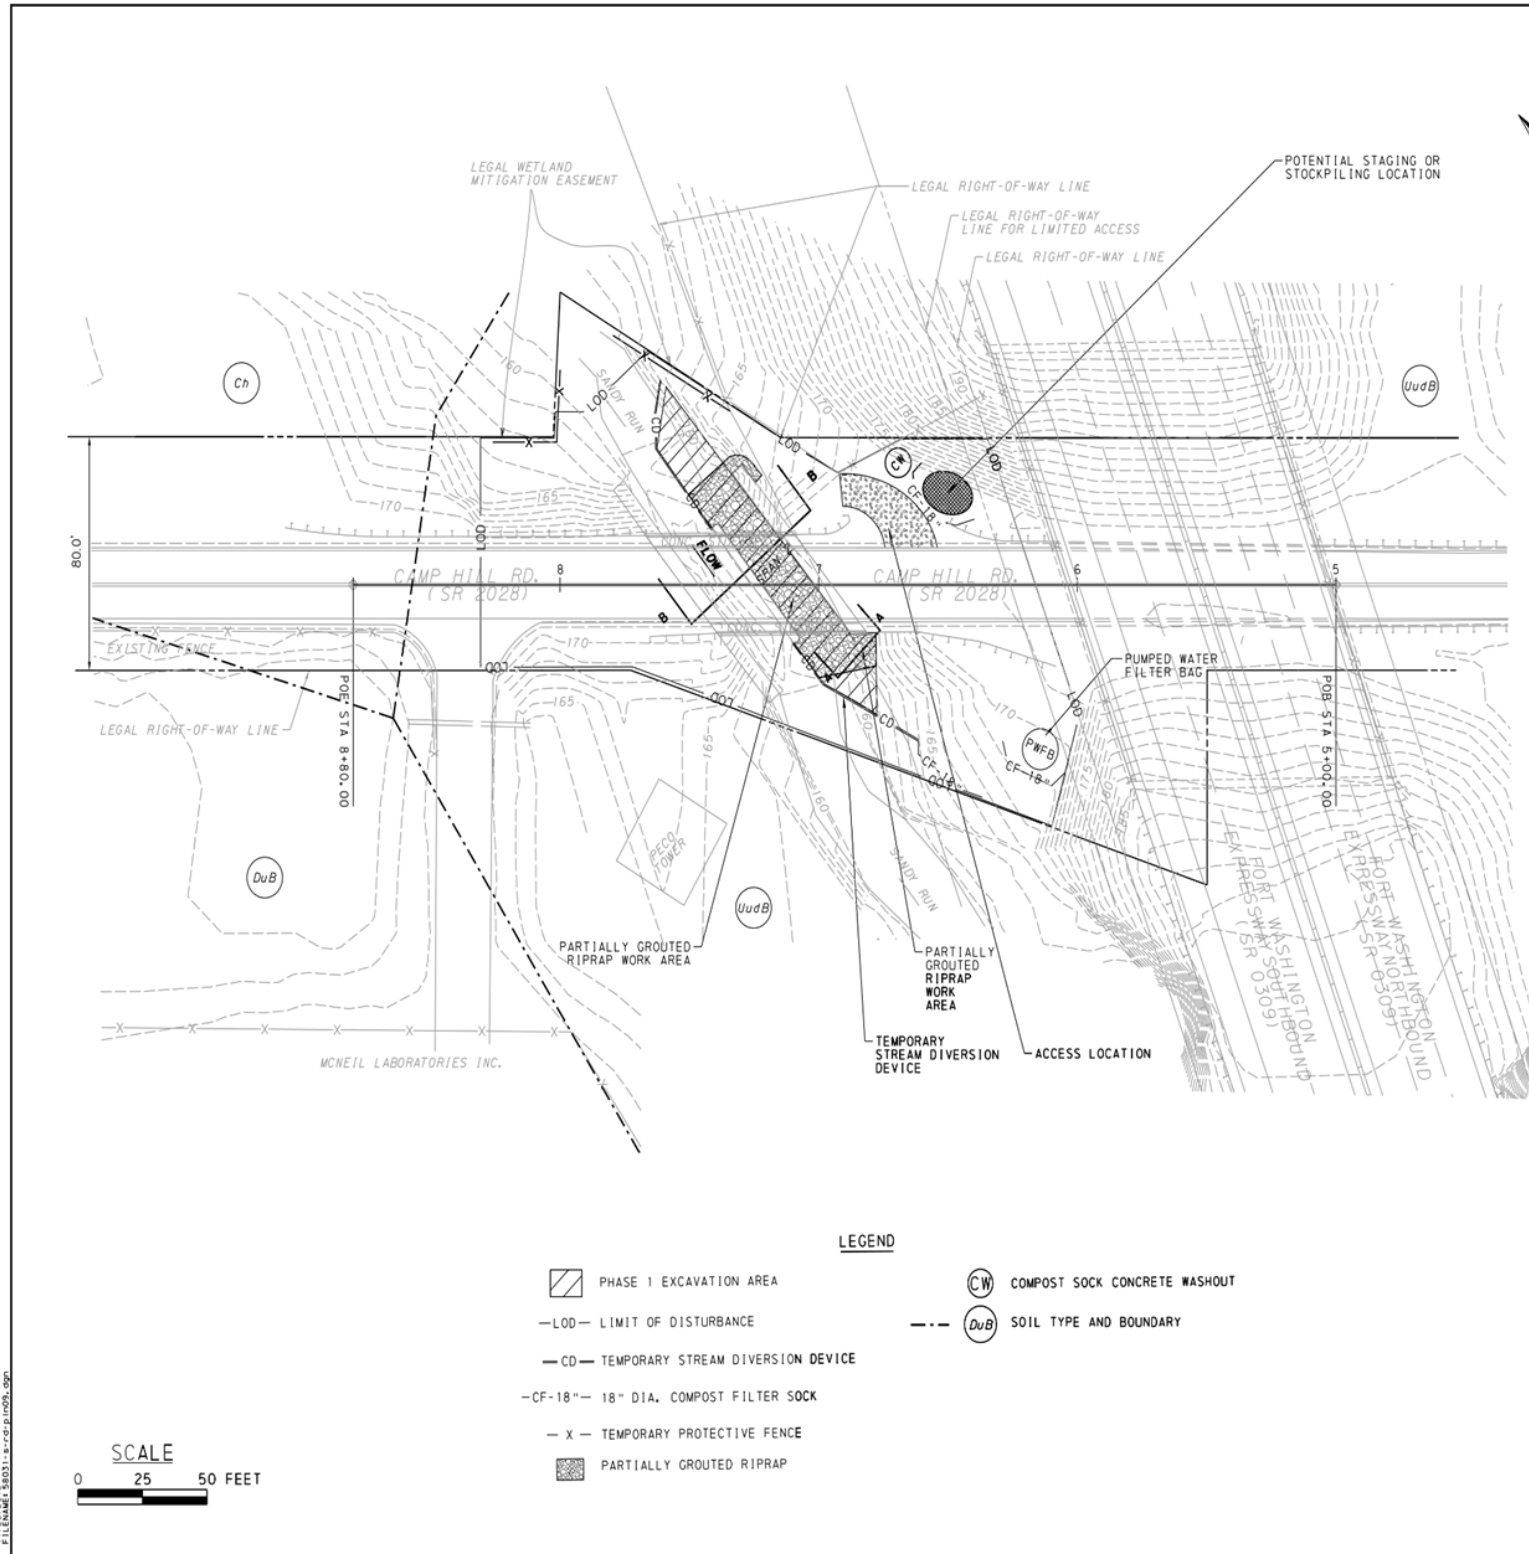
DISTRICT	COUNTY	ROUTE	SECTION	SHEET
6-D	MONTGOMERY	2028	PGR	8 OF 9
WHITEMARSH TOWNSHIP				
REVISION NUMBER	REVISIONS	DATE	BY

1. PHASE 1 EXCAVATION TO OCCUR WITHIN DESIGNATED AREAS ONLY.
2. PUMP AS REQUIRED TO MAINTAIN DRY WORK AREAS. PUMP WATER FROM WORK AREAS MUST BE DISCHARGED THROUGH A SEDIMENT CONTROL DEVICE SUCH AS A PUMPED WATER FILTER BAG.
3. TEMPORARY PROTECTIVE FENCING SHALL BE PLACED ALONG WETLAND MITIGATION LIMITS DOWNSTREAM OF THE BRIDGE TO PREVENT ACCESS TO THE RESTRICTED AREA.
4. INSTALL PARTIALLY GROUDED RIPRAP IN DESIGNATED AREAS IN DRY CONDITIONS.
5. AT ALL SUBSTRUCTURES, PGR SHALL BE INSTALLED LEVEL WITH THE TOP OF FOOTINGS.
6. THE PGR SHALL BE INSTALLED TO THE LIMITS AND DETAILS INDICATED ON THE DESIGN PLANS. REFER TO PARTIALLY GROUDED RIPRAP DETAILS.

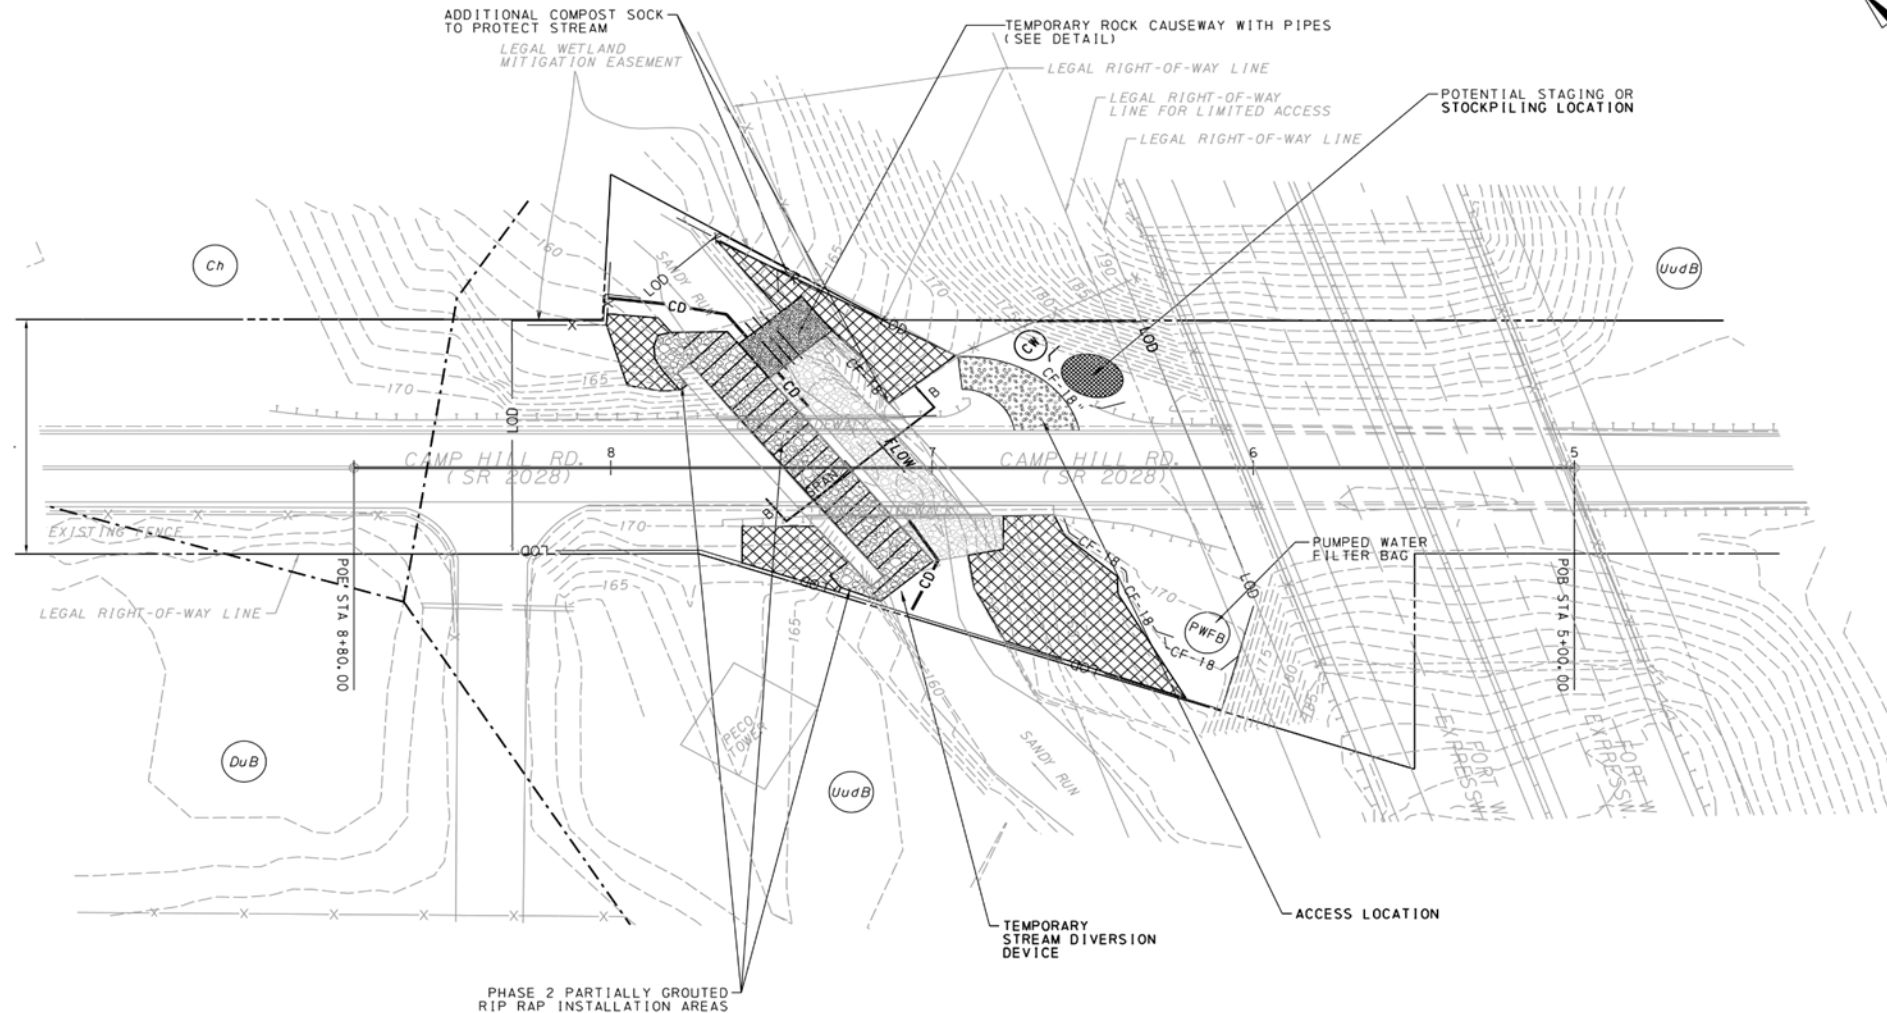
DISTRICT	COUNTY	ROUTE	SECTION	SHEET
6-0	MONTGOMERY	202B	PGR	9 OF 9
WHITEMARSH TOWNSHIP				
REVISION NUMBER	REVISIONS	DATE	BY

1. PUMP WORK AREA AS REQUIRED TO MAINTAIN DRY WORK AREAS. PUMPED WATER FROM WORK AREAS MUST BE DISCHARGED THROUGH A SEDIMENT CONTROL DEVICE SUCH AS A PUMPED WATER FILTER BAG.
2. TEMPORARY CONSTRUCTION FENCING SHALL BE PLACED ALONG WETLAND MITIGATION LIMITS DOWNSTREAM OF THE BRIDGE TO PREVENT ACCESS TO THE RESTRICTED AREA.
3. ADJUST AND INSTALL ADDITIONAL COMPOST FILTER SOCK AS REQUIRED FOR PHASE 2.
4. INSTALL PARTIALLY GROUTED RIP RAP IN DESIGNATED AREAS IN DRY CONDITIONS.
5. AT ALL SUBSTRUCTURES, PGR SHALL BE INSTALLED LEVEL WITH THE TOP OF FOOTINGS.

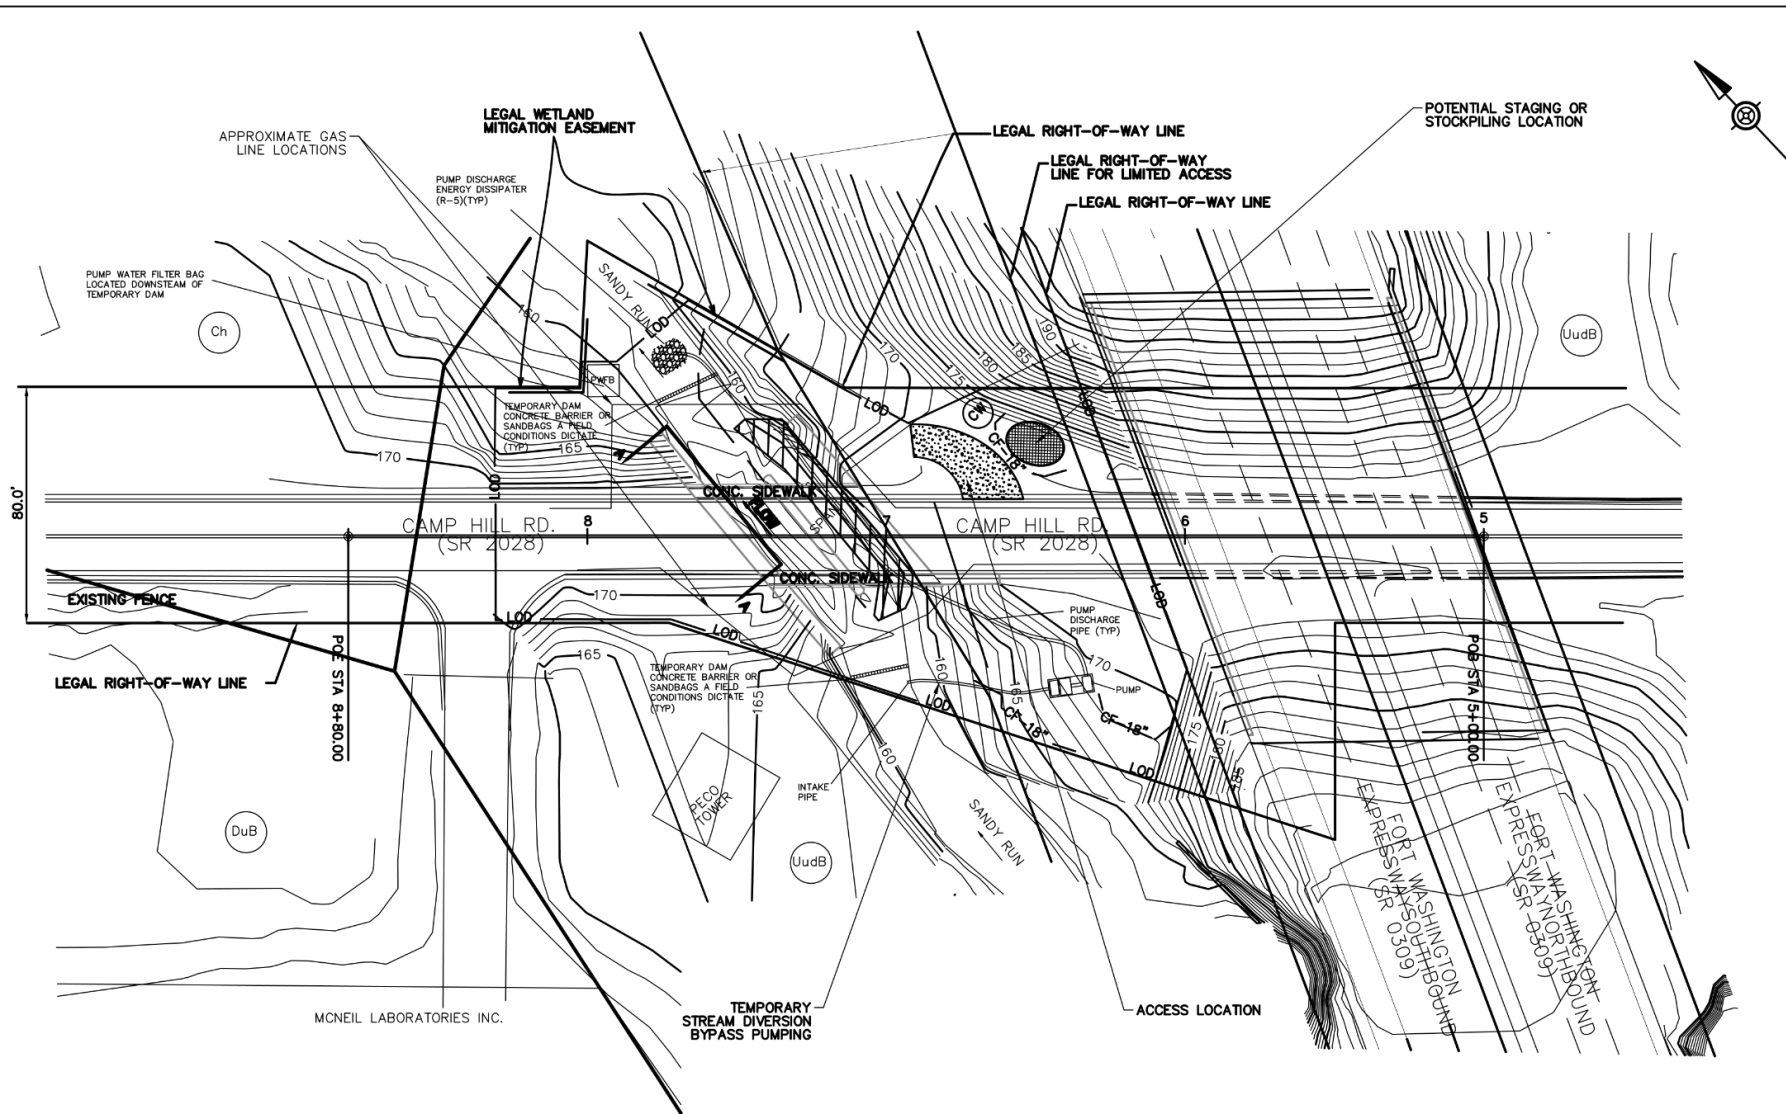
DISTRICT	COUNTY	ROUTE	SECTION	SHEET
6-0	MONTGOMERY	202B	PGR	9 OF 10
WHITEMARSH TOWNSHIP				
REVISION NUMBER	REVISIONS	DATE	BY

1. PHASE 1 EXCAVATION TO OCCUR WITHIN DESIGNATED AREAS ONLY.
2. PUMP AS REQUIRED TO MAINTAIN DRY WORK AREAS. PUMP WATER FROM WORK AREAS MUST BE DISCHARGED THROUGH A SEDIMENT CONTROL DEVICE SUCH AS A PUMPED WATER FILTER BAG.
3. TEMPORARY PROTECTIVE FENCING SHALL BE PLACED ALONG WETLAND MITIGATION LIMITS DOWNSTREAM OF THE BRIDGE TO PREVENT ACCESS TO THE RESTRICTED AREA.
4. MAINTAIN 5' MINIMUM CLEARANCE FROM EXISTING GAS LINES.

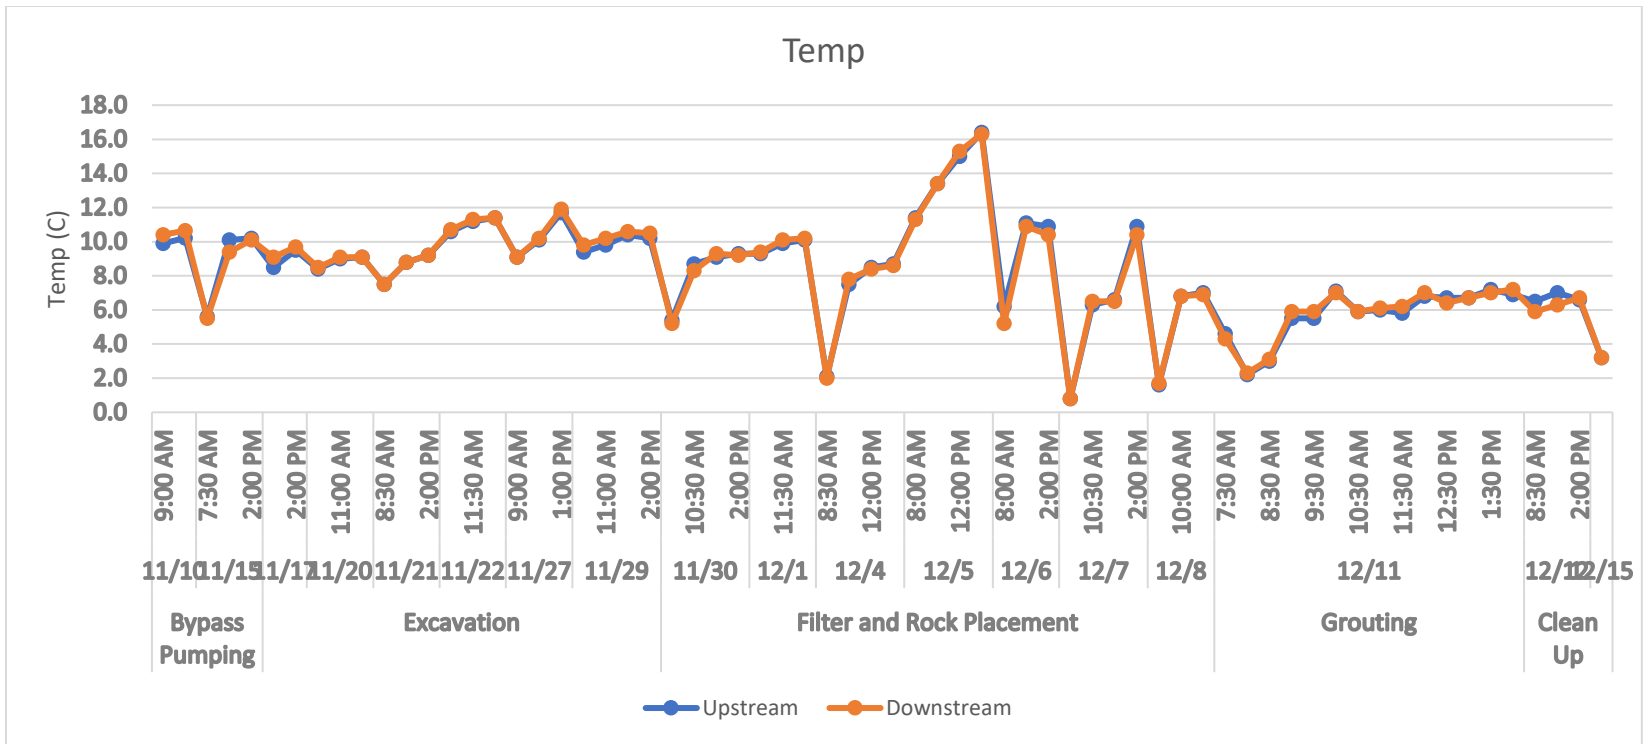
Figure 11: Temperature measurements before, during, and after the construction of PGR at Bridge SR 2028

Results from temperature testing before, during, and after the construction of PGR bridge SR 2028 is shown in Figure 11. Upstream and downstream temperature was nearly the same throughout the construction period of PGR as shown in Figure 11.

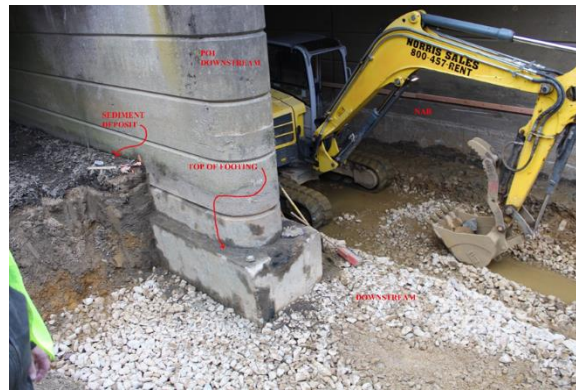
Photo 50 Cross-Section of the Streambed in Span 2

is no scour present. Additionally, the intended design of the scour countermeasure for bridge SR 2028 was to direct all the water flow into Span 1 due to miss alignment of the upstream channel with the bridge opening and the constant sediment built up in Span 2 that would prevent water flow through Span 2. The observed scouring of the streambed in Span 2 and the sediment built-up in Span 2 after one year of completing the PGR construction should not be used to define the scour condition of bridge SR 2028. Furthermore, there is no scour in Span 1, bridge SR 2028 should be classified as non-scour critical due to implementation of PGR as a permanent scour countermeasure.

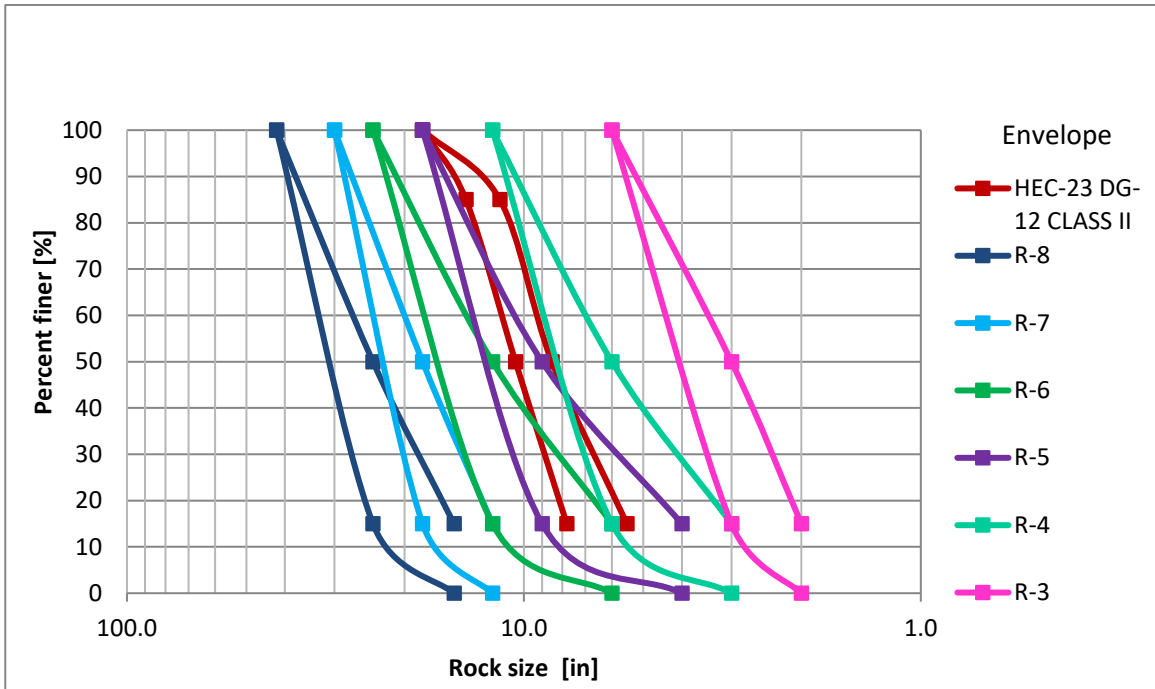
Figure A-1: Comparison of Rock Gradation Envelope Between HEC-23 DG-12 Class II and PennDOT Class Size No R-Values

Based upon envelope plotting and comparison shown in Figure A-1, A-2, and A-3, it was found that the Class Size No R-8 and R-7 are comprised of particles too large for PGR, and Class Size No of R-4 and R-3 are comprised of particles too small. As indicated in HEC-23 DG-12, too large or too small particle sizes compromise grout placement in PGR.

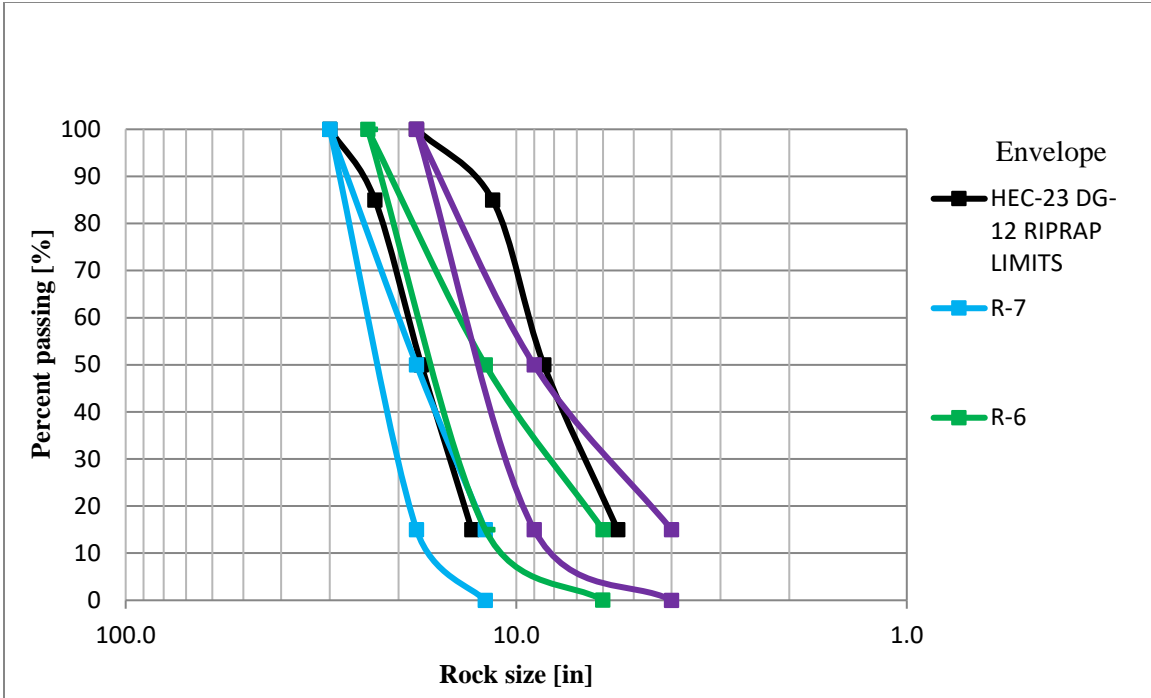
Figure A-4: Gradation Envelope for HEC-23 DG-12 Riprap Class Limits and PennDOT Class Size No R-5, R-6, and R-7

Due to the above-mentioned differences in the classification specifications, none of the PennDOT Class Size No R-Values gradation envelopes fell within a single HEC-23 DG-12 class gradation envelope. Since the HEC-23 DG-12 class II, III, and IV are all suitable for partially grouted riprap and not velocity dependent, a new gradation envelope can be formed with the minimum gradation for HEC-23 DG-12 class II as the lower bound, and the maximum gradation for HEC-23 DG-12 class IV as the upper bound. With this new gradation envelope shown in Figure A-4 and A-5, it is shown that R-6 classification envelope resides within the HEC-23 DG-12 recommended limits.

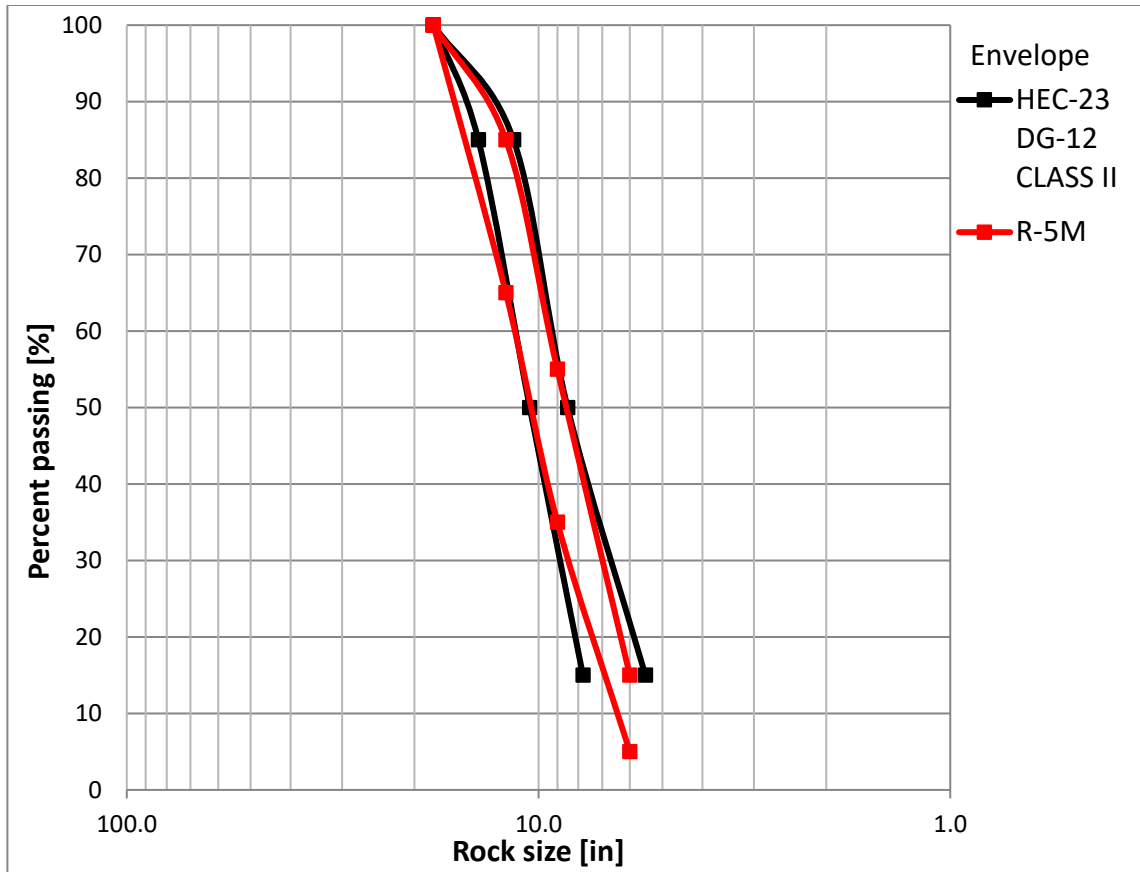
Figure A-6: Rocks Gradation of R-5M and HEC-23 DG-12 Class II

The modified size and gradation of R-5M, R-6M, and R-7M are plotted against HEC-23 DG-12 class II, III, and IV respectively in Figure A-6 through A-8. The modified size and gradation of R-5M, R-6M, and R-7M coincide with HEC-23 recommended classes for PGR and thus can be used for PGR applications.

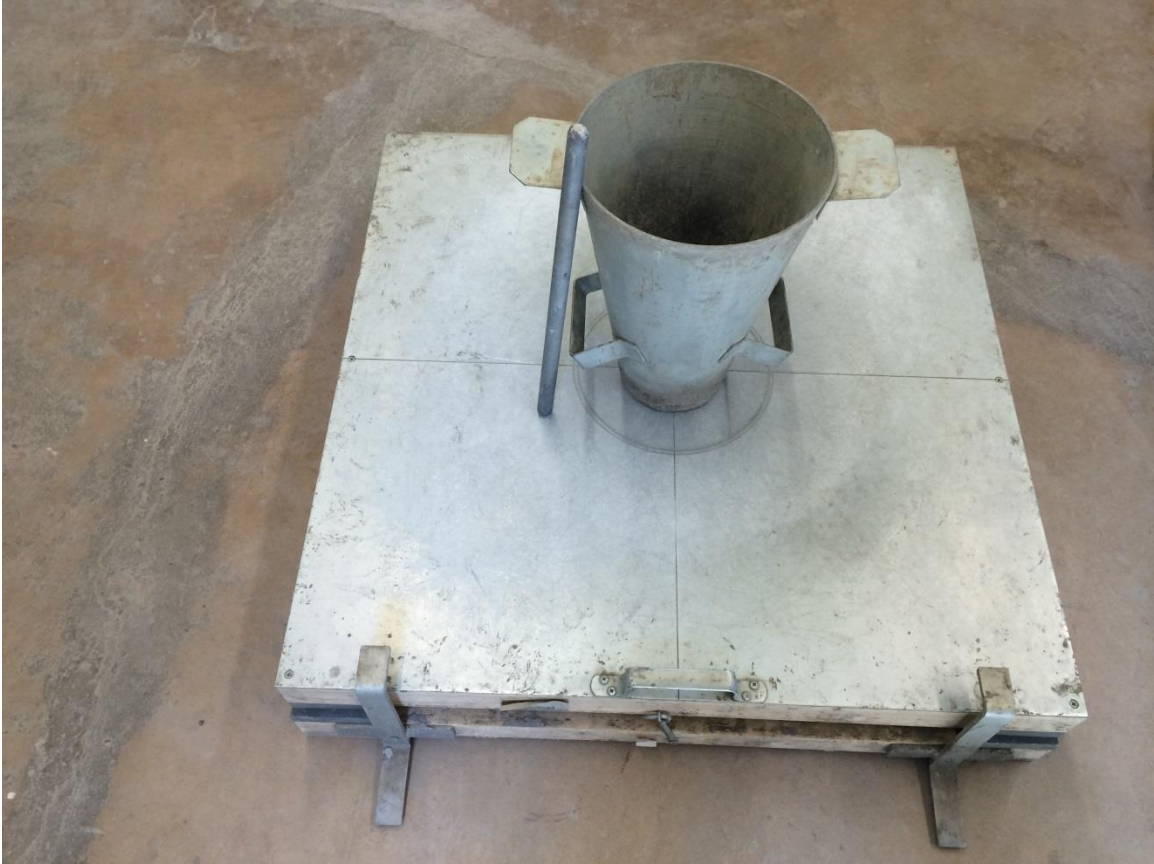
Photo B-2: ASTM C 1611 "Standard Test Method for Slump of Self-Consolidating Concrete"  
"Spread-Test"

- ASTM C 1611 “Standard Test Method for Slump of Self-Consolidating Concrete” “Spread-Test” shown in photo B2
- US Army of Engineers Standards CRD-C 61 – 89A “Test Method for Determining the Resistance of Freshly Mixed Concrete to Washing Out in Water”. Only for grout placement in the wet and shown in photo B-3
- ASTM C39 “Standard Test Method for Compressive Strength of Cylindrical Concrete Specimens”.
- ASTM C231 “Standard Test Method for Air Content of Freshly Mixed Concrete by the Pressure Method”.

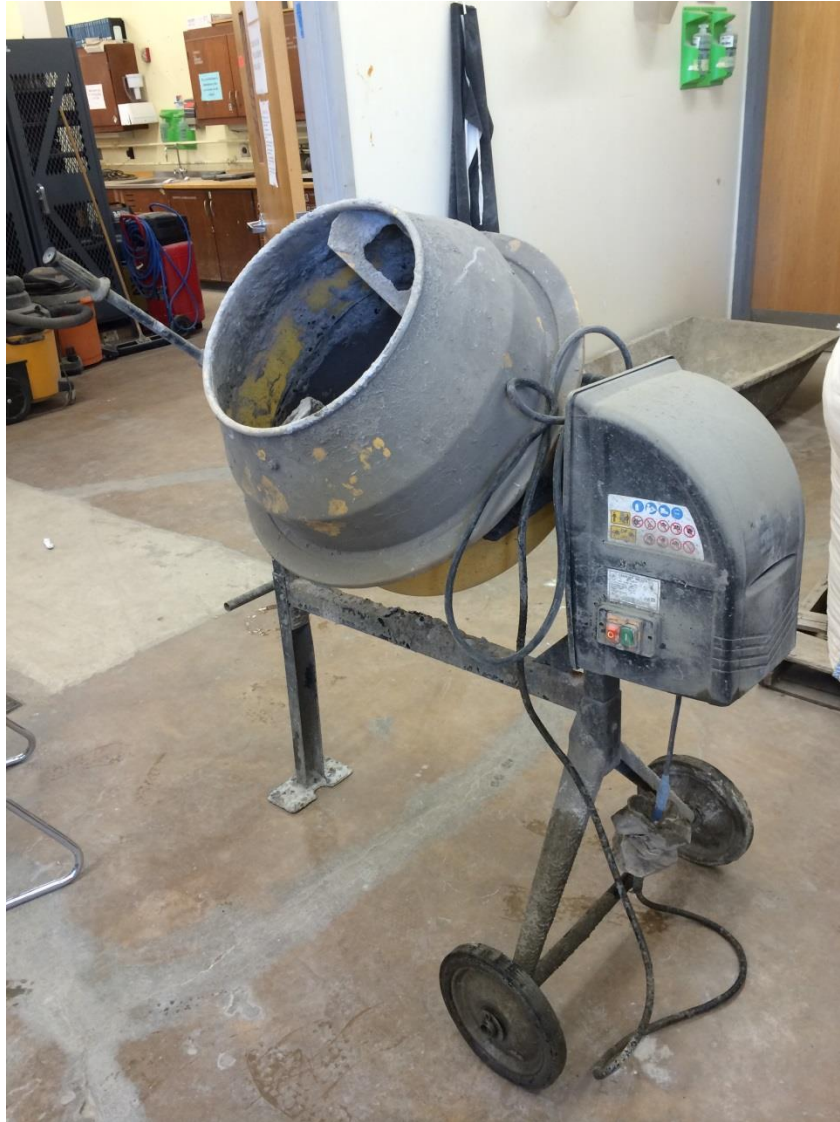
Photo B-4: Concrete Mixer While Mixing Concrete

The required quantity of the grout materials and admixtures for each batch mix were weighed in separate containers. The dry material (cement, fine aggregate and coarse aggregate) were placed in the drum of electrically powered one cubic yard portable concrete mixer shown in photo 4 and mixed for five minutes. Then the water, air-entraining admixture, and water-reducing admixture were added to the dry materials of the batch and the grout mixed for five minutes. For grout to be placed in the wet, the anti-washout admixture added last to the mix and the grout mixture were mixed for additional five minutes.

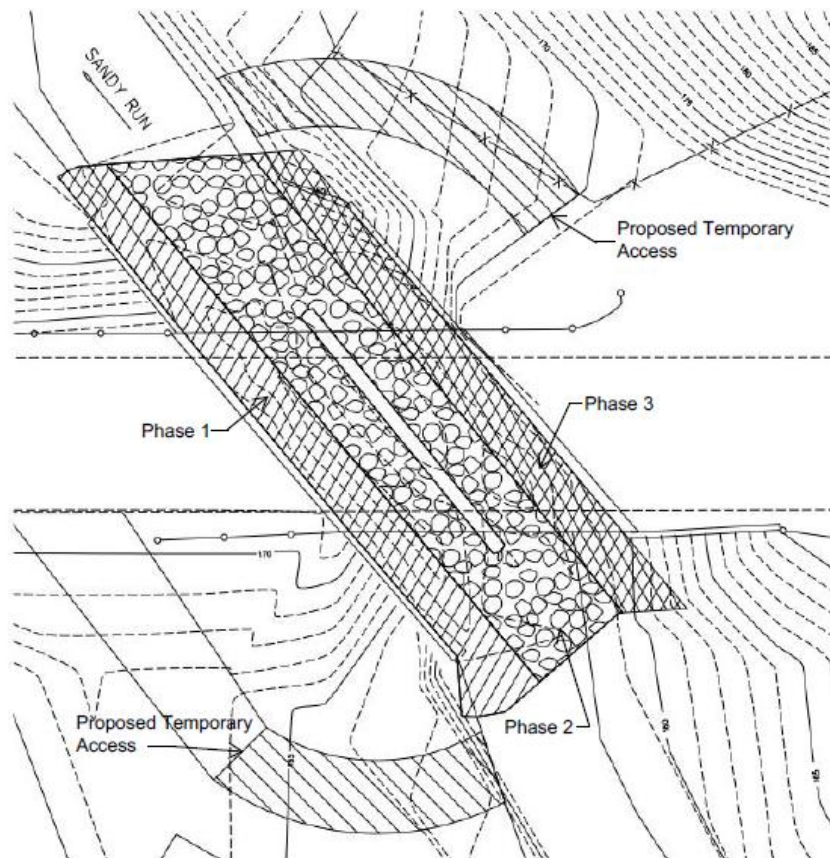
Figure 1 Preliminary Phasing Plan

The installation of the proposed countermeasure will follow an assumed phased approach that will allow for access to parts of the channel, abutments and pier. This phase approach does not represent the finale design approach. Further, since all work for the proposed project is to be completed near the foundations of the existing structure, Temple/CHA does not anticipate that a detour or temporary bridge will be necessary. An explanation of the assumed phasing is provided in Figure 1. The final installation and construction details for the temporary condition will be developed during the final countermeasure design.
