Controlling Debris at Pennsylvania Bridges

FINAL REPORT

October 2008

By S. A. Sheeder and P. A. Johnson
The Thomas D. Larson
Pennsylvania Transportation Institute

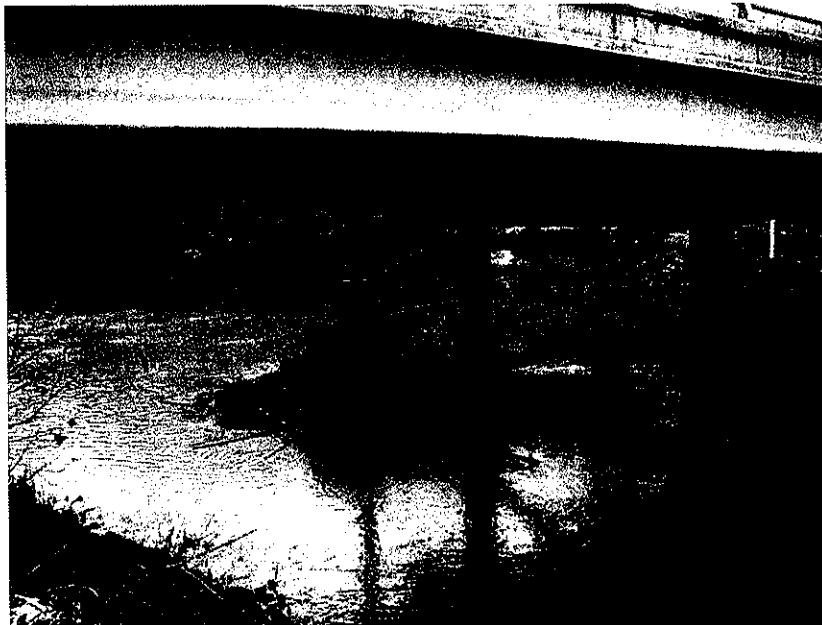
BENT #29 WITH DRIFT

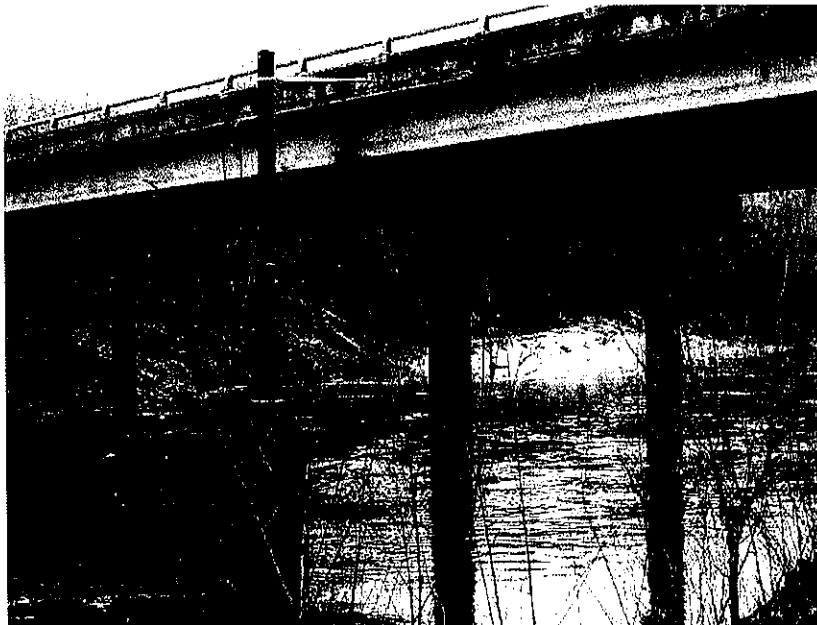
BENT #29 & DRIFT PROTECTOR

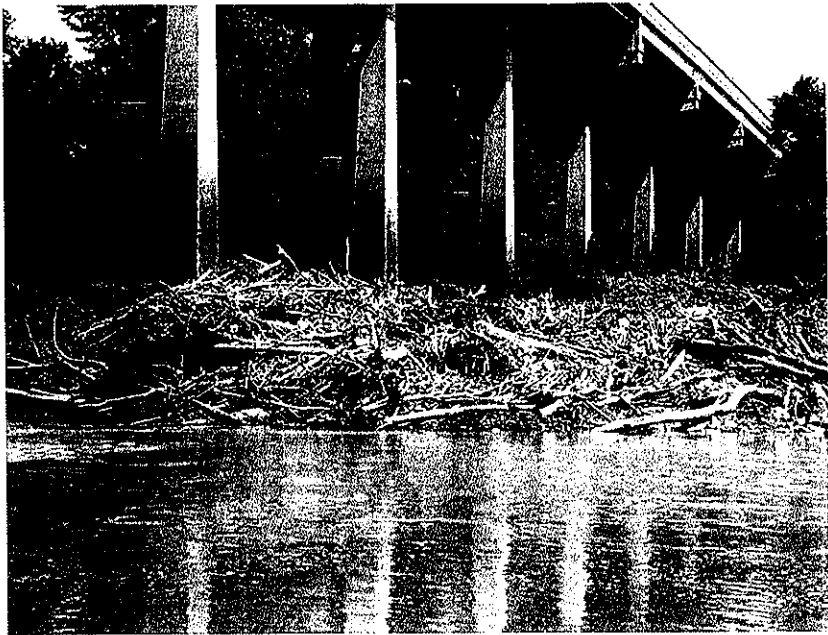
DRIFT AT BENT #8, TYPICAL

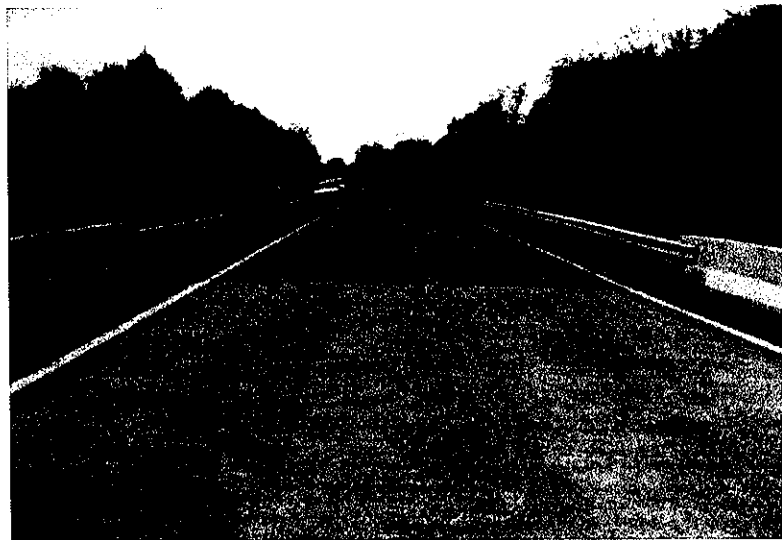
PIC2

#1 END LOOKING BACK

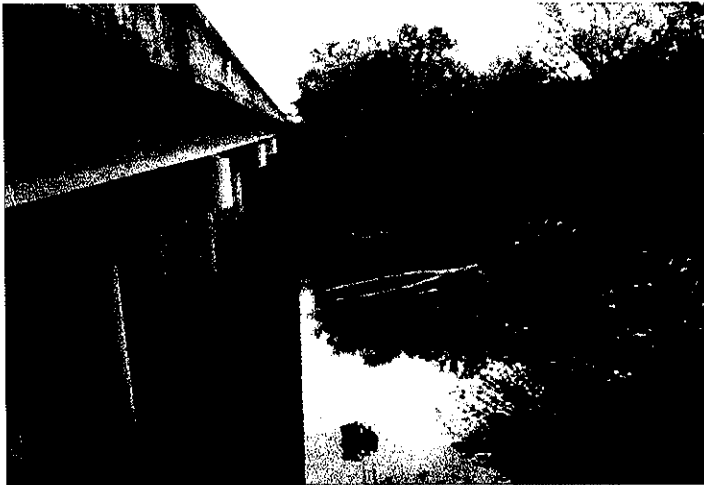
PIC 10

INLET
